## HAZMAT Assessment

**36-38 Maitland Street, Muswellbrook**

Report Ref: E0032-HAZ-001-Rev0

23 February 2023

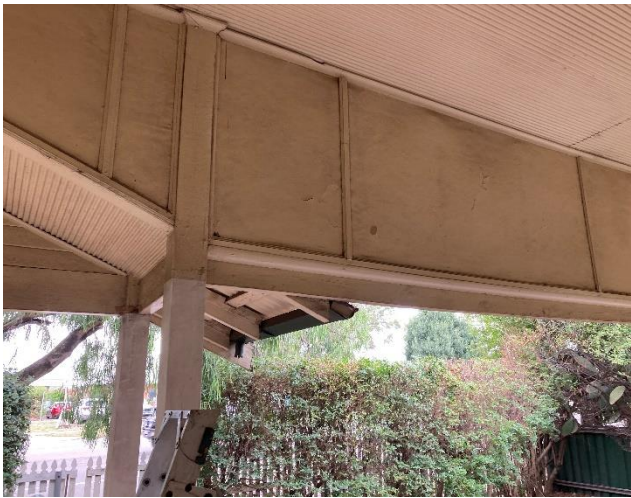
| Location - Description | Hazardous Material | Condition | Sample ID | Signage | |
|---|---|---|---|---|---|
| 38 Maitland Street – Veranda internal cladding | Chrysotile & Crocidolite Asbestos Detected | Good | S8 | No | |
| R4 – Minimal Risk – The material is in good condition and is unlikely to be disturbed during site activity. | | | | | |

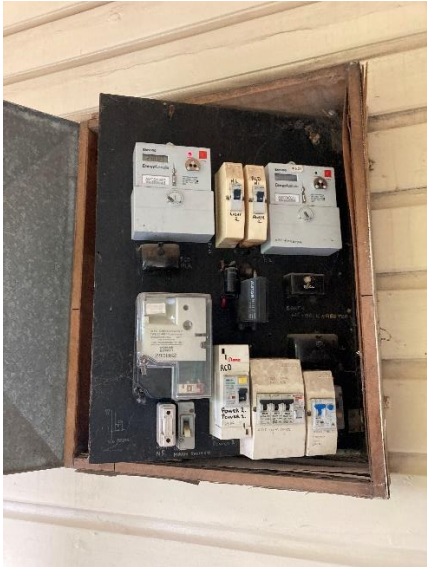
| Location - Description | Hazardous Material | Condition | Sample ID | Signage | |
|---|---|---|---|---|---|
| 38 Maitland Street – Electrical Switchboard backing board (Zelemite) | Presumed Asbestos | Good | N/A | No | |
| R4 – Minimal Risk – The material is in good condition and is unlikely to be disturbed during site activity. | | | | | |

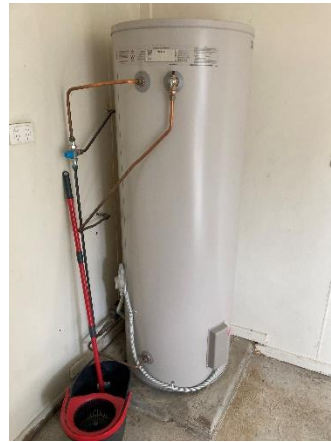
SMF is presumed to be contained within hot water heater identified at the 38 Maitland Street Site. SMF should be removed if degraded or damaged or in the instance they may be disturbed by demolition works.

| Location - Description | Hazardous Material | Condition | Sample ID | Signage | |
|---|---|---|---|---|---|
| 38 Maitland Street – Hot Water System | Synthetic Mineral Fibre (SMF) | Good | - | - | |
| R4 – Minimal Risk – The material is in good condition and is unlikely to be disturbed during site activity. | | | | | |

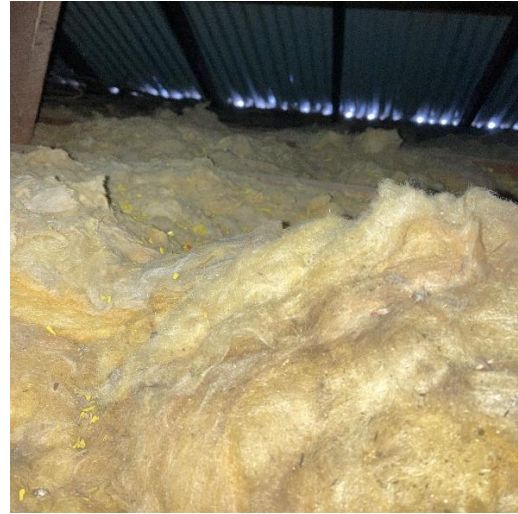
| Location - Description | Hazardous Material | Condition | Sample ID | Signage | |
|---|---|---|---|---|---|
| 38 Maitland Street – Rear/external bathroom – skillion roof insulation | Synthetic Mineral Fibre (SMF) | - | - | - | |
| R4 – Minimal Risk – The material is in good condition and is unlikely to be disturbed during site activity. | | | | | |
