Revised Remediation Action Plan

Proposed School
Lot 100, DP1261496 Maitland Street, Muswellbrook

Prepared for
Pacific Brook Christian School

Project 91601.04
July 2024

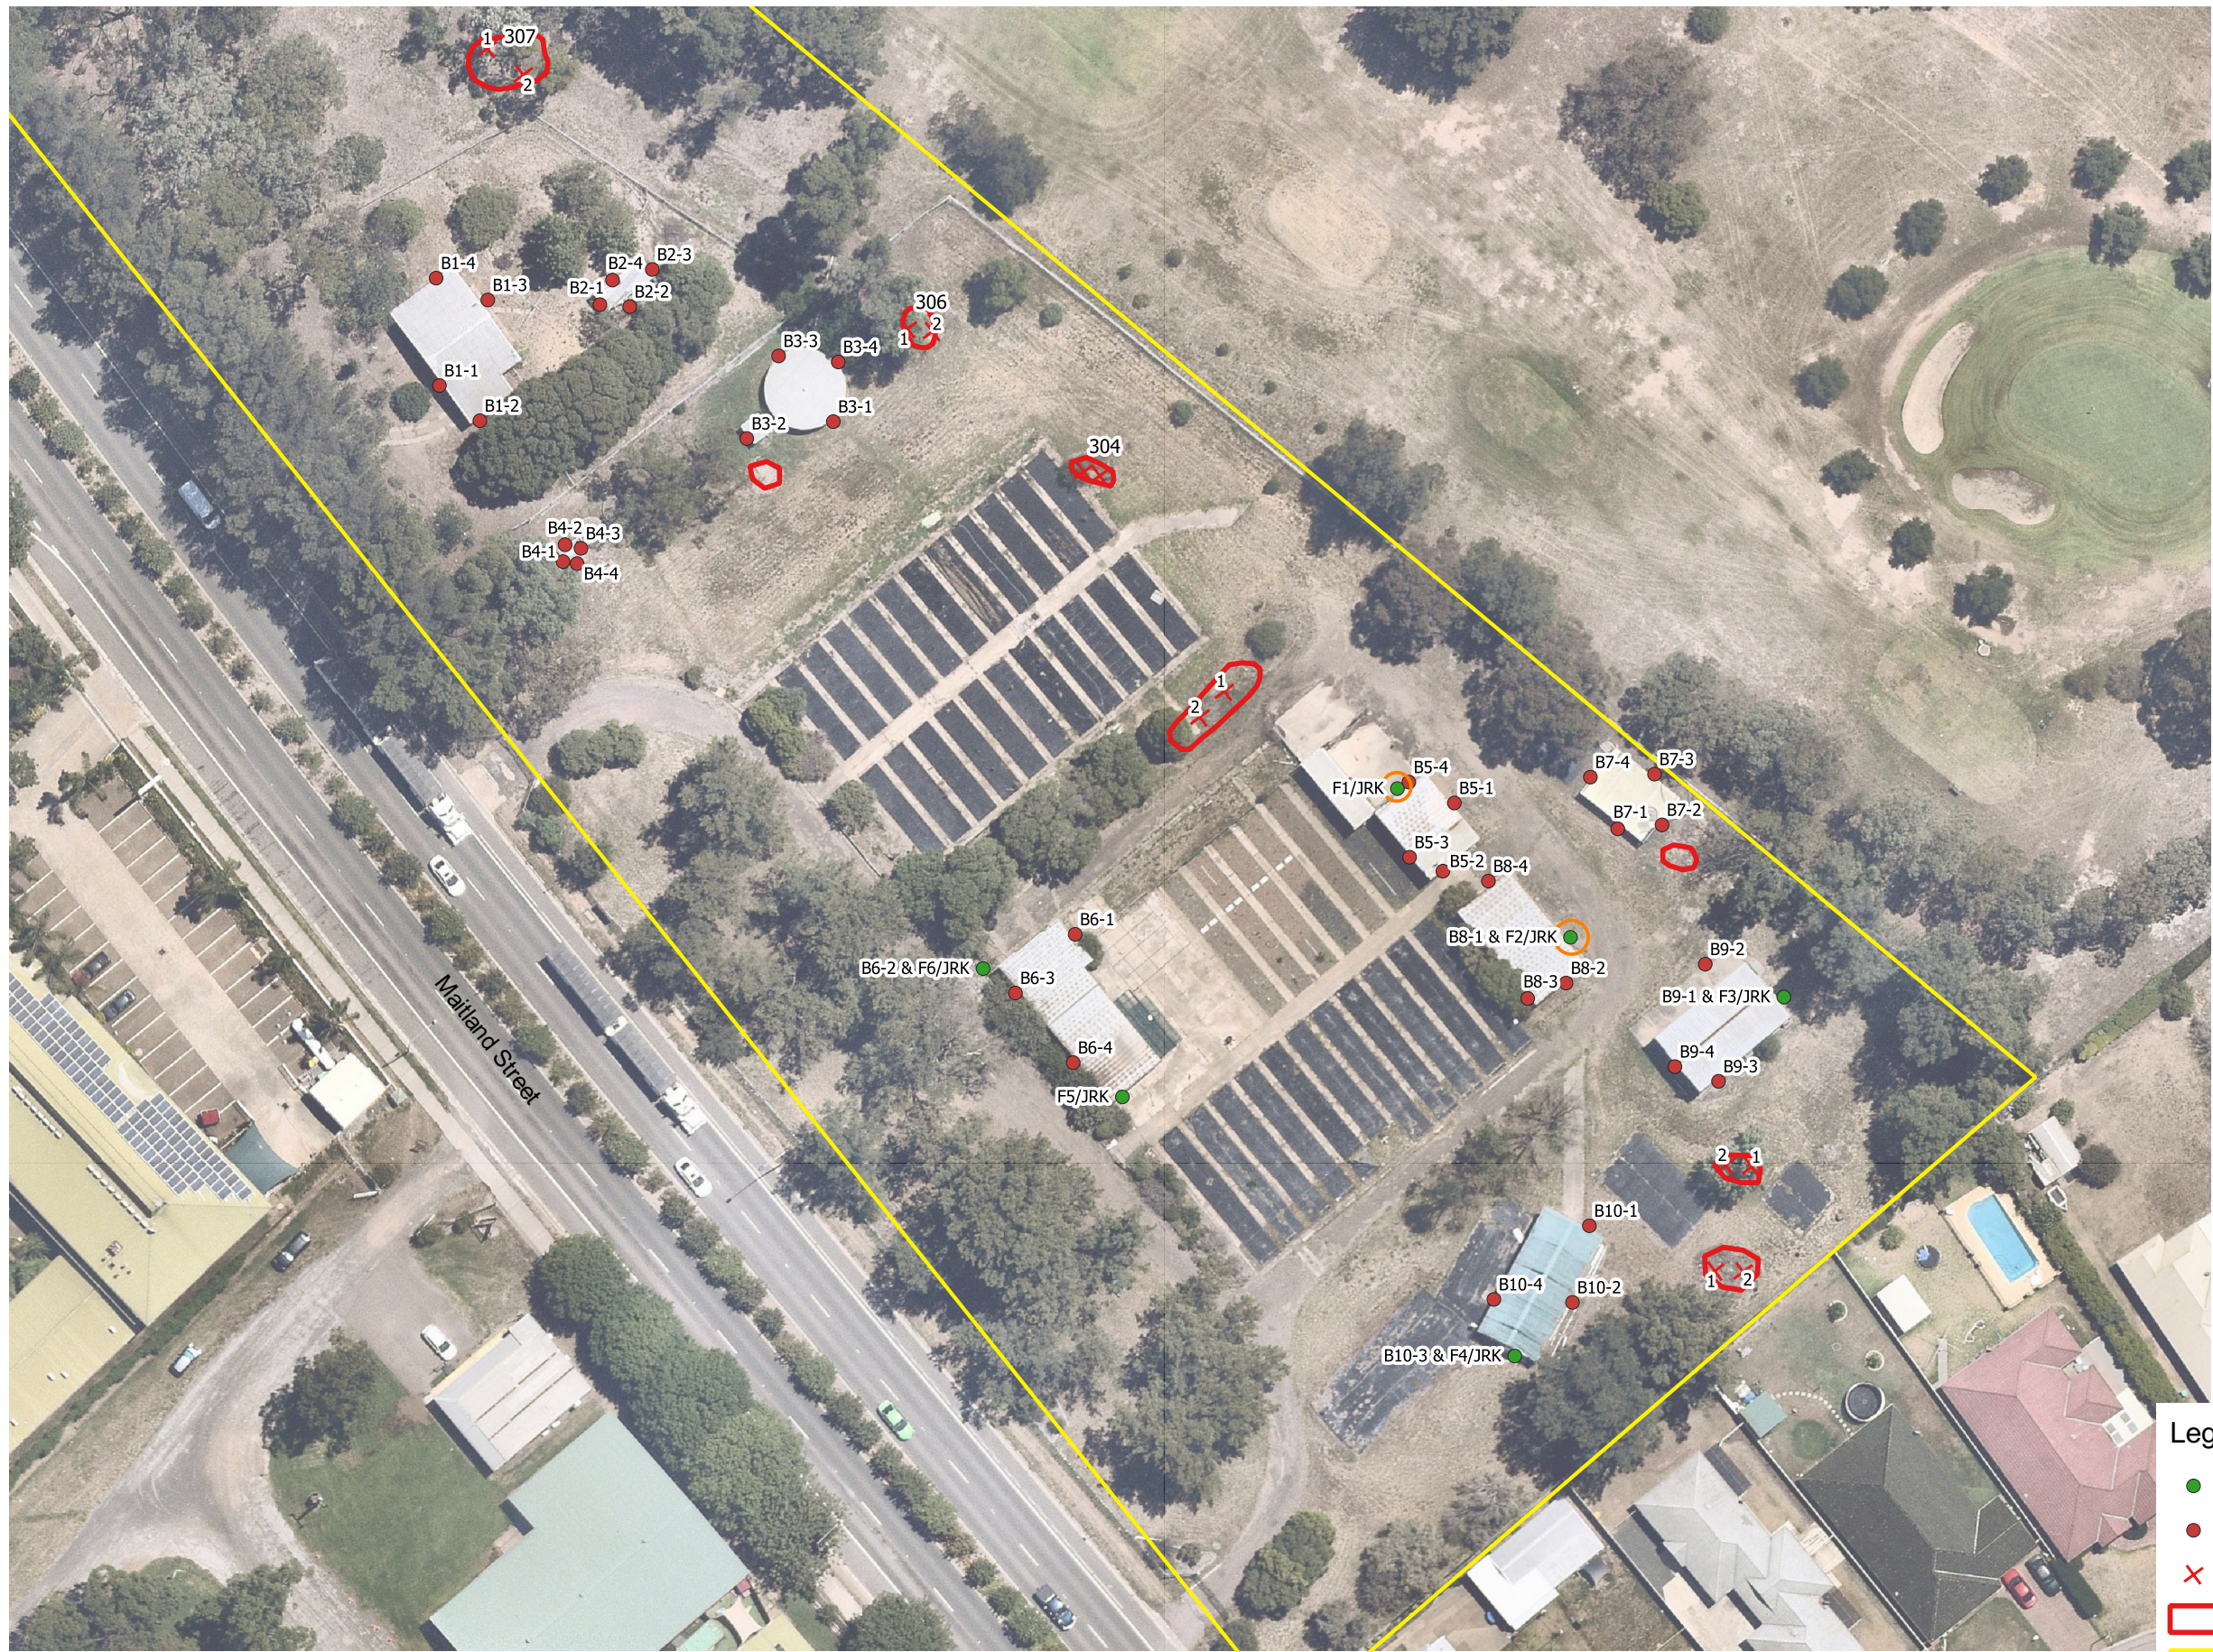
An inspection of the existing building surrounds was also conducted in the supplementary assessment by DP. Fibro fragments (generally in good condition) were observed at the surface adjacent to Buildings 5, 6, 8, 9 and 10, and at the surface in the south eastern portion of the site adjacent to the northern boundary. Testing confirmed the presence of ACM in two fibro fragments observed at the surface adjacent to Buildings 5 and 8 (samples F1/JRK and F2/JRK respectively). Approximate locations of fibro fragments and the confirmed ACM locations are presented on Drawing 2 in Appendix B.

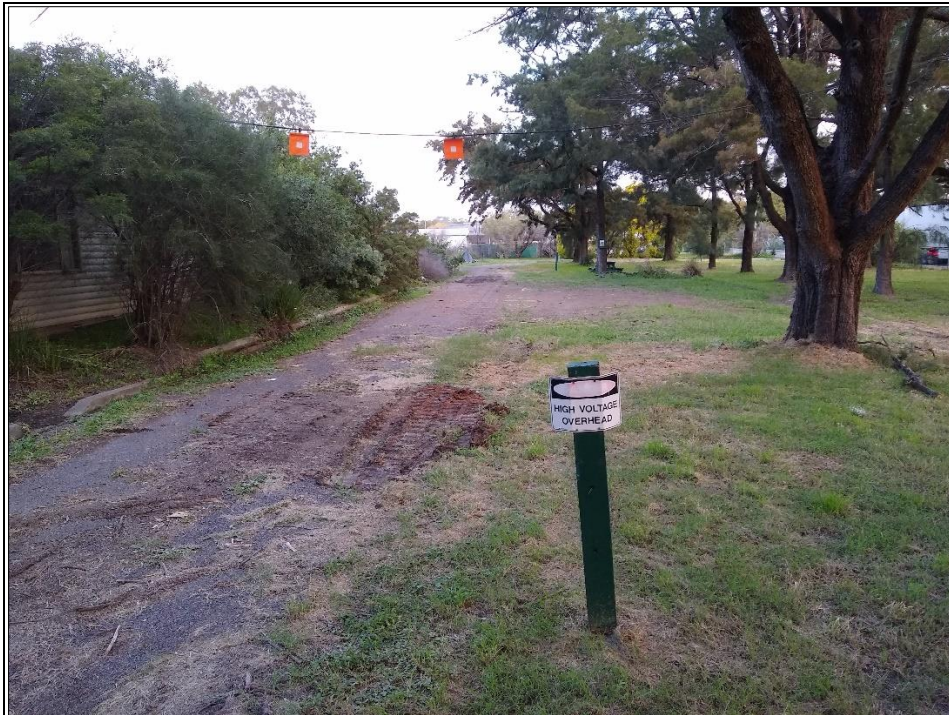
Figure 4: General condition of asphalt access track, south of the buildings, looking east.

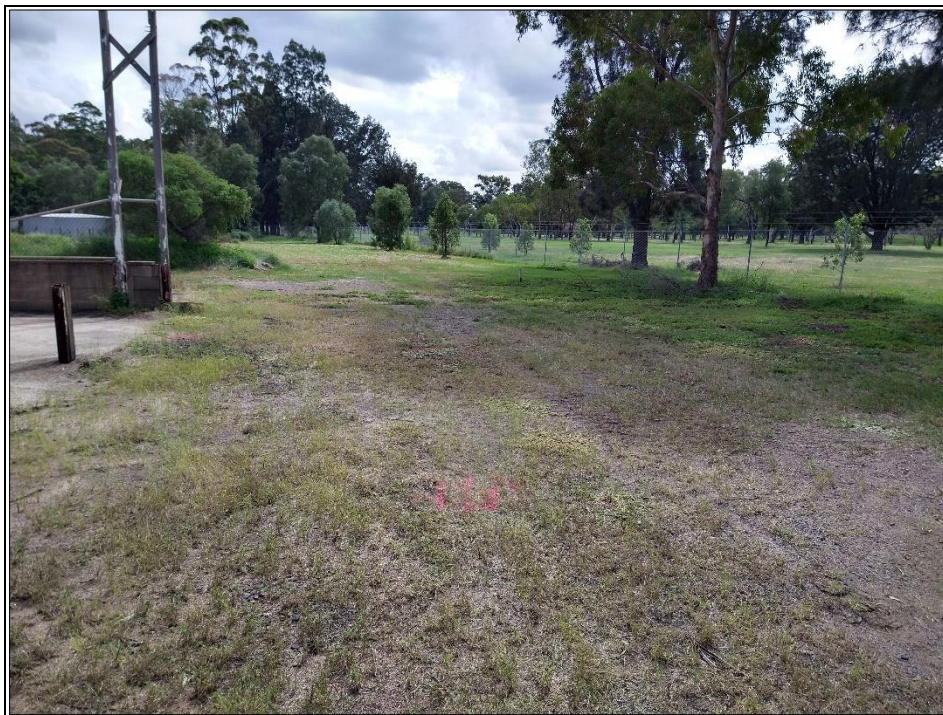
The buried asphalt lenses (associated with a former pavement) were identified within pits north-west of Building 5 (Pits 406, 407, 408, 409, 106 and 106A). The lenses varied in thickness from 20 mm to 100 mm and were generally located below clean granular soils. The lenses were observed from depths of 0.05/0.3 m to depths of 0.1/0.4 m. Refer to Logs in Appendix A for details.

Figure 5: Area of buried asphalt access track, north of the Building 5, looking west.

The following procedures are recommended for the placement of the asphalt impacted materials beneath the Stage 1 carpark pavement:

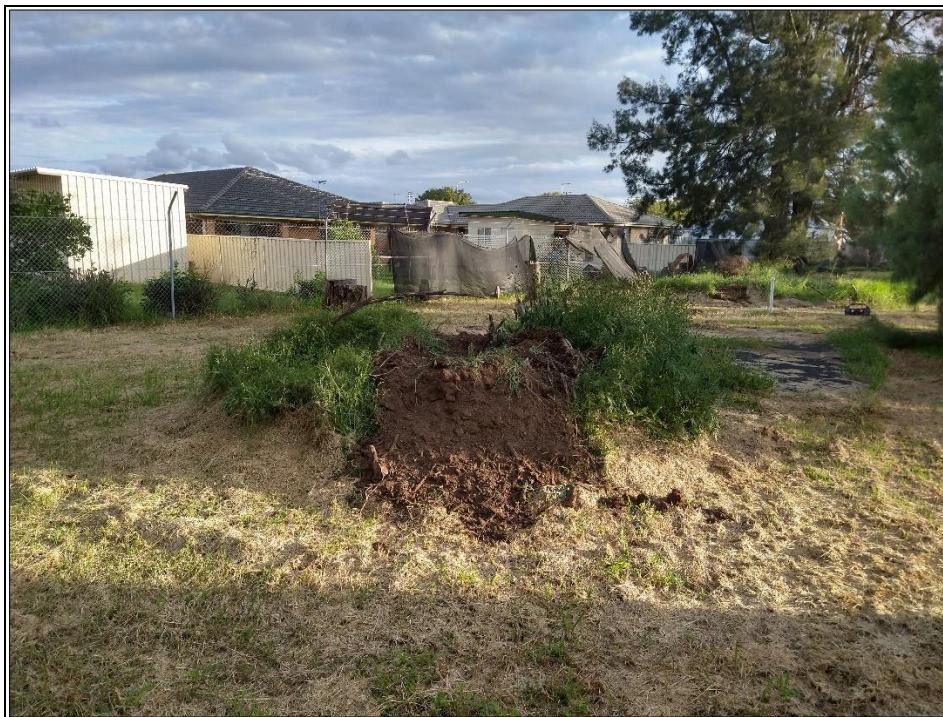
Figure 6: Stockpile 301 located in the eastern portion of the site, generally comprising gravelly silty sand and abundant vegetation.

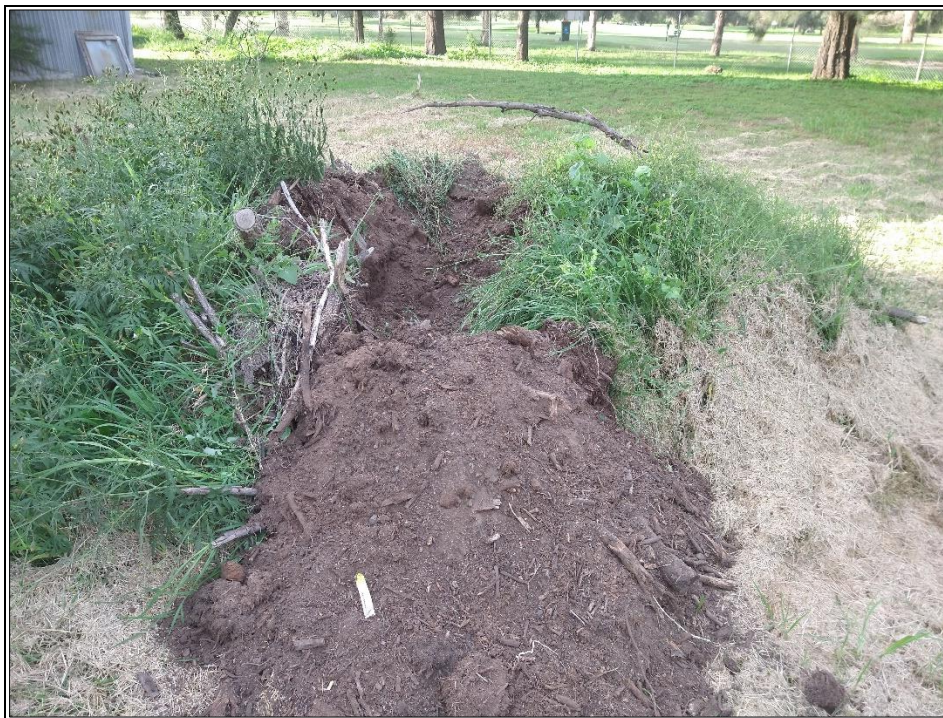
Figure 7: Stockpile 301A located in the eastern portion of the site, generally comprising gravelly silty sand and abundant vegetation.

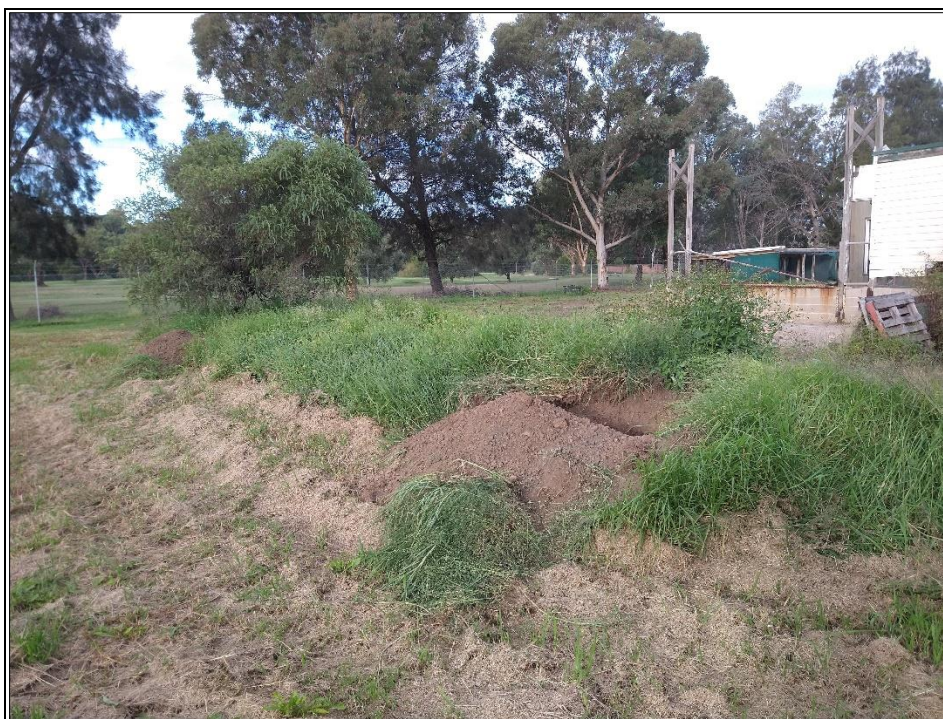
Figure 10: Stockpile 303 located in the central northern portion of the site, generally comprising silty sand and gravel.

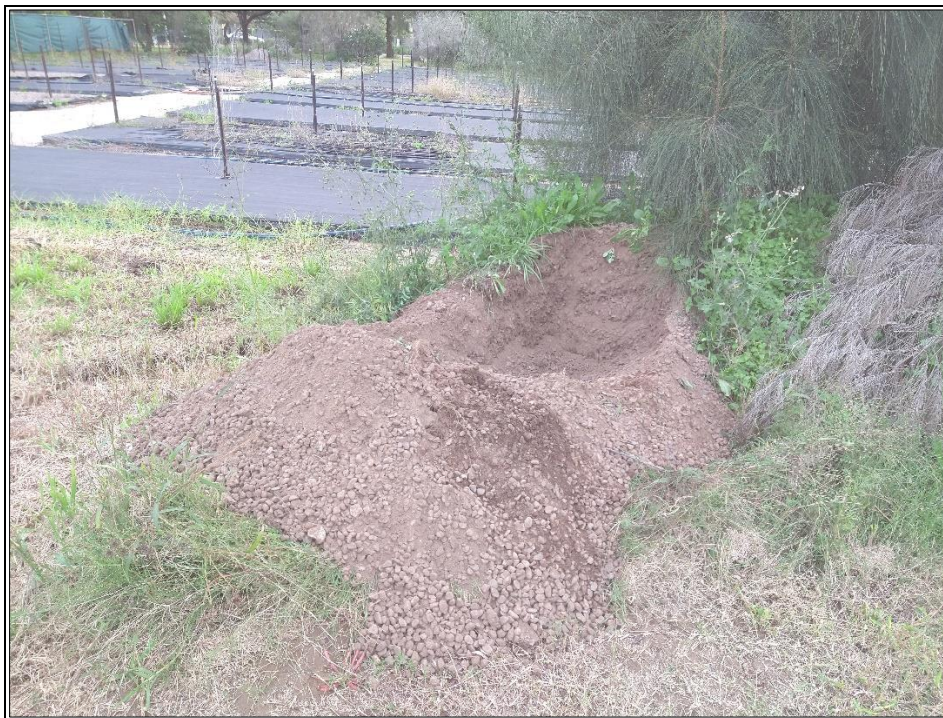
Figure 11: Stockpile 304 located in the central northern portion of the site, generally comprising silty sand and gravel.

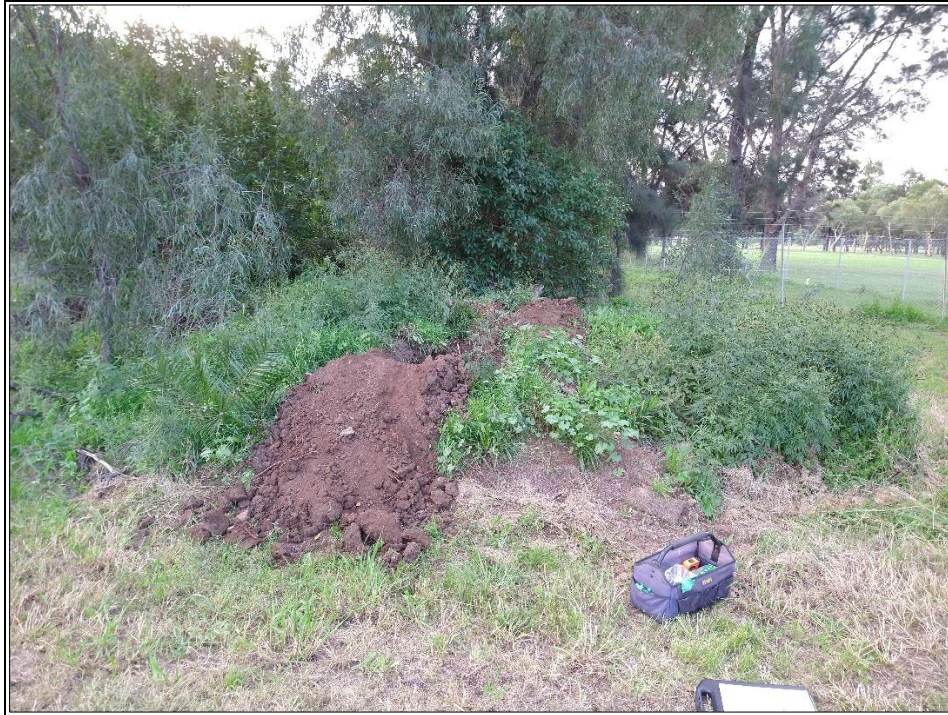
Figure 13: Stockpile 306 located in the central northern portion of the site, generally comprising silty sand and gravel and intermixed clay with trace asphalt.

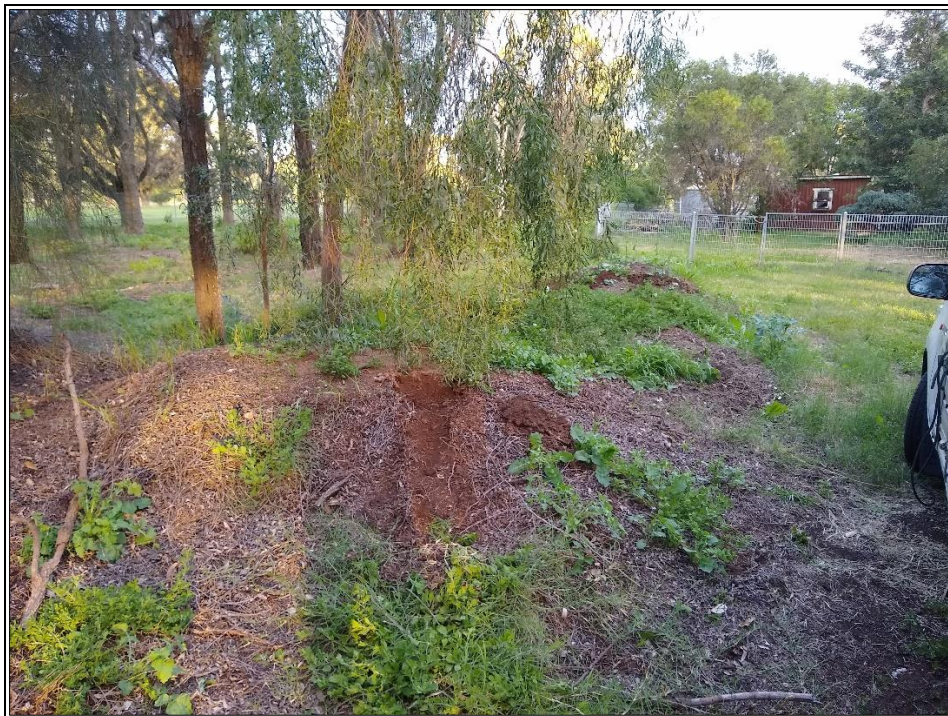
Figure 14: Stockpile 307 located in the western portion of the site, generally comprising silty sand and gravel.

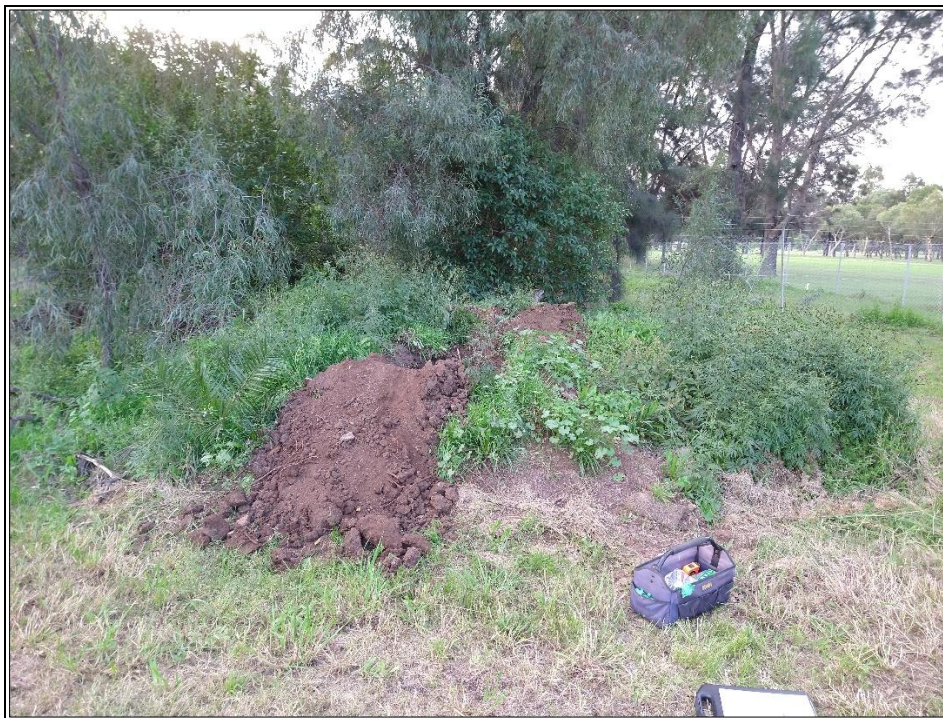
Figure 13: Stockpile 306 located in the central northern portion of the site, generally comprising silty sand and gravel and intermixed clay with trace asphalt.

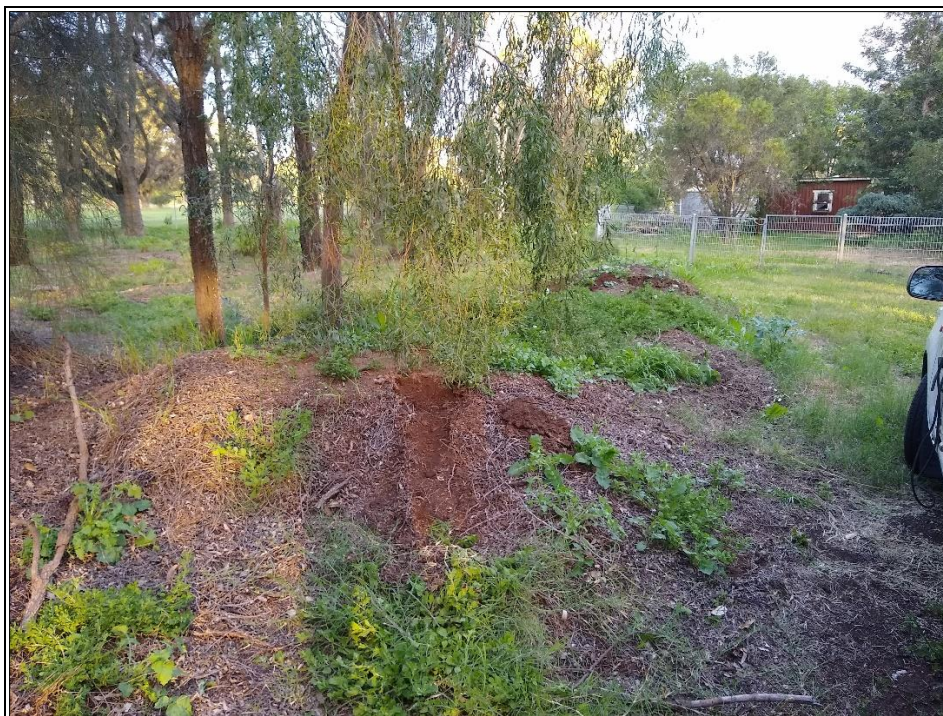
Figure 14: Stockpile 307 located in the western portion of the site, generally comprising silty sand and gravel.

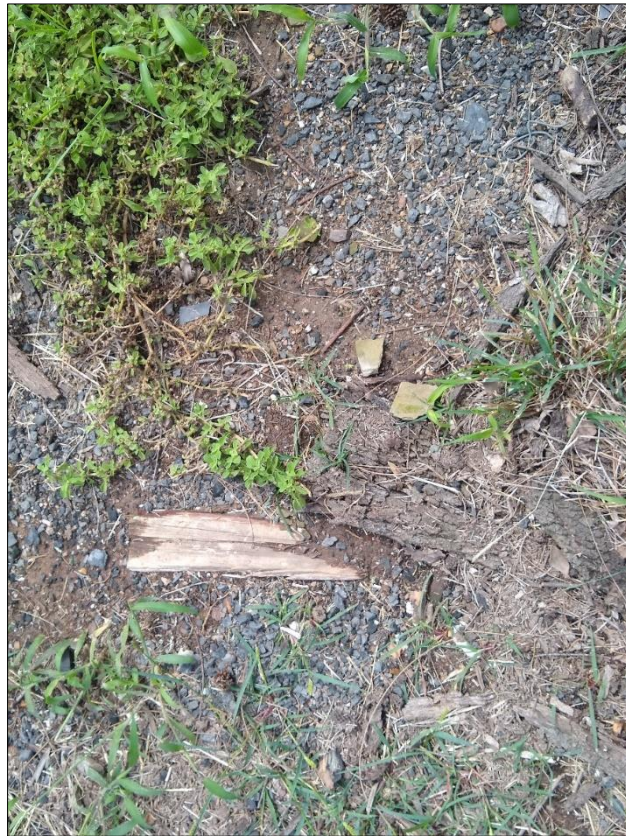
Figure 26: Fibro fragment F3/JRK found along the north eastern face of Building 9.

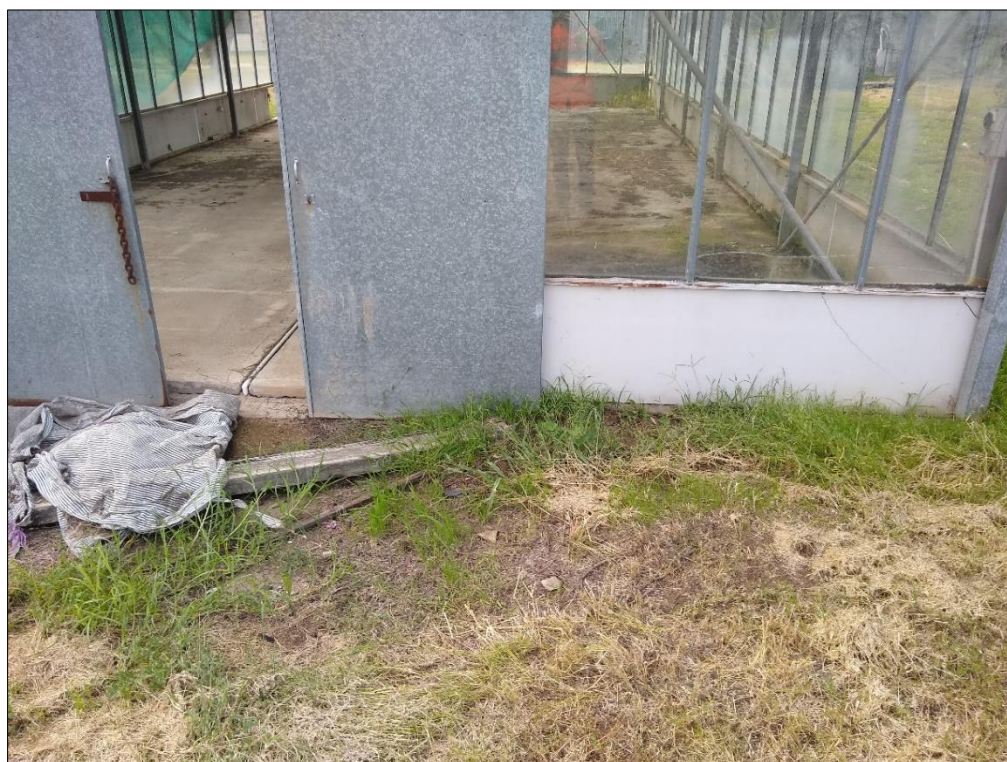
Figure 28: Fibro fragment F4/JRK located along the southern side of Building 10.

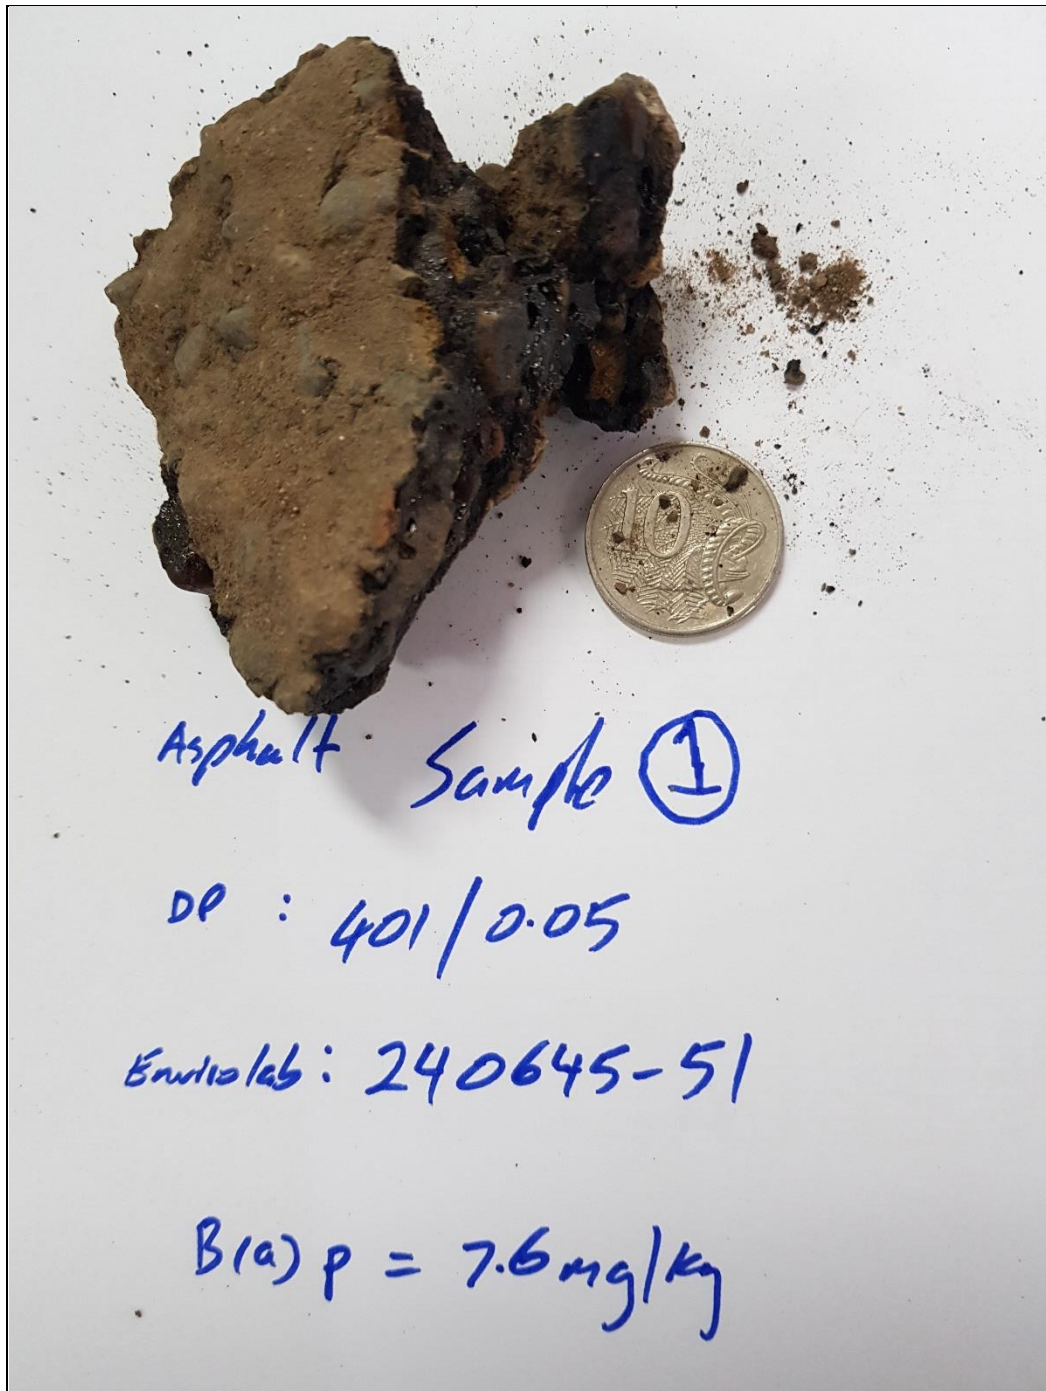
Although the asphalt materials contained elevated PAH, the elevated results can be attributed to the asphalt / bitumen wearing course which typically has low bioavailability and is relatively immobile. The elevated results are therefore not considered to be significant as presented in the supplementary investigation by DP.

Figure 35: Photo of surface asphalt from test pit 401.

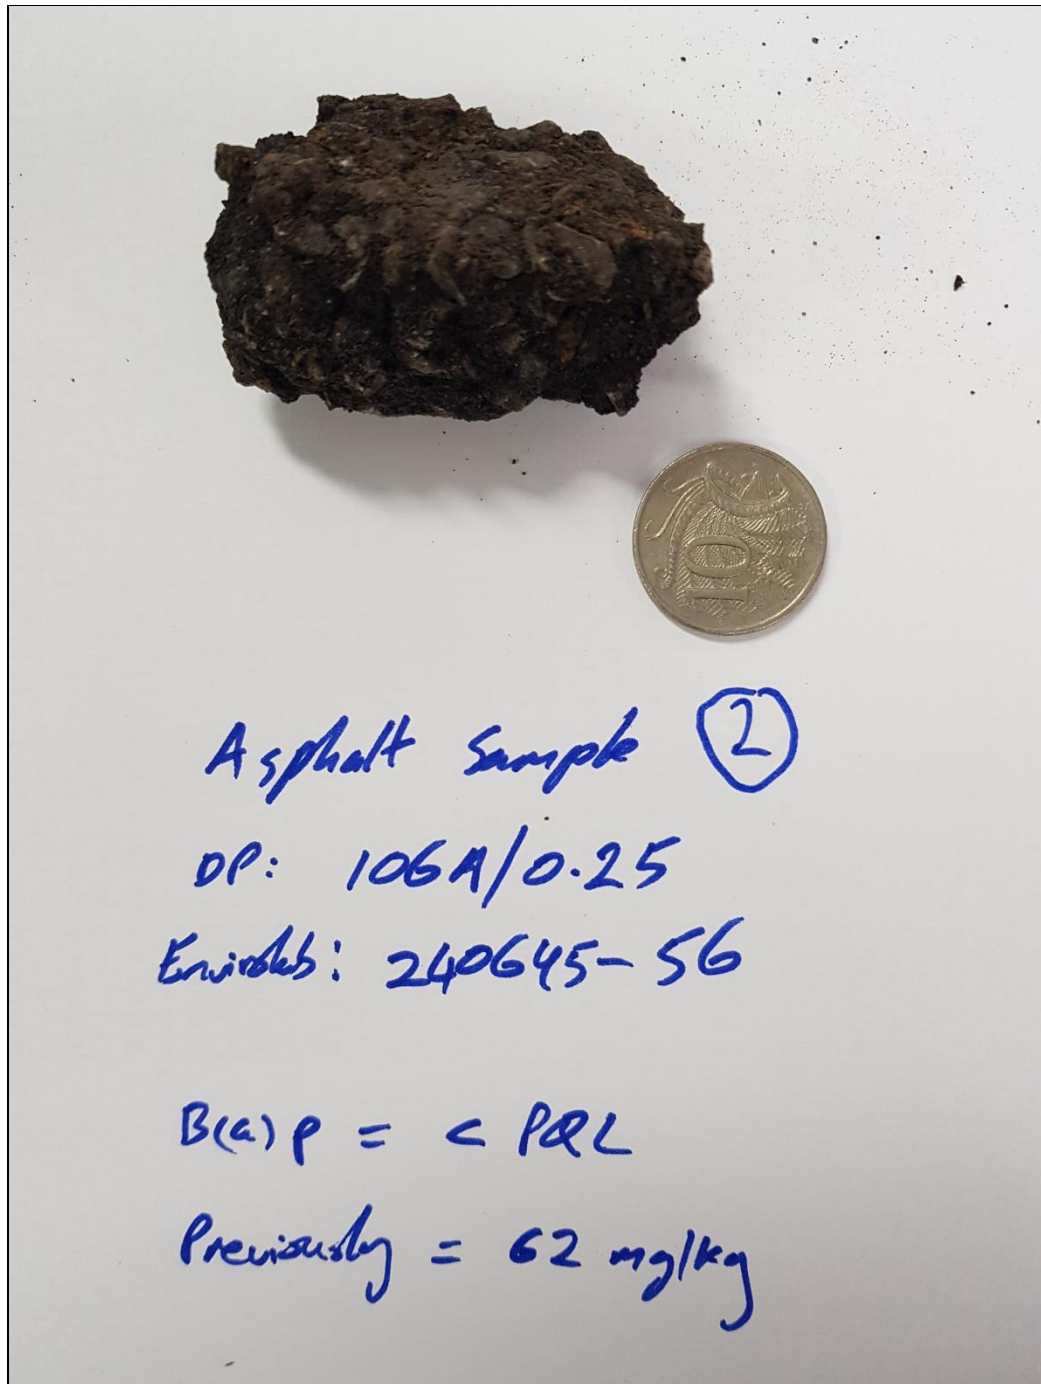
Figure 36: Photo of buried asphalt from test pit 106A.

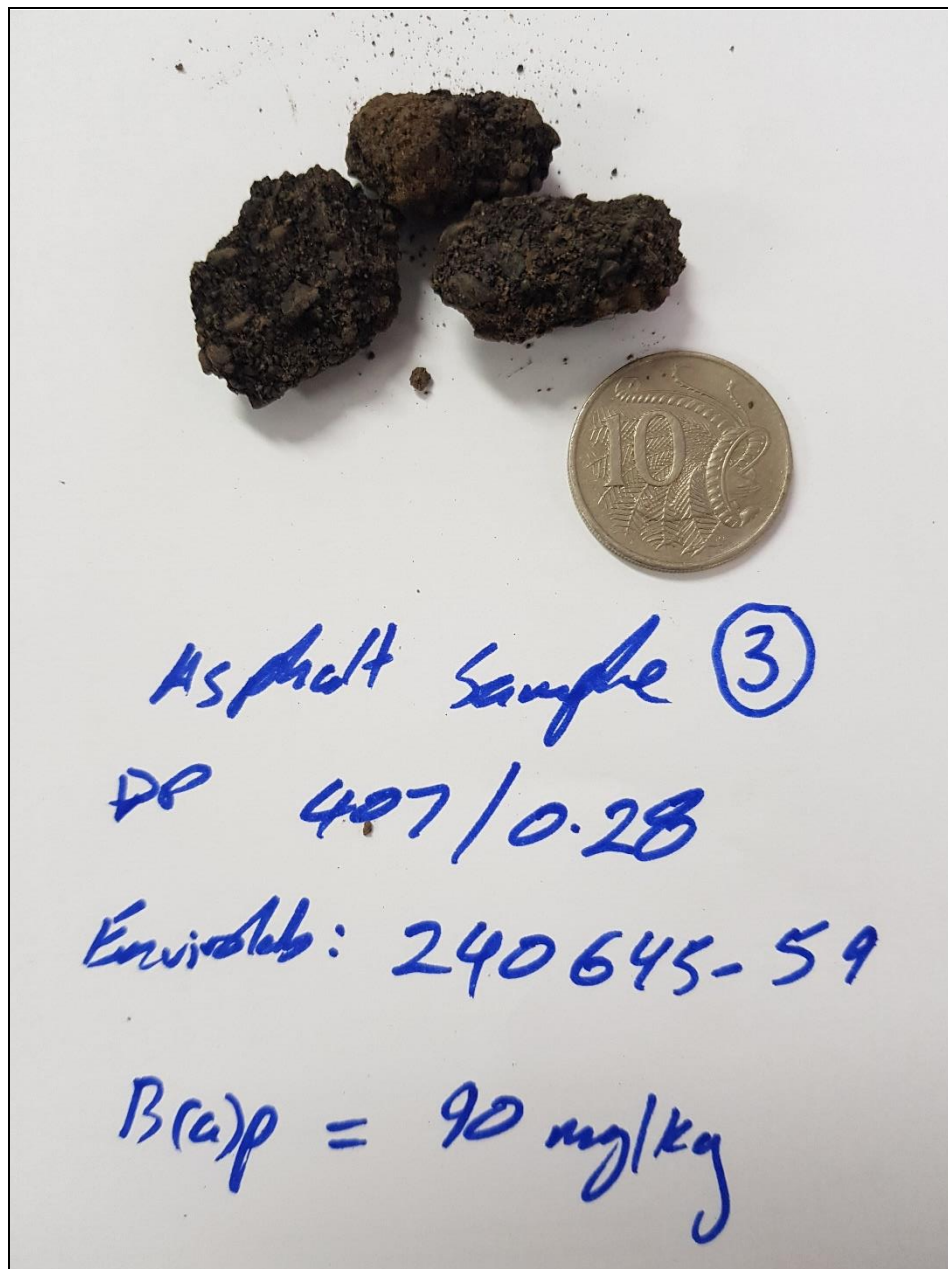
Figure 37: Photo of buried asphalt from test pit 407.

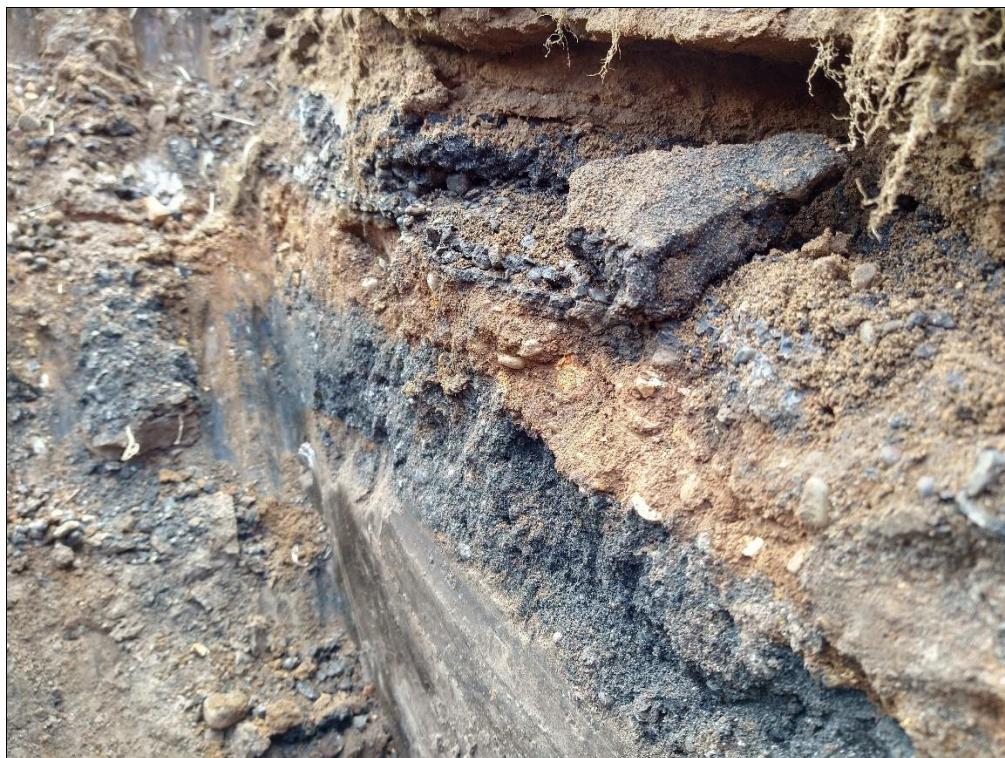
Figure 37: Photo of buried asphalt from test pit 106A (upper dark grey materials and ash filling (lower dark grey materials)).
