# **ARBORIST'S REPORT**

PROPERTY OF THE PROPOSED	84 Brook Street, Muswellbrook NSW
DEVELOPMENT:	
NUMBER OF SUBJECT TREES:	6
DATE OF REPORT:	7 December 2022
REQUESTED BY:	Janssen Designs

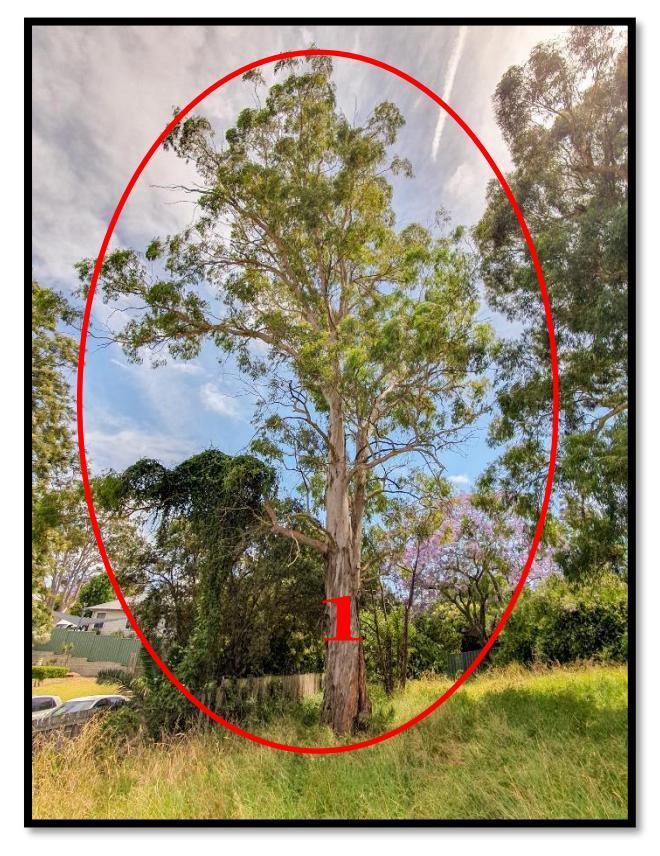
Tree 1 is in fair – health, structurally defective with a fair shape.

Tree 1 is structurally defective and the risk it poses will increase substantially as use under the canopy increases. This tree requires removal.

Tree 1 viewed from the south.

Tree 1 is proposed for removal as it is structurally defective and presents a high risk to the subject and adjacent properties.

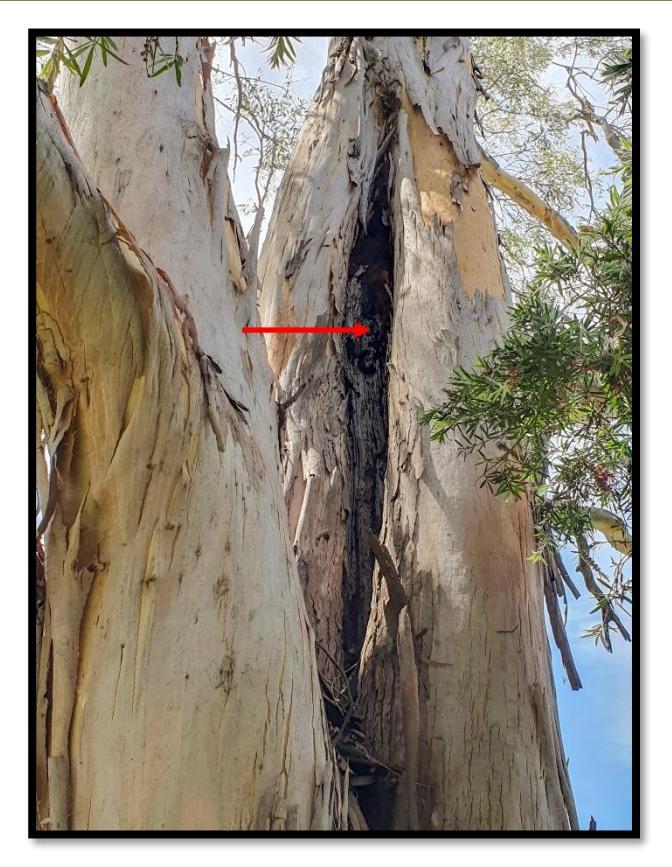
Cavity in the largest stem of Tree1.

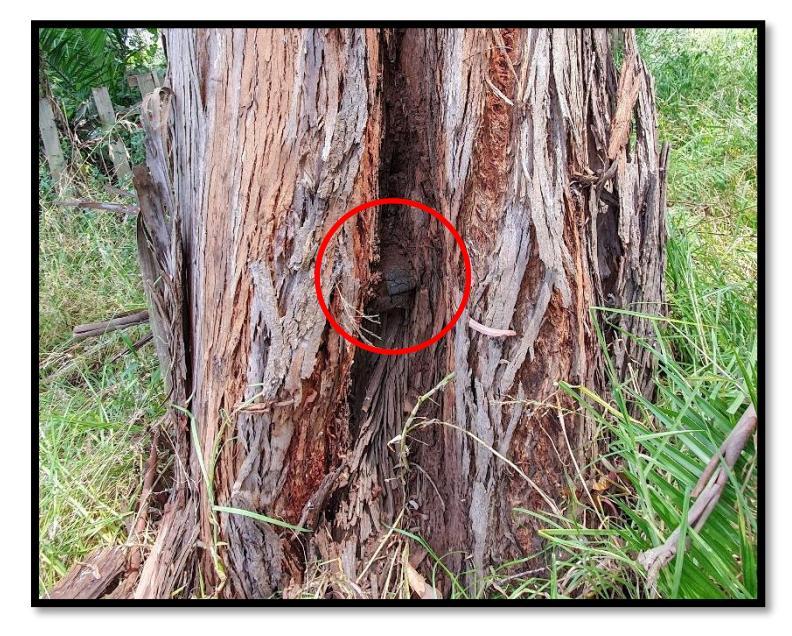
Wood decay fungal bracket at the base of Tree 1.

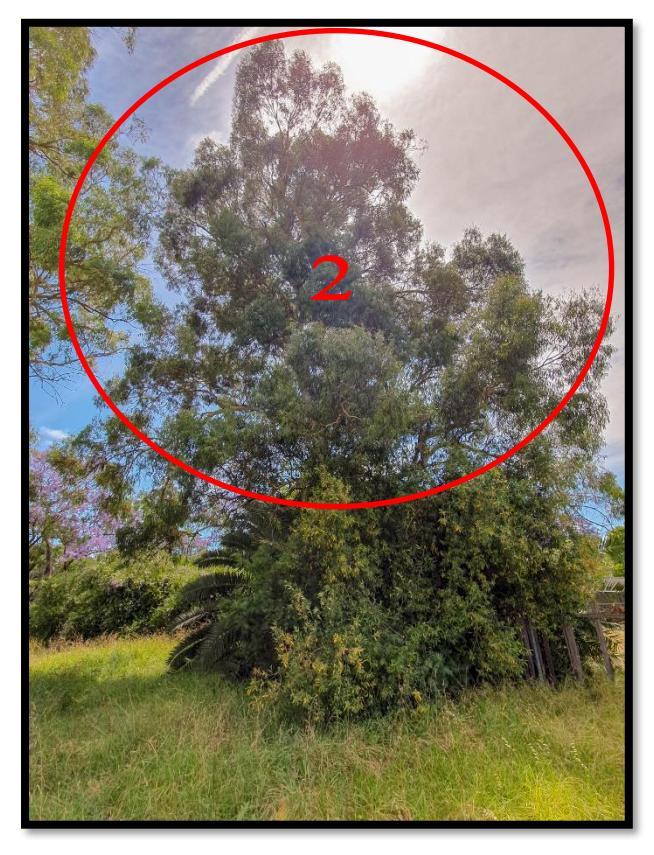
Tree 2 is in good health, structurally sound with a good shape (clearing around the base and an aerial inspection required to confirm).

Tree 2 viewed from the south.

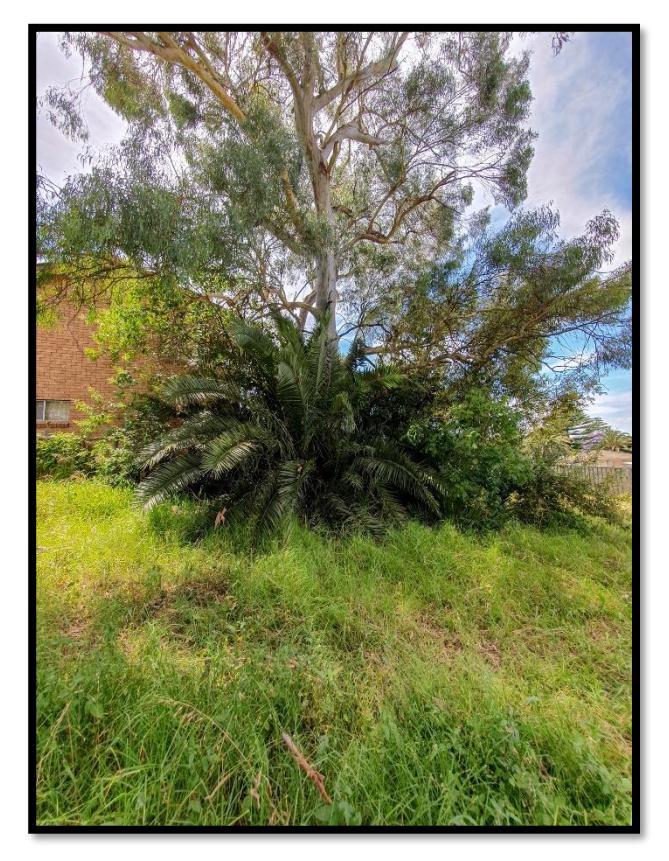
The trunk diameter (DBH) for Tree 2 is an estimate as the base is surrounded by large shrubs and a spreading Date Palm on the west side.

Base of Tree 2 viewed from the west.

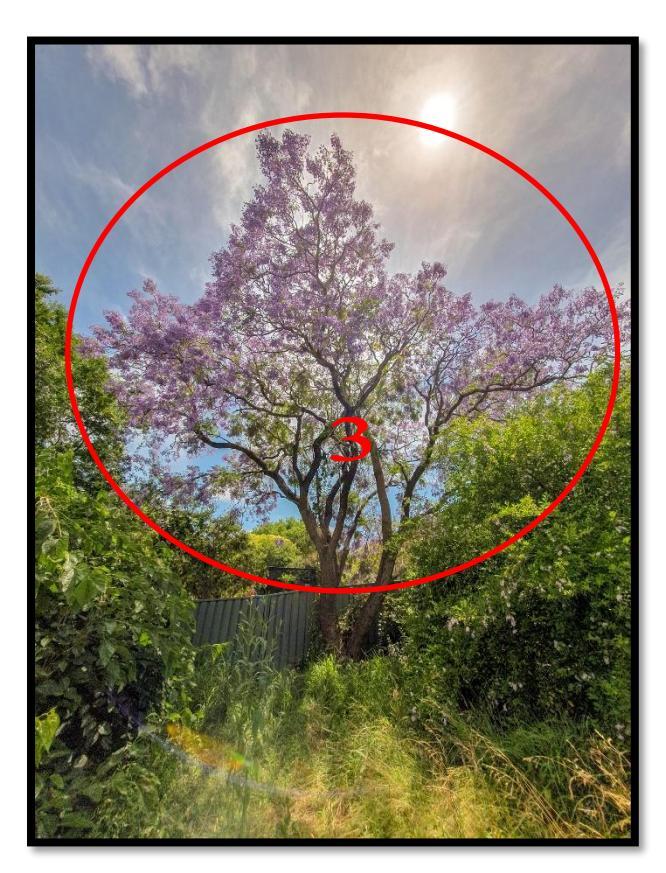
Tree 3 is in good health, structurally sound with a fair shape.

Tree 3 viewed from the south.

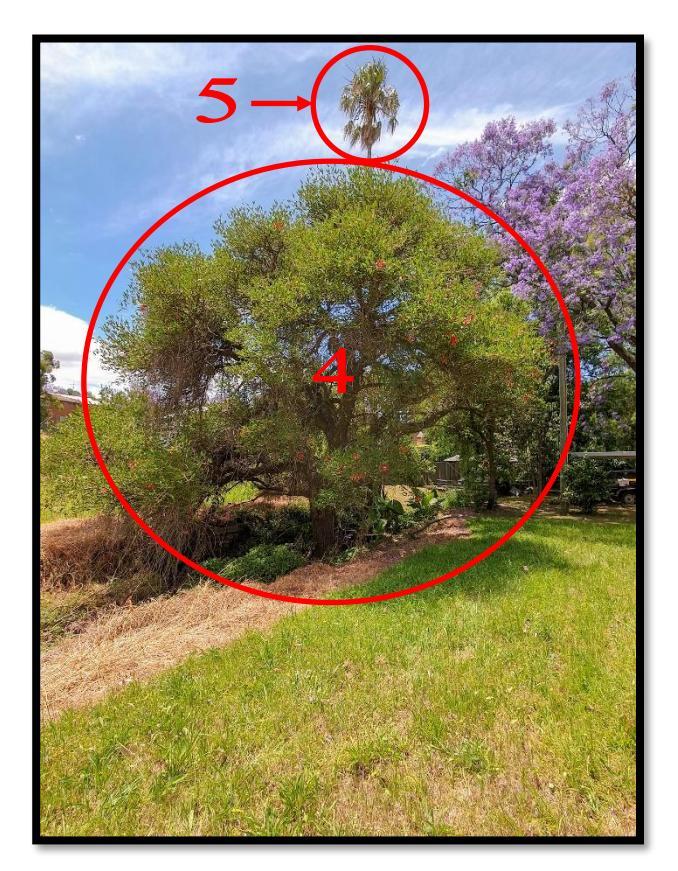
Tree 4 is in good health, structurally fair with a fair shape.

Tree 4 viewed from the west, with the top of Tree 5 behind.

Trees 4 and 5 are proposed for removal for the proposed development due to the amount of encroachment required into their TPZs. It is considered they cannot be adequately protected during and after construction in accordance with *AS* 4970 (2009), *Protection of Trees on Development Sites*.

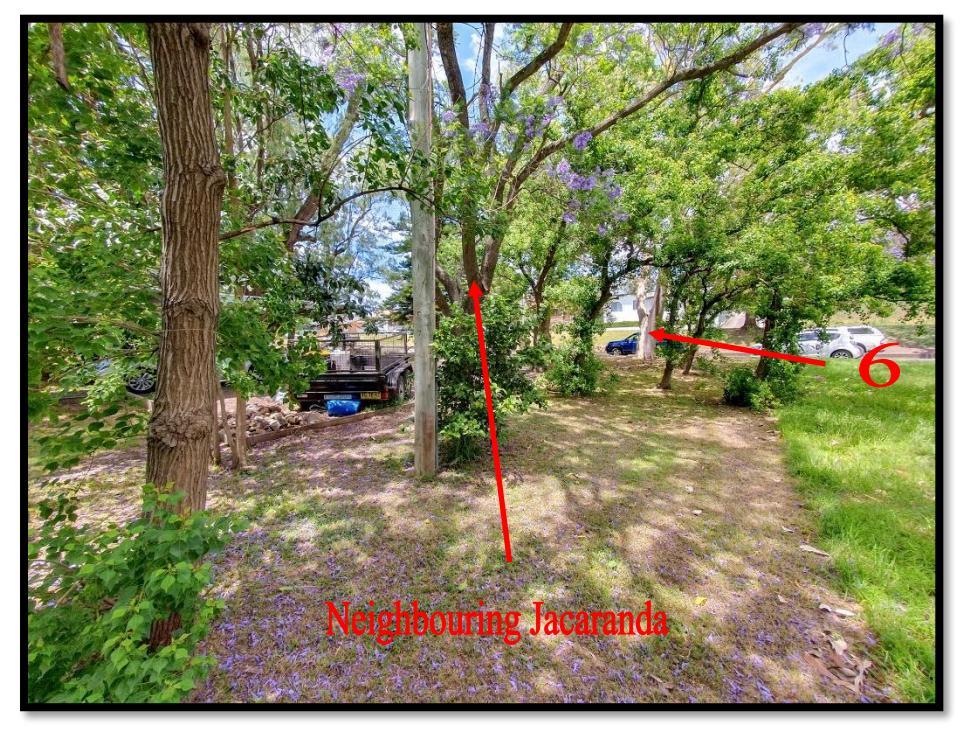
The smaller trees and neighbouring trees adjacent to Tree 6.

The 5 specimens of Chinese Tallow between Trees 5 and 6 are also proposed for removal due to the amount of encroachment required.
