## Catchment Management Plan for Muscle Creek and Possum Gully

Client: Muswellbrook Shire Council

Reference: PA3263-RHD-MB-XX-RP-C-0001

Date: 2 July 2024

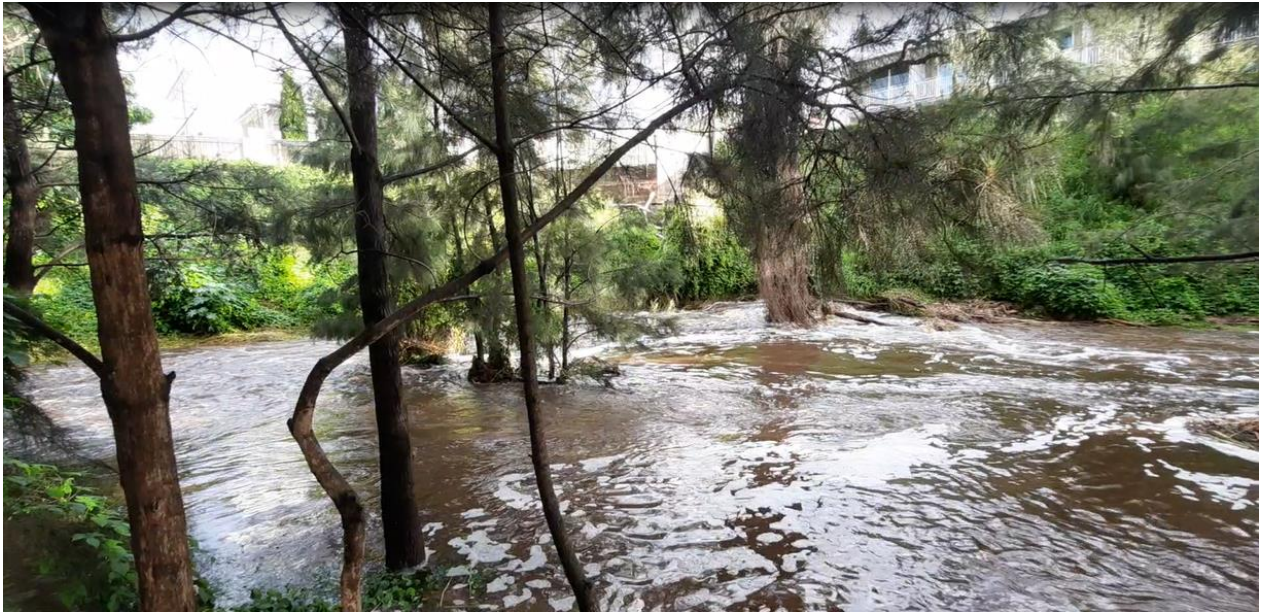
*Figure 2-9: Muscle Creek after rain (behind Remington Hotel) – 14th February 2022 (Council Staff Record)*

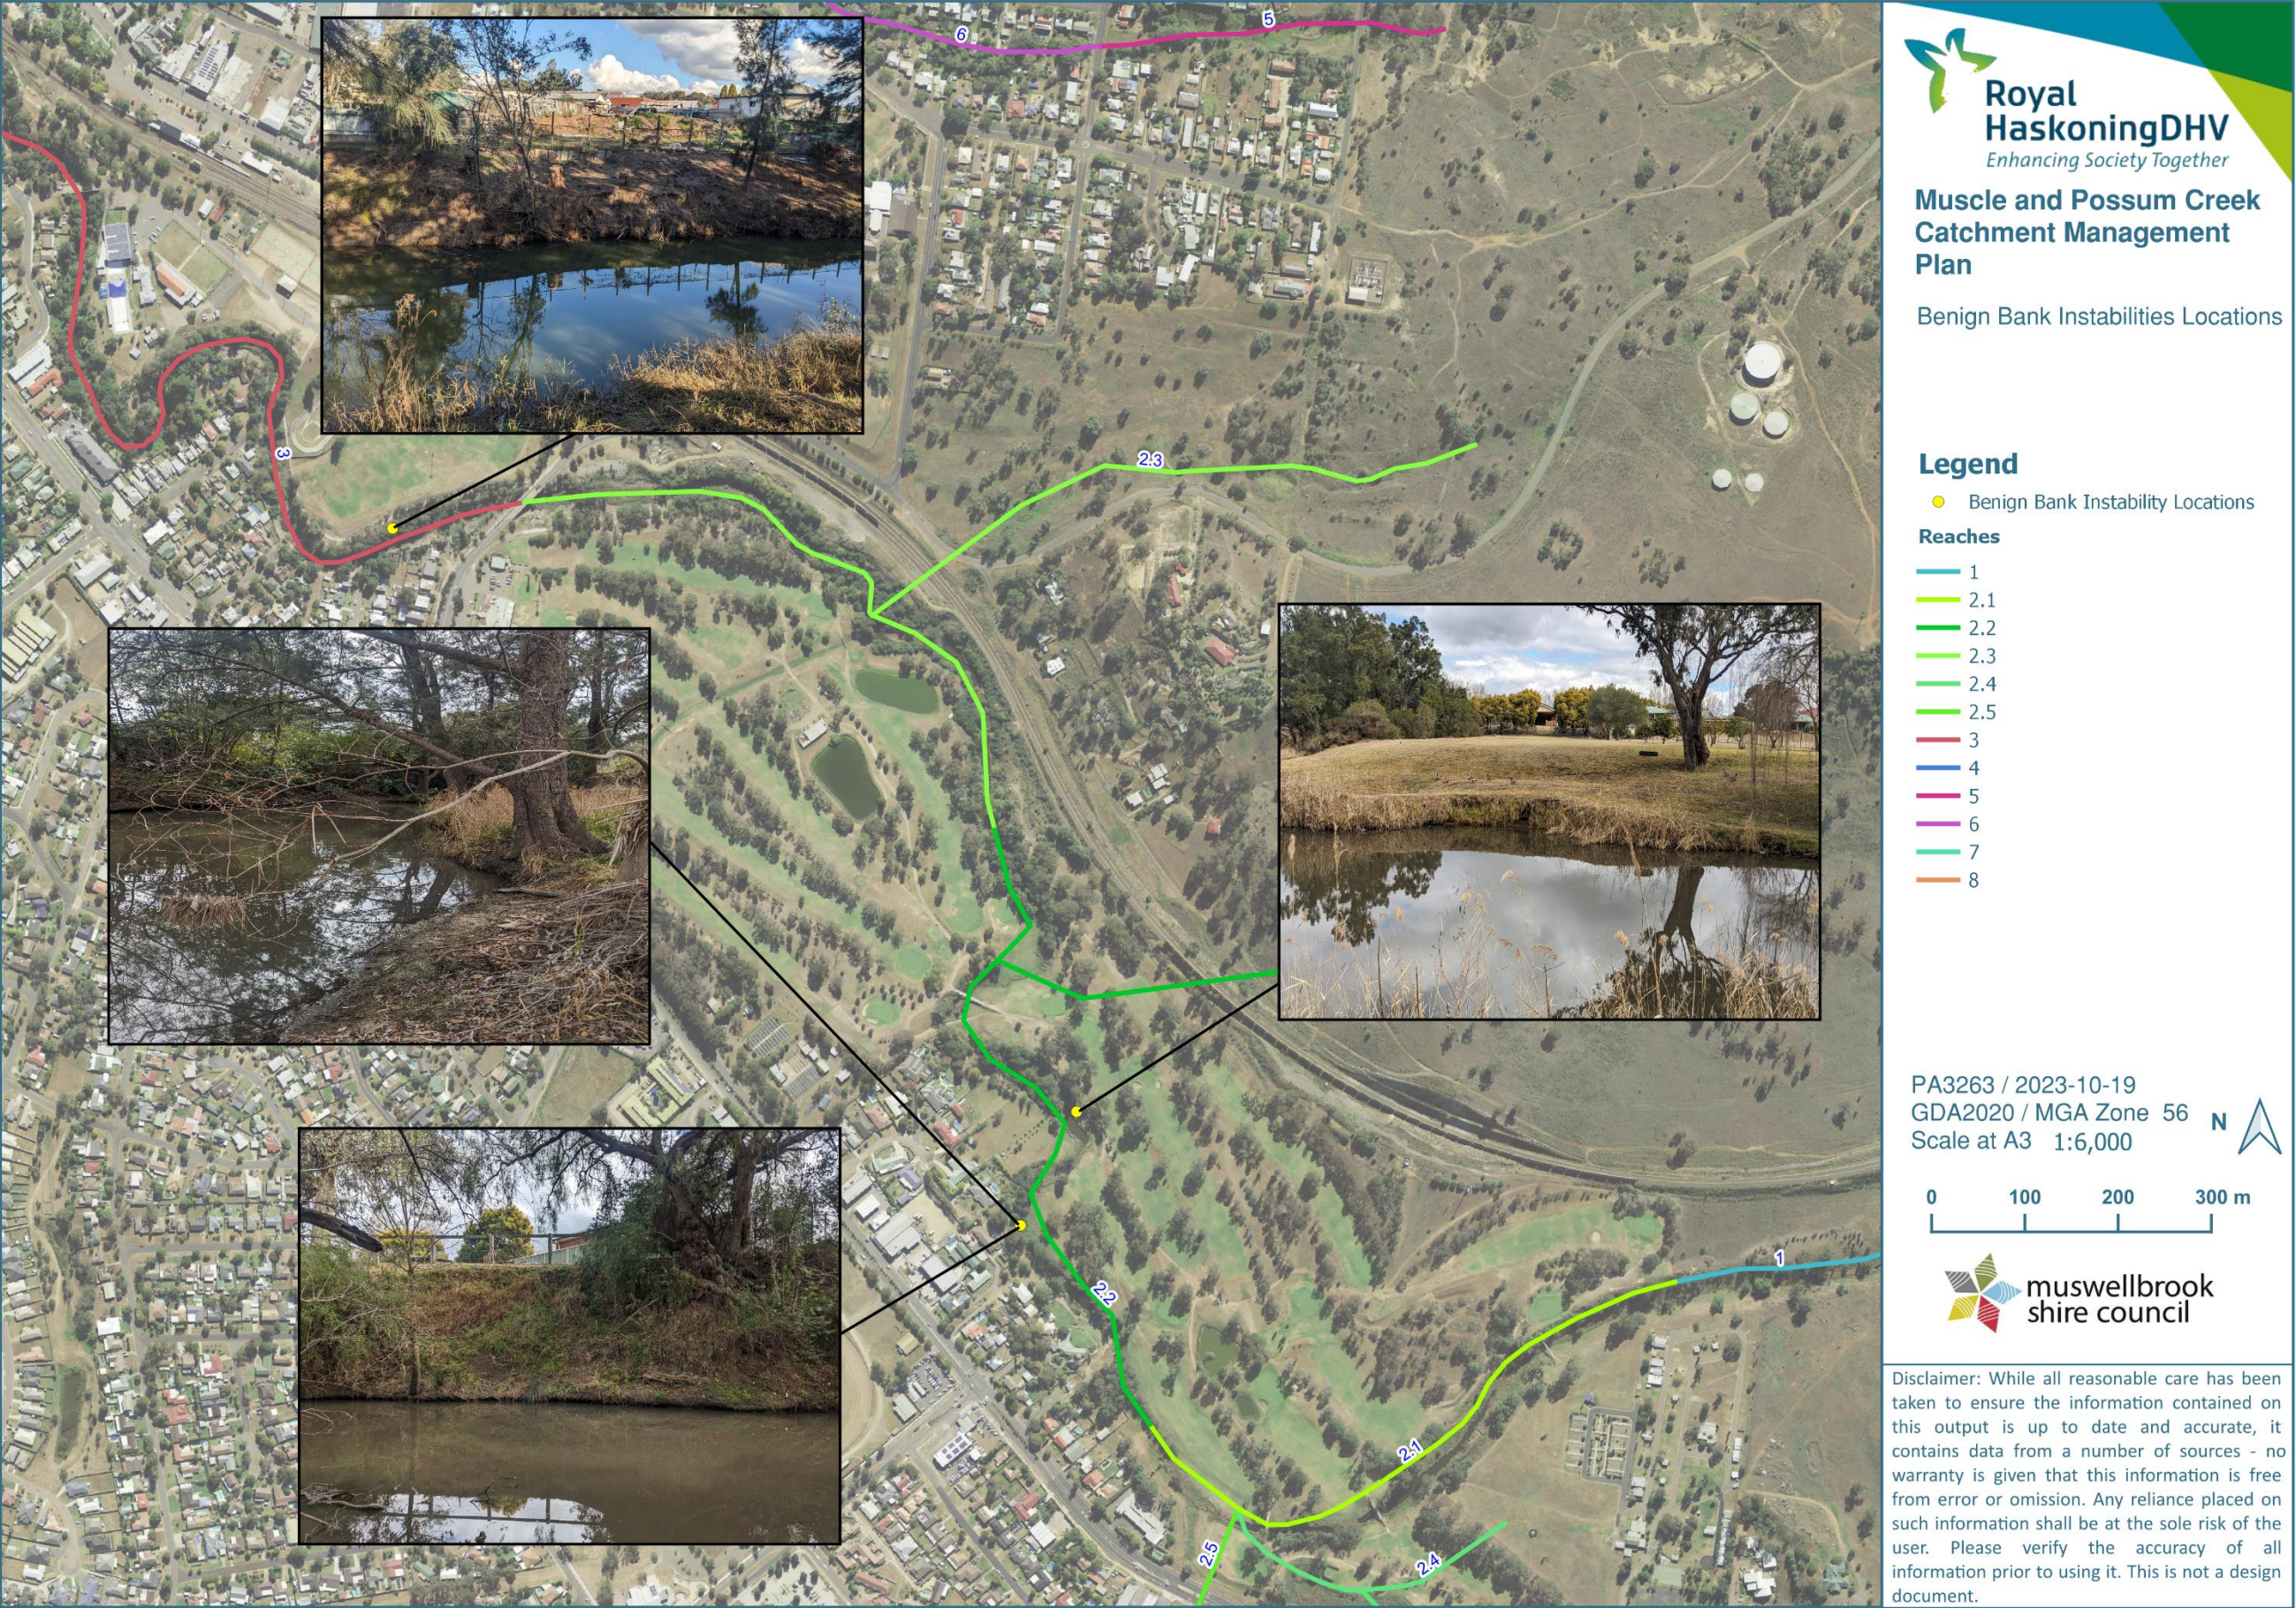
Figure 7-12: Benign bank instability locations

Locations of low risk bank instability and higher-risk bank instability are shown in **Figure 7-12** of **Appendix A1** and **Figure 7-35** of **Appendix A6** respectively. Locations where works have previously been undertaken to arrest instability, observed during fieldwork, have been noted in **Figure 7-13** and **Figure 7-14**.

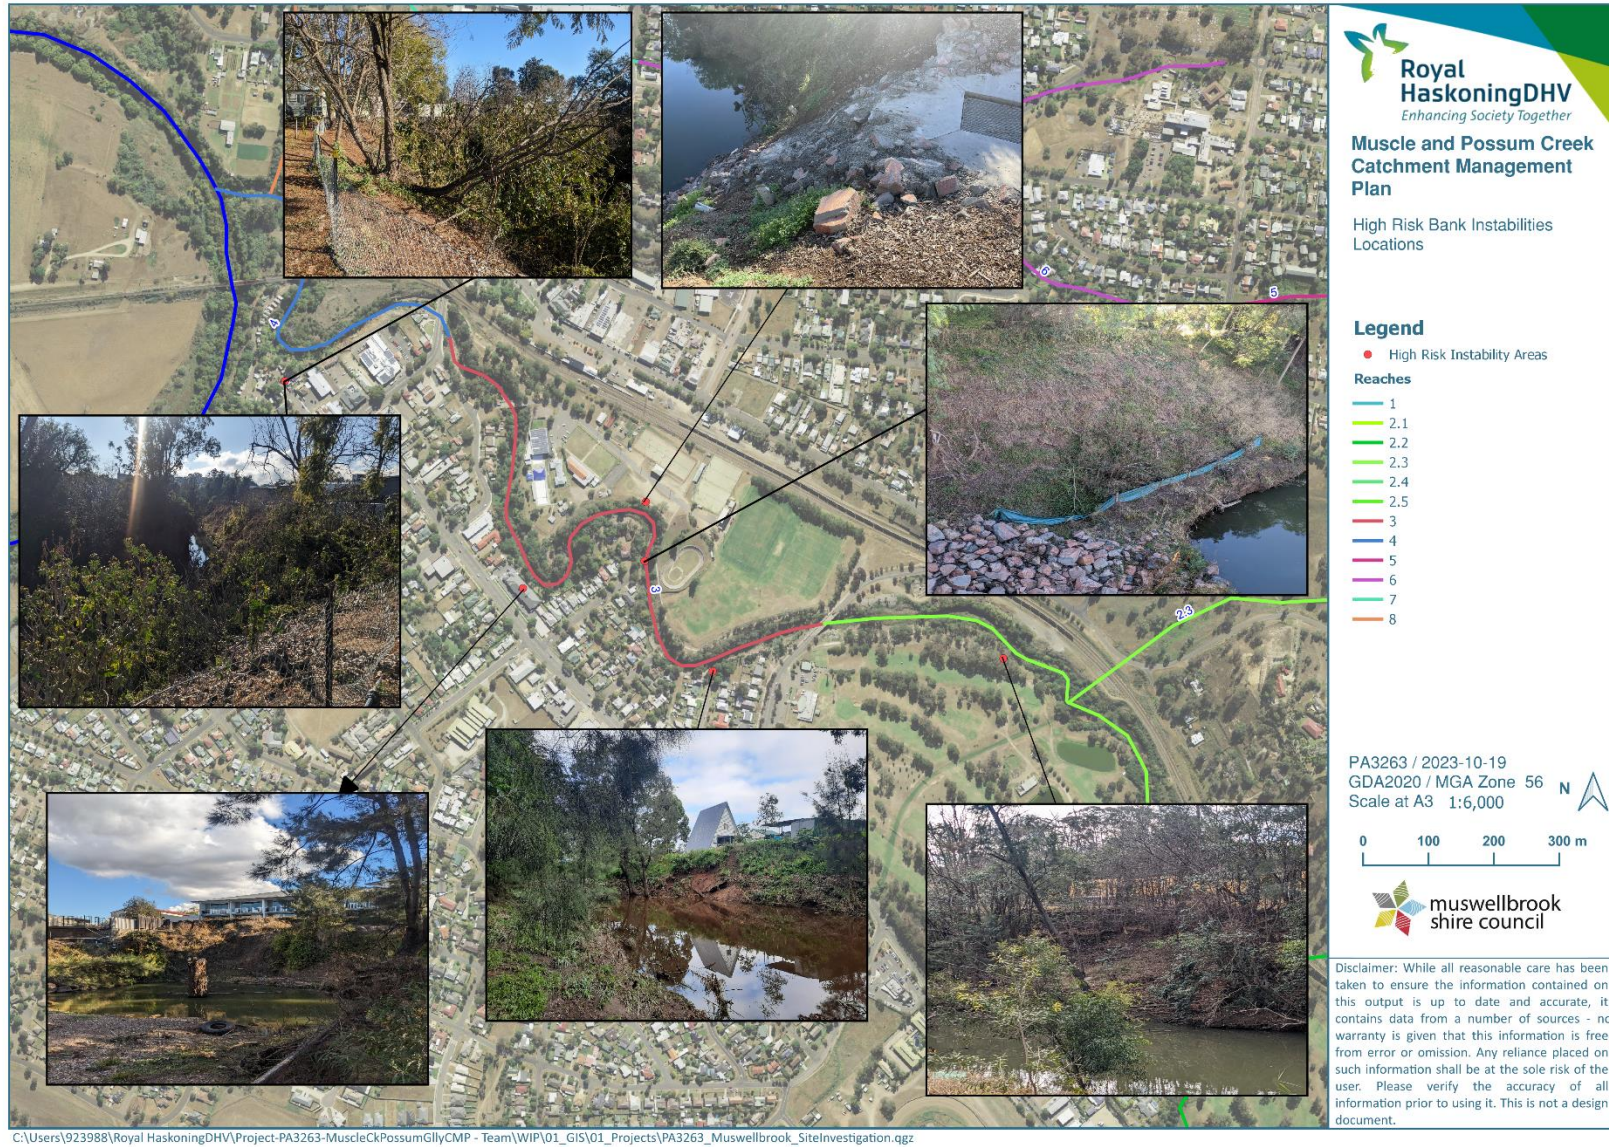
Figure 7-35: High Risk Bank Instability

This Appendix discusses potential methodology and considerations for selected (two) high-risk bank instability locations along Muscle Creek. Other high risk bank instability locations are shown in **Figure 7-35**.

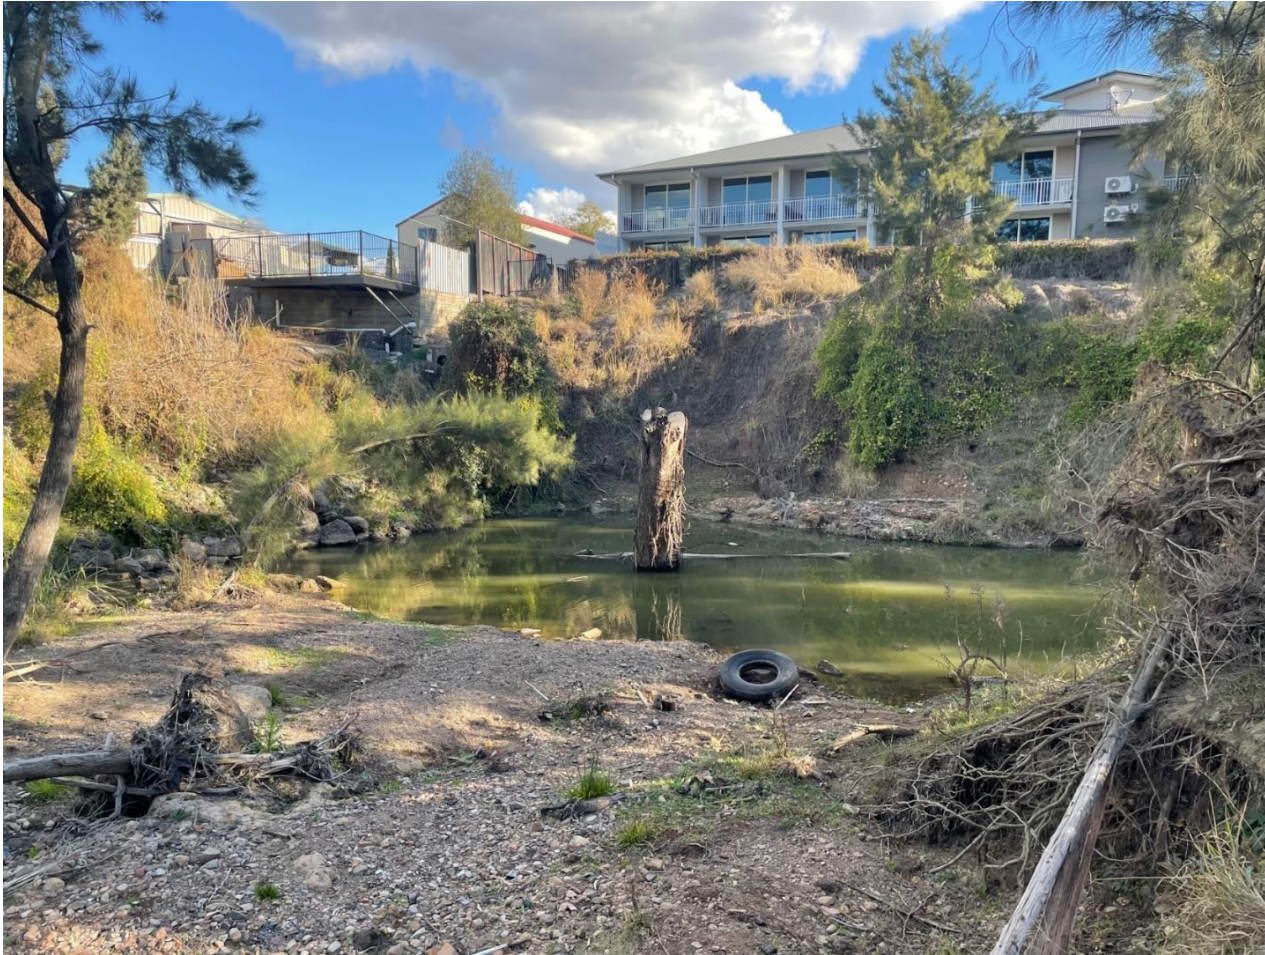
*Figure 7-37: Creek bank erosion at Motor Inn site, looking downstream from right hand bank.*

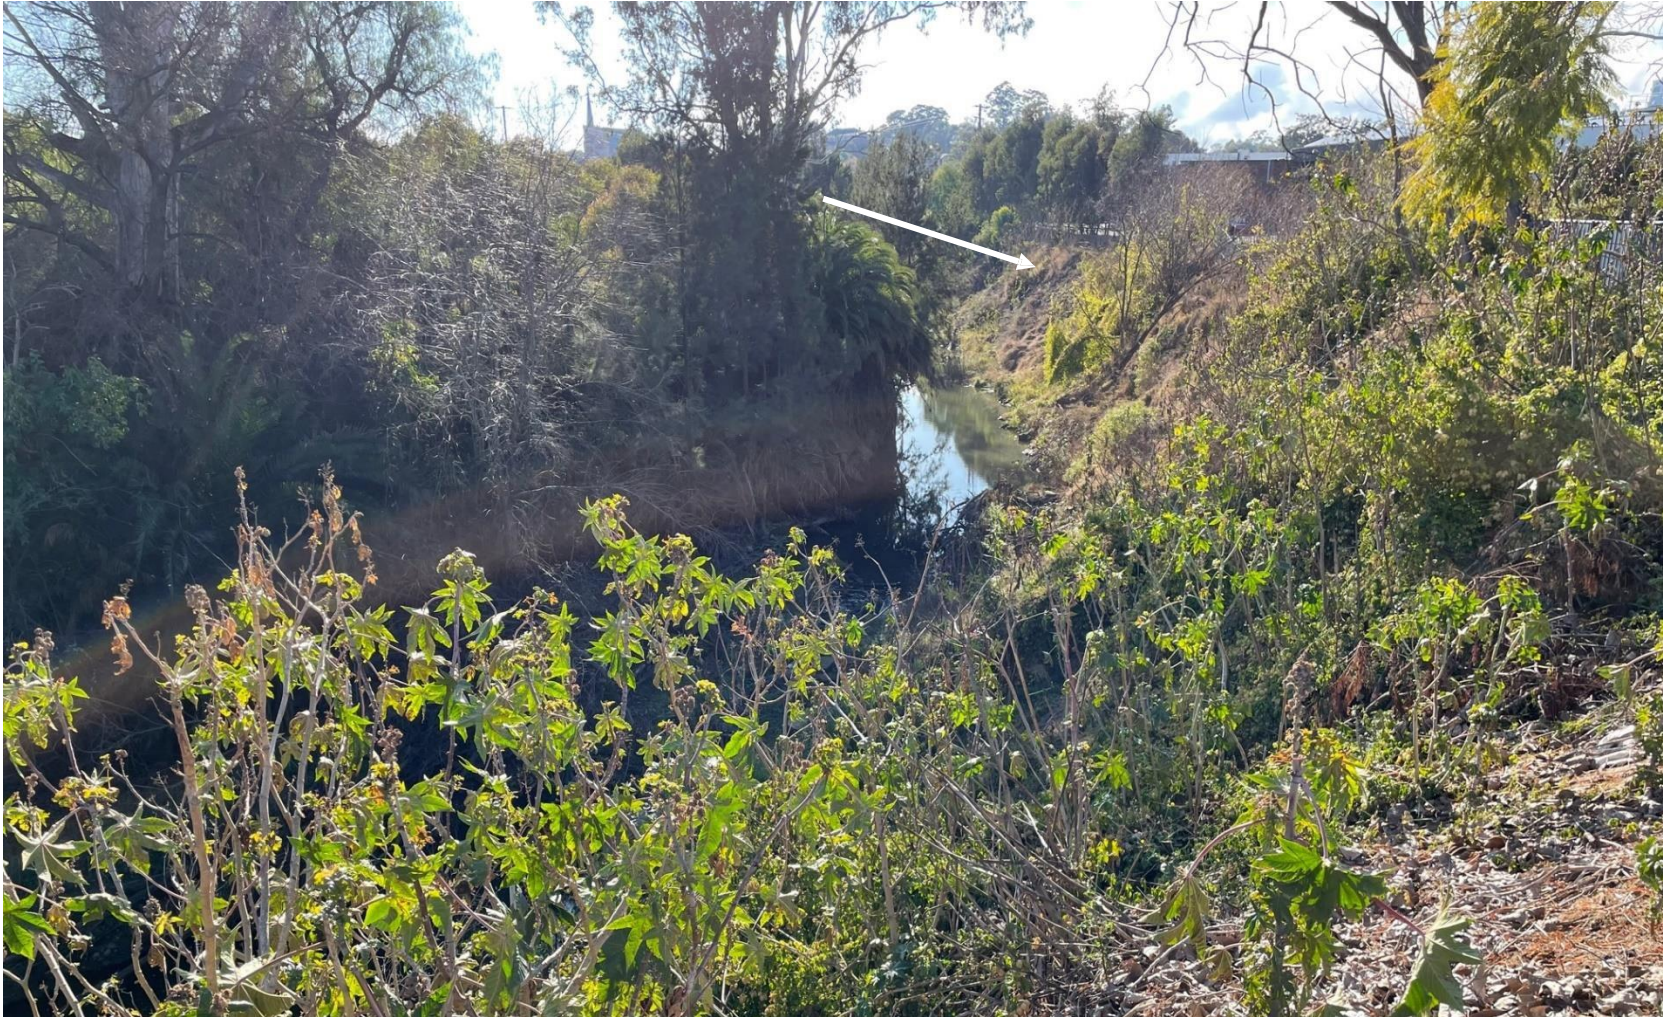
*Figure 7-43: Creek bank looking upstream, fronting the Workers Club shown by white arrow. Creek flow direction is toward the foreground.*

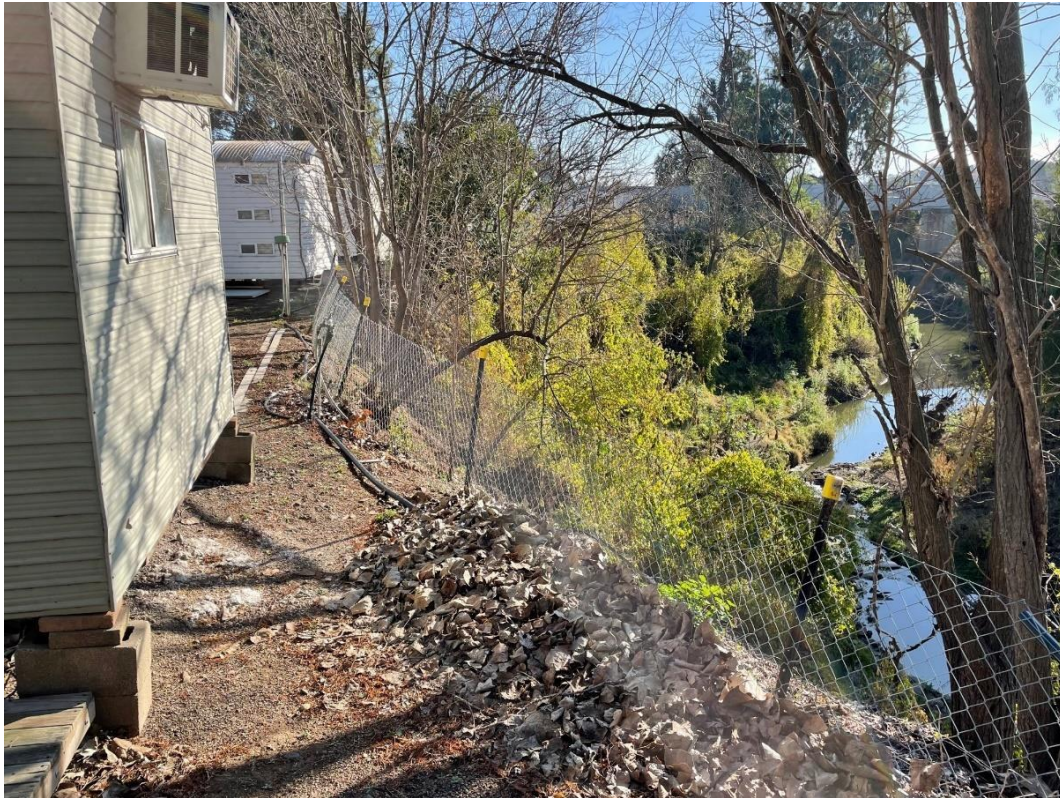
*Figure 7-44: Caravans located immediately at the top of steep, high unstable creek bank.*
