# **Demolition Plan**

Demolition 22 Sydney Street - Ampol Muswellbrook Prepared For Ampol

Destructive Hazardous Materials (HAZMAT) Assessment and Demolition Hazardous Materials Management Plan

22 Sydney Street, Muswellbrook NSW

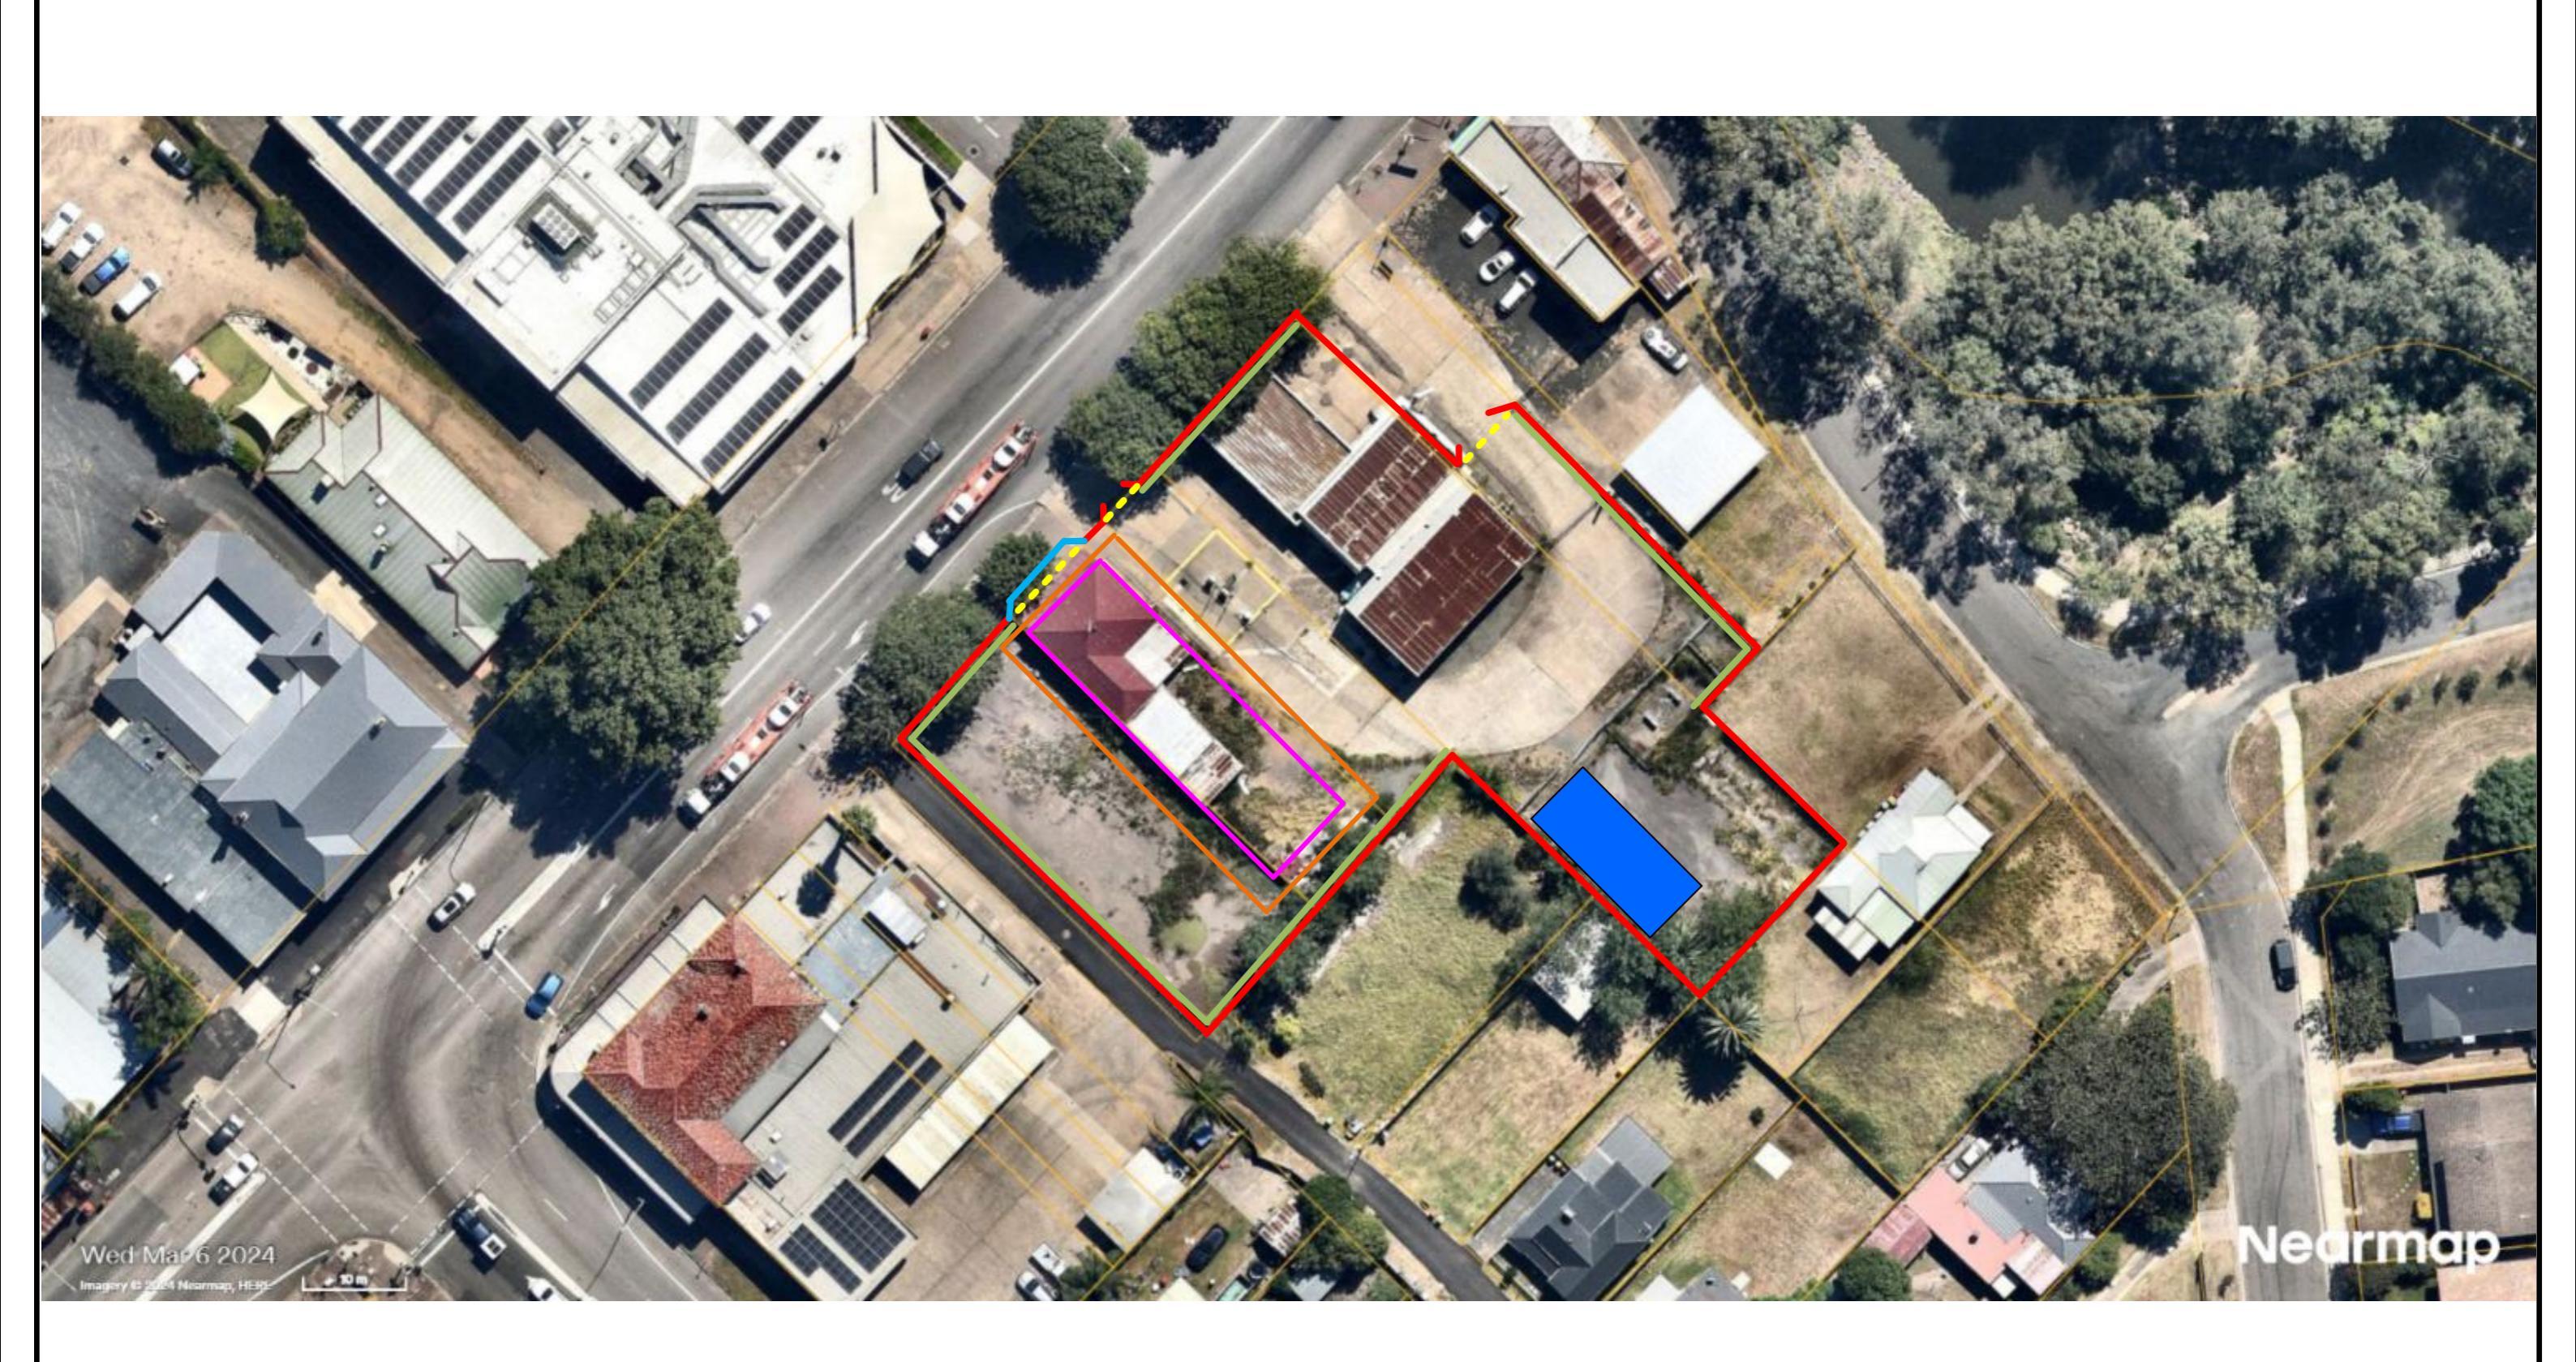
N.T.S	AMPOL MUSWELLBROOK –		
C. TINDALL	22 SYDNEY STREET SITE PLAN	JOB N°	IR03008
C. TINDALL		DWG N°	D003
C. TINDALL		REV	V01
09/05/2025		SHEET	1 of 1

Approximate locations can be seen in the site layout – Appendix A

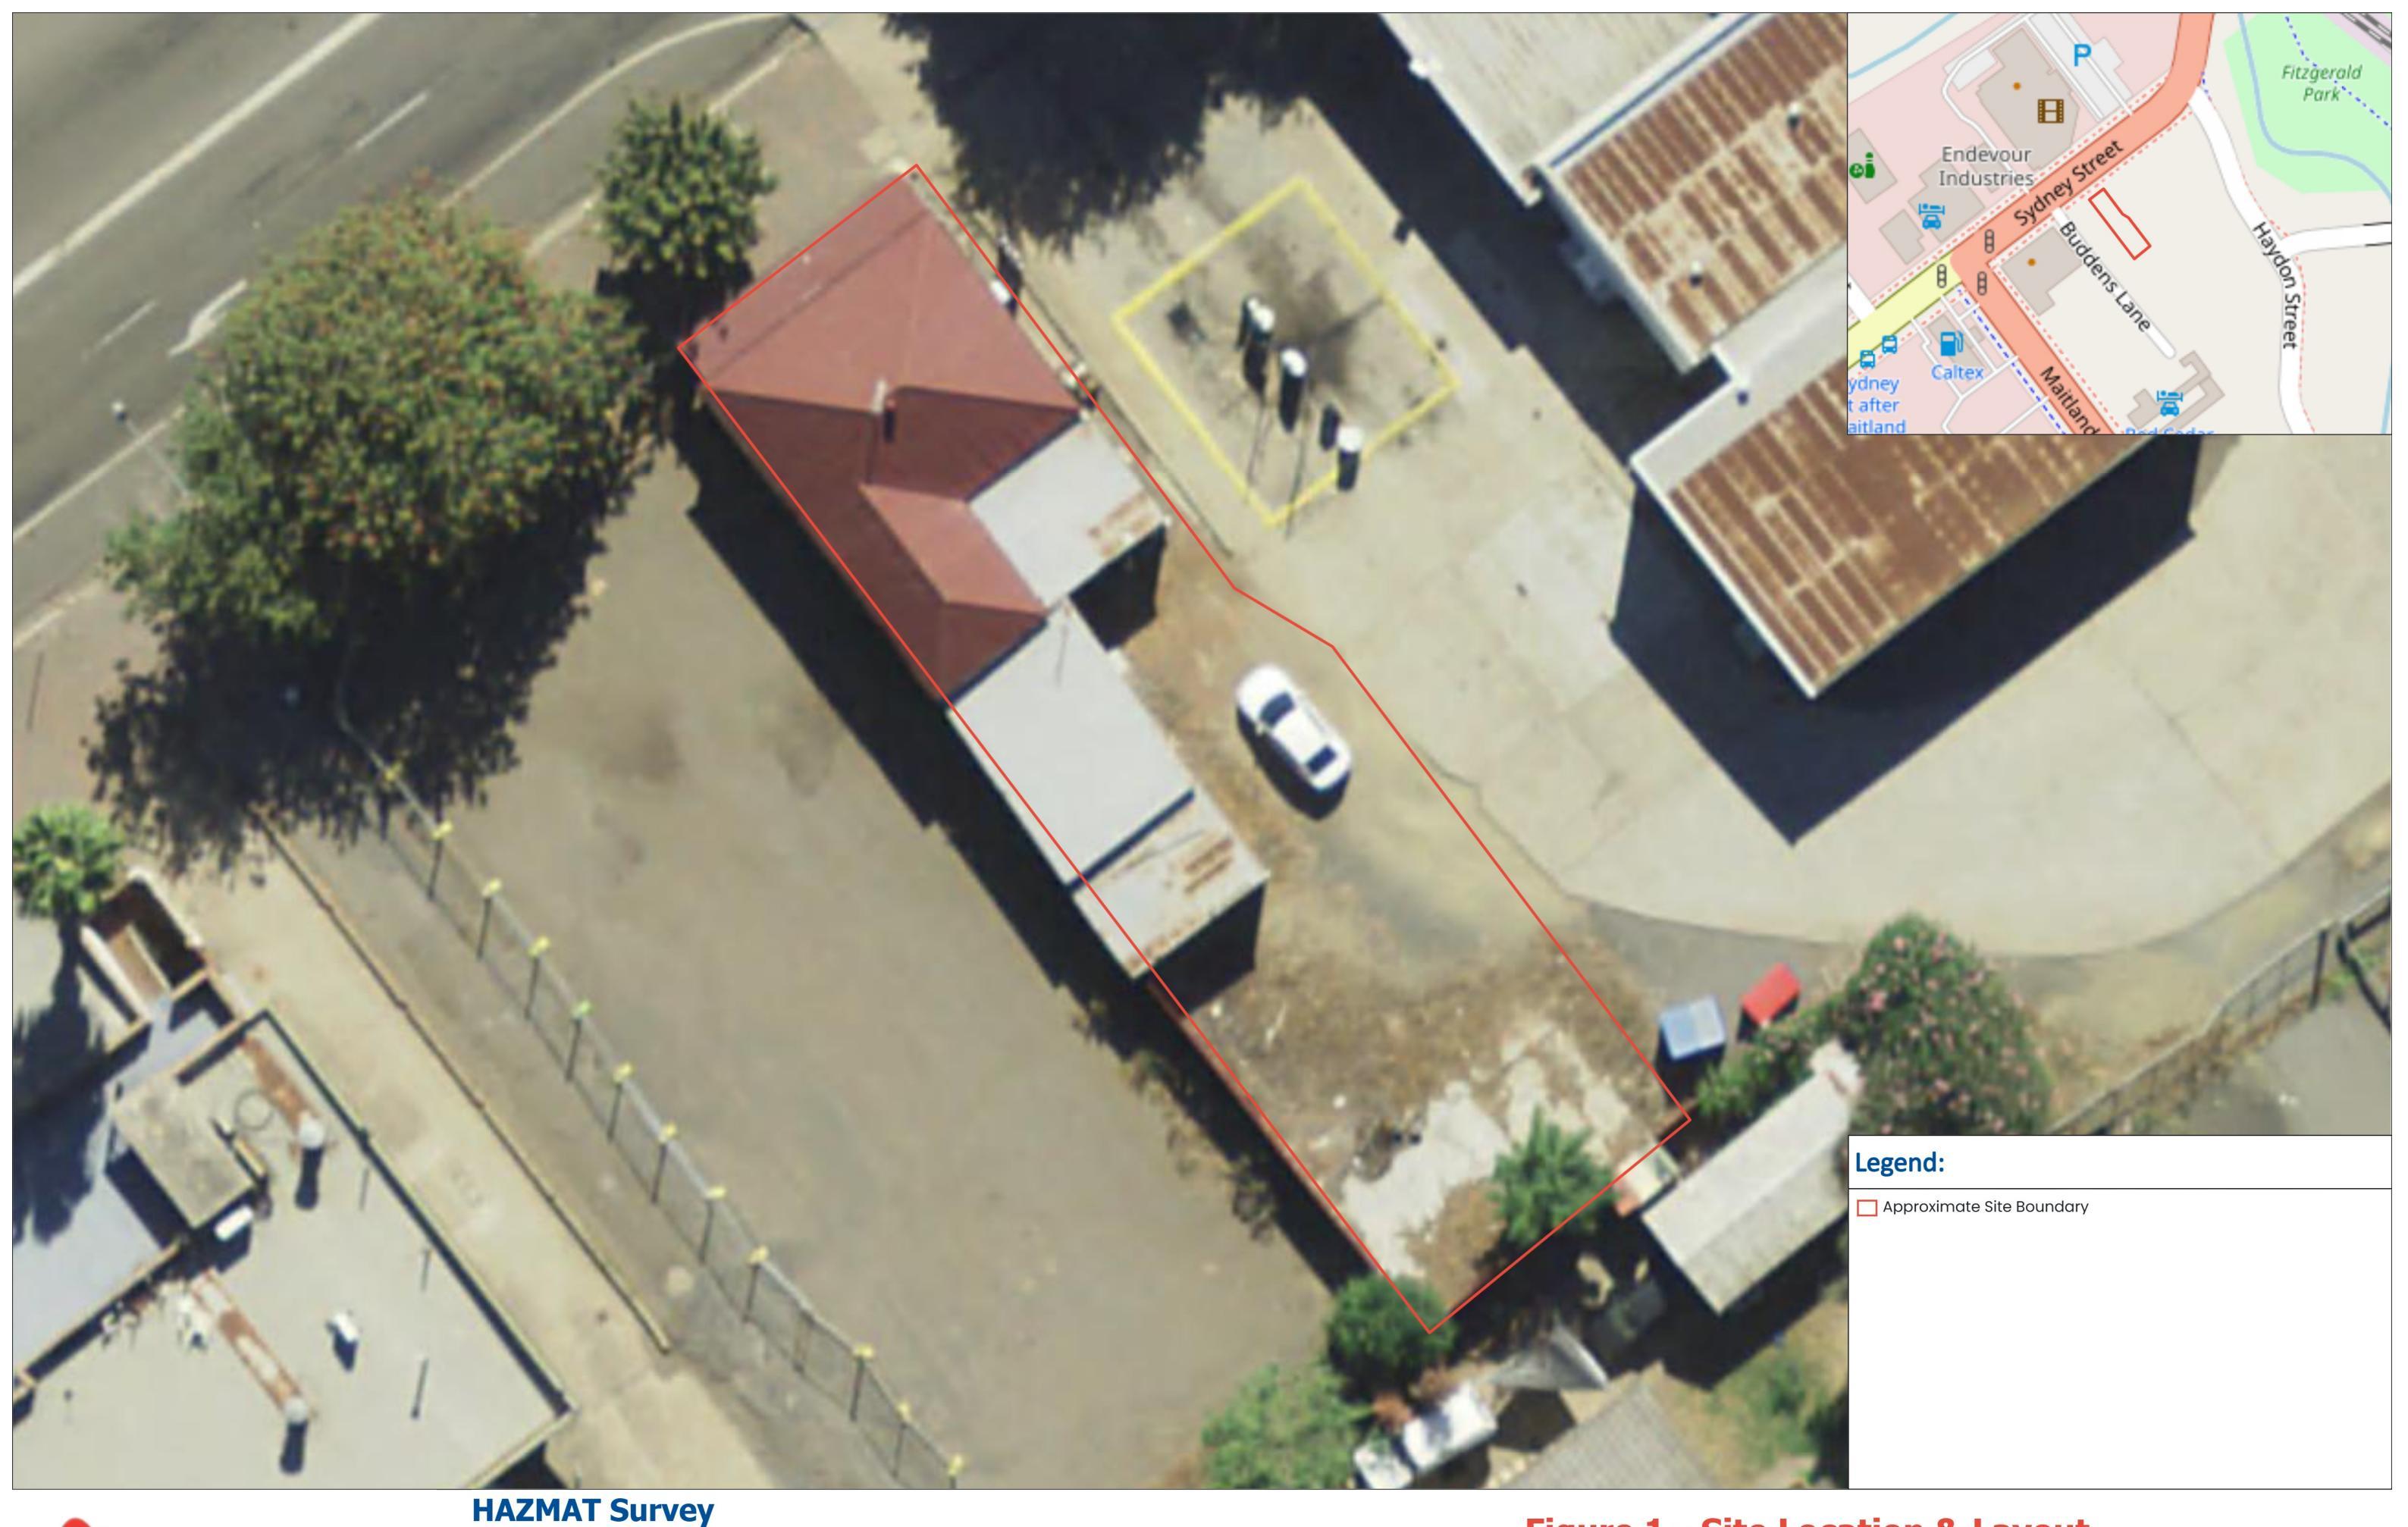
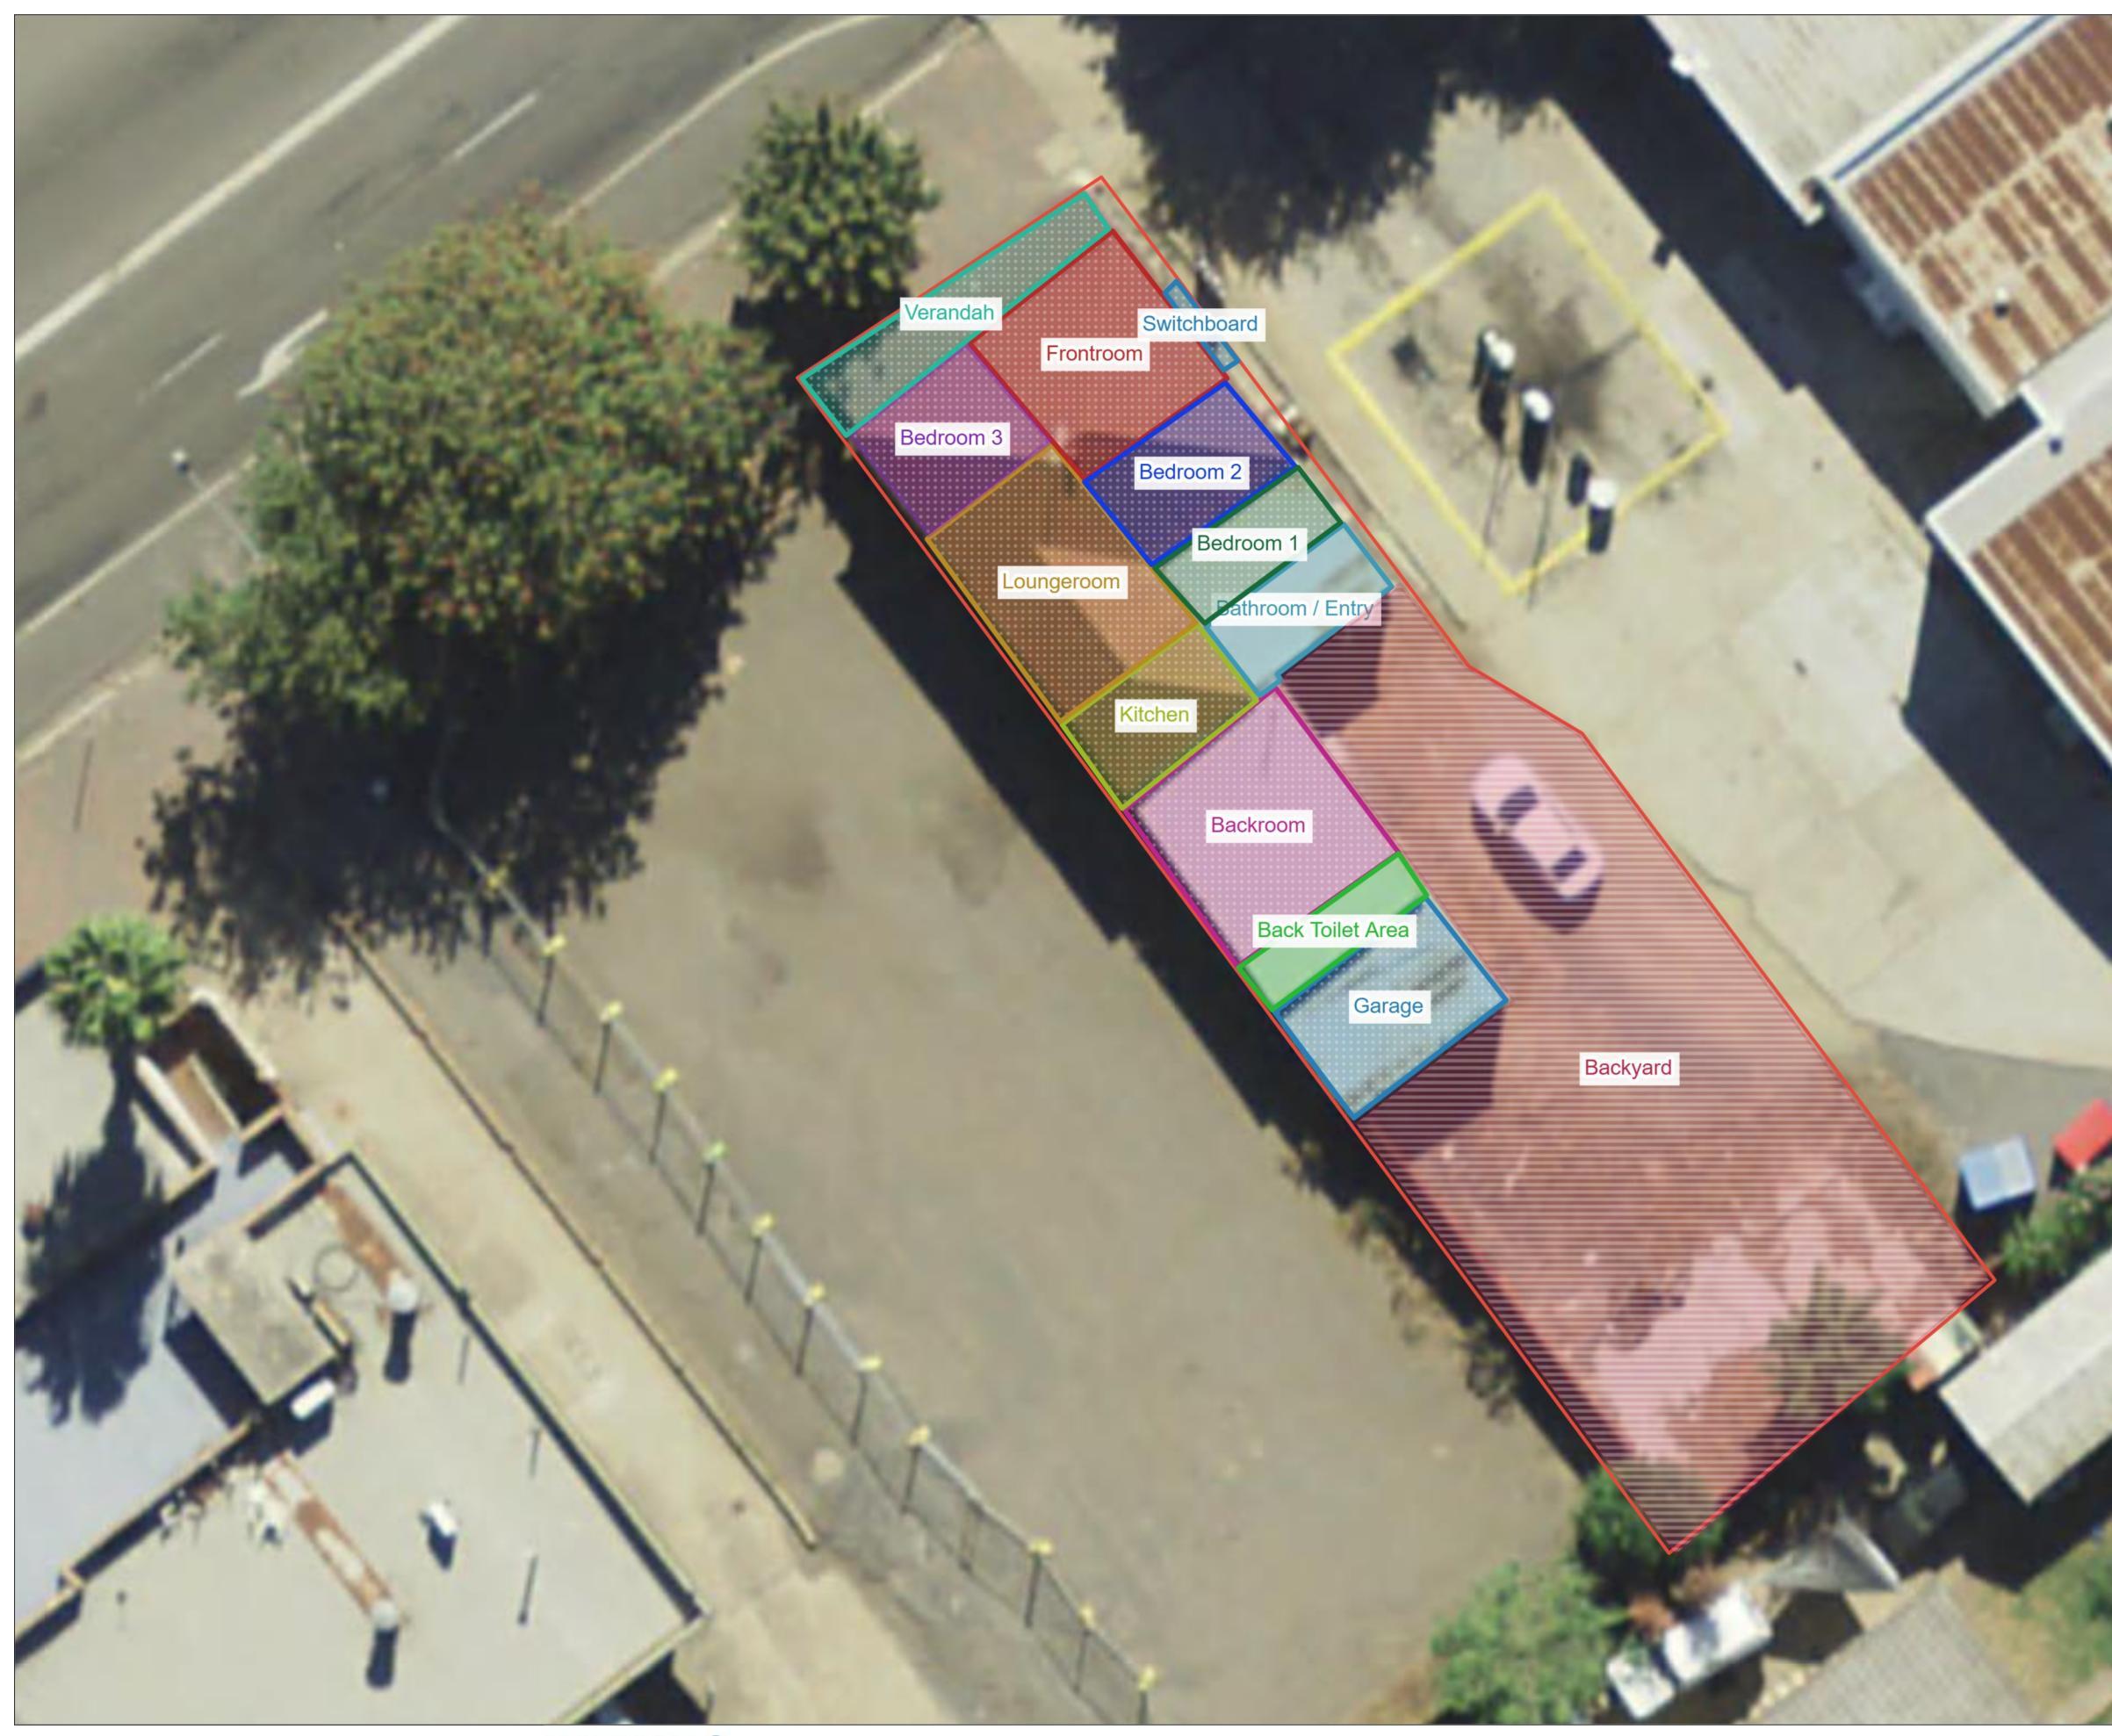
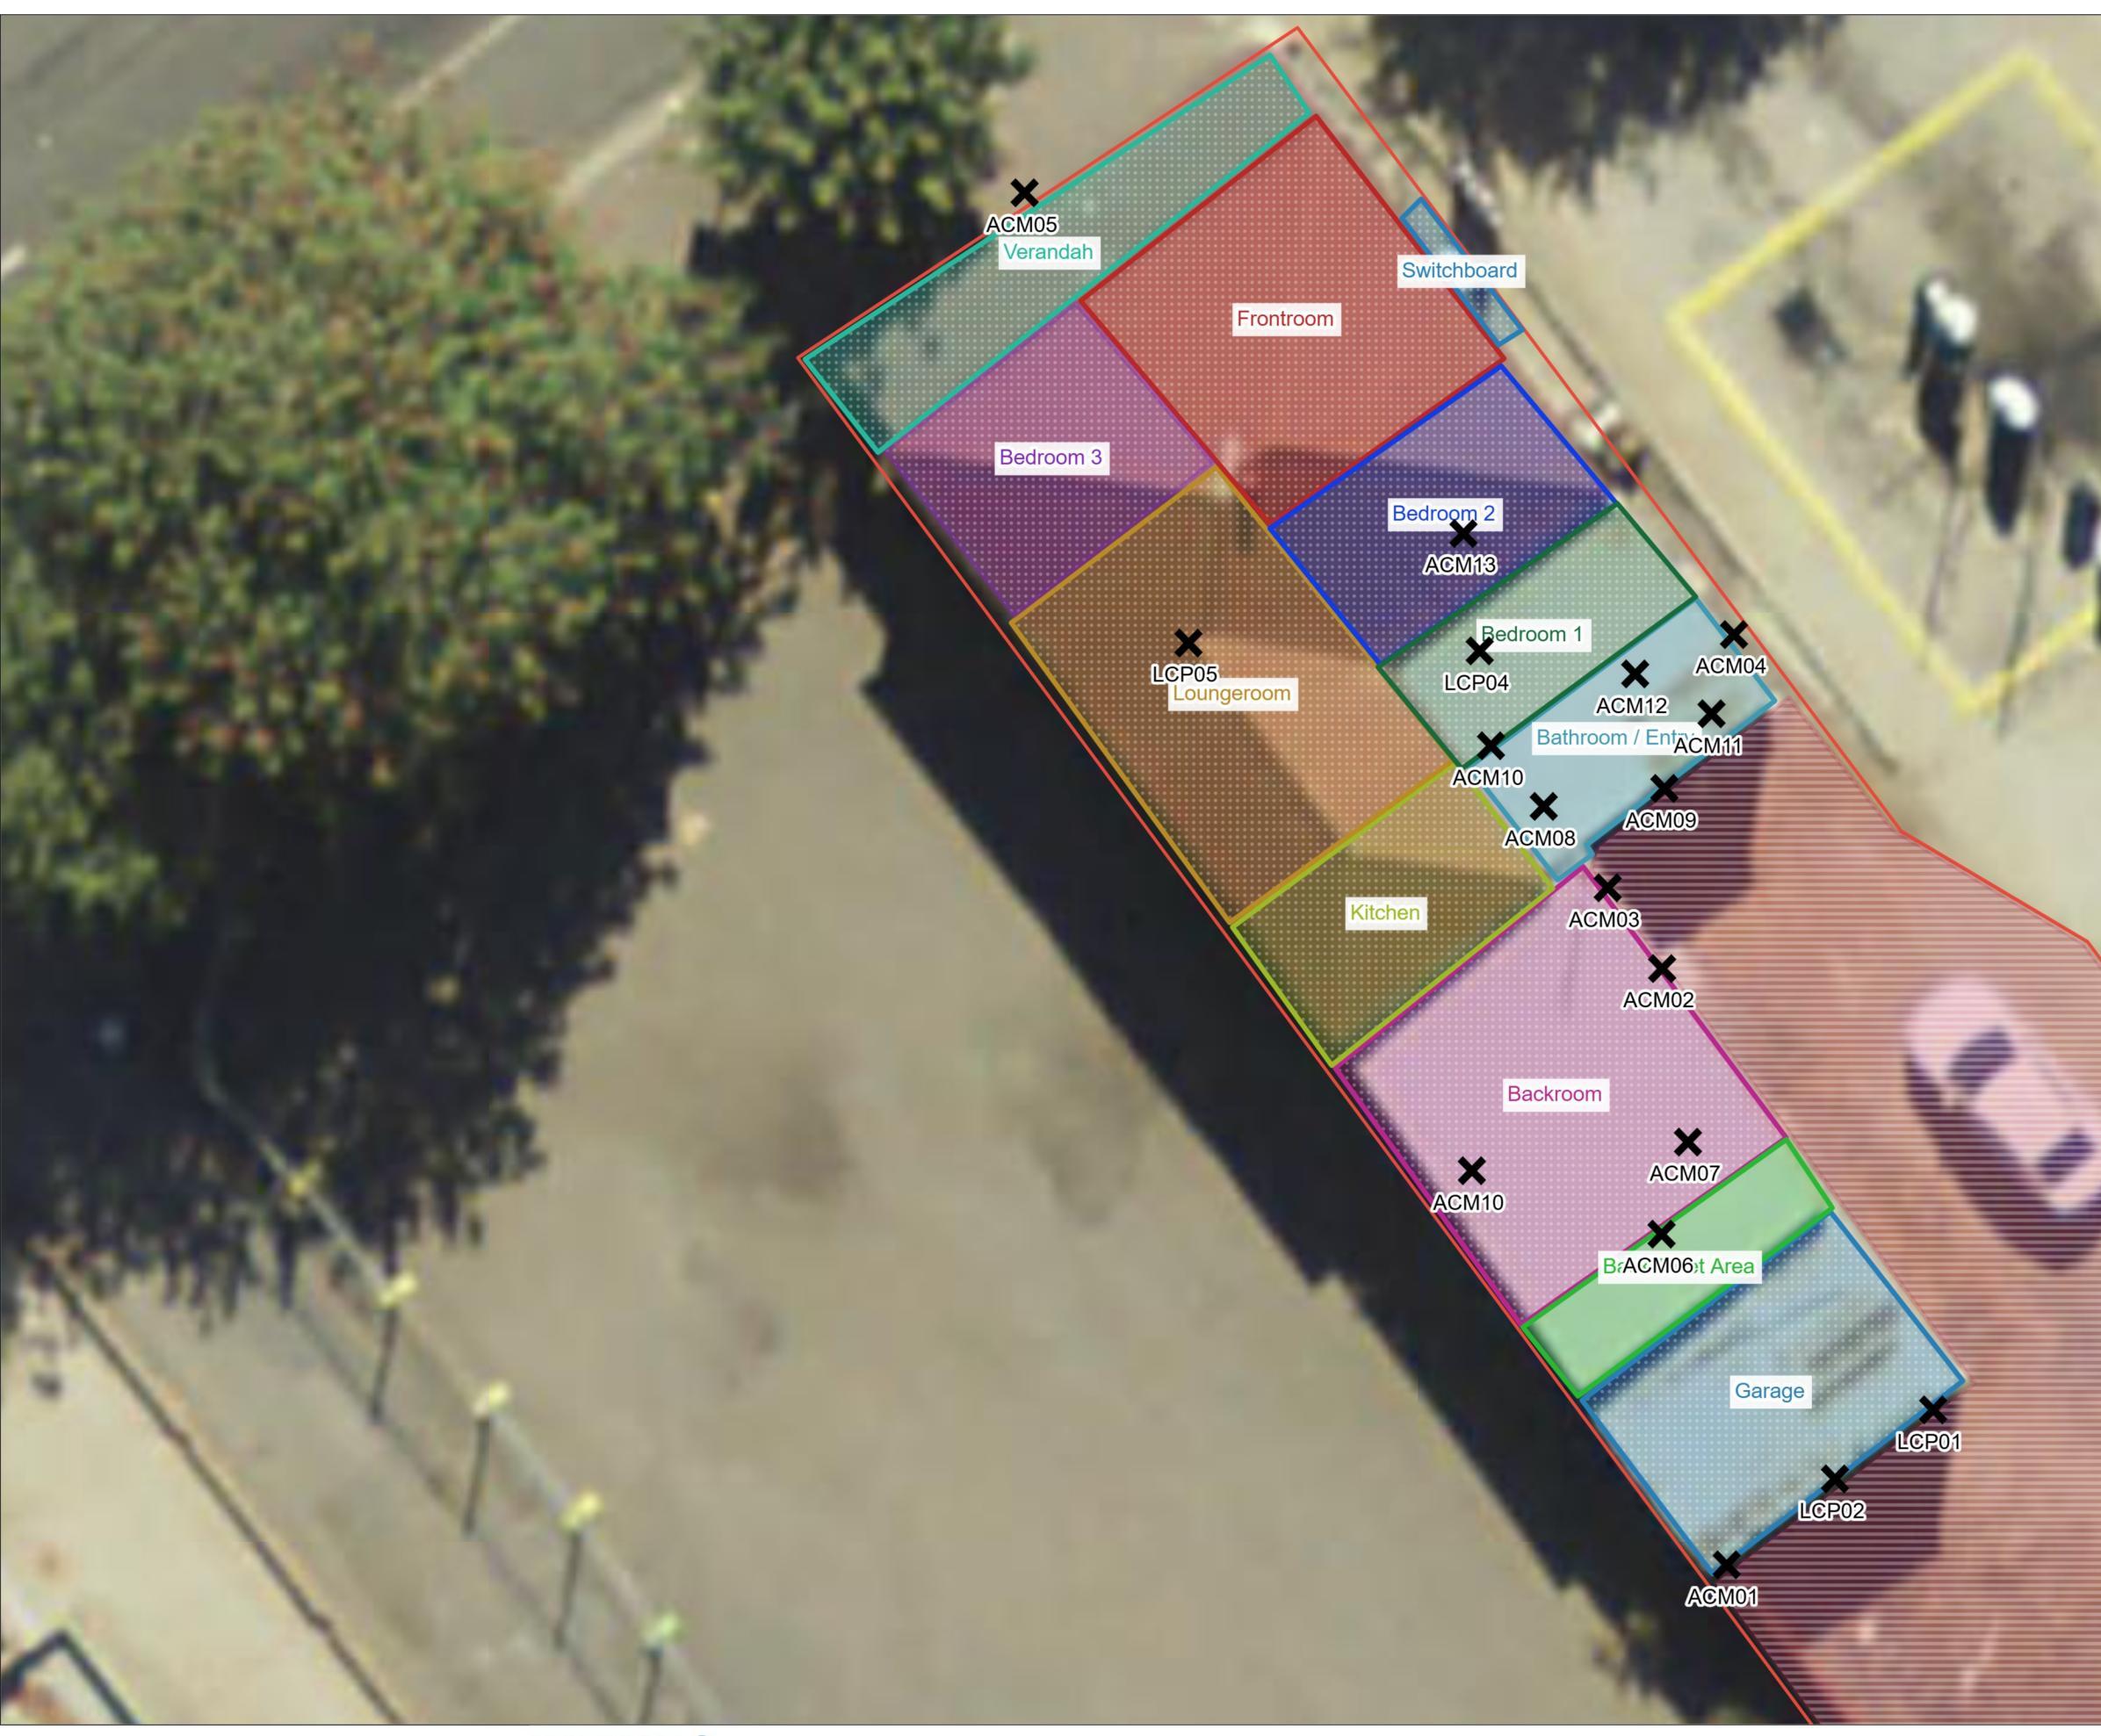
# Attachment 1 – Figure 1-3

EP Risk Management Pty Ltd (EP Risk) is pleased to provide InSite Remediation Services Pty Ltd (InSite) with this Hazardous Materials Assessment and Demolition Management Plan (the HAZMAT Assessment), for a former dwelling located on a property at 22 Sydney Street, Muswellbrook New South Wales (NSW) (the survey area). The location of the survey area is shown within **Attachment 1 – Figure 1**.
