Statement of Heritage Impact

Proposed New Service Station & Food Outlet
147 Bridge Street Muswellbrook NSW

On a vacant corner site within the Bridge Street Conservation Area

August 2018

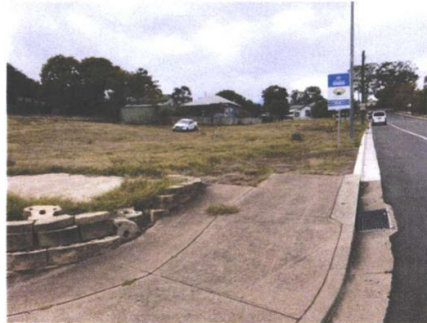
The vacant site from the Bridge
Street corner, with remnants of
retaining walls and conc. paving

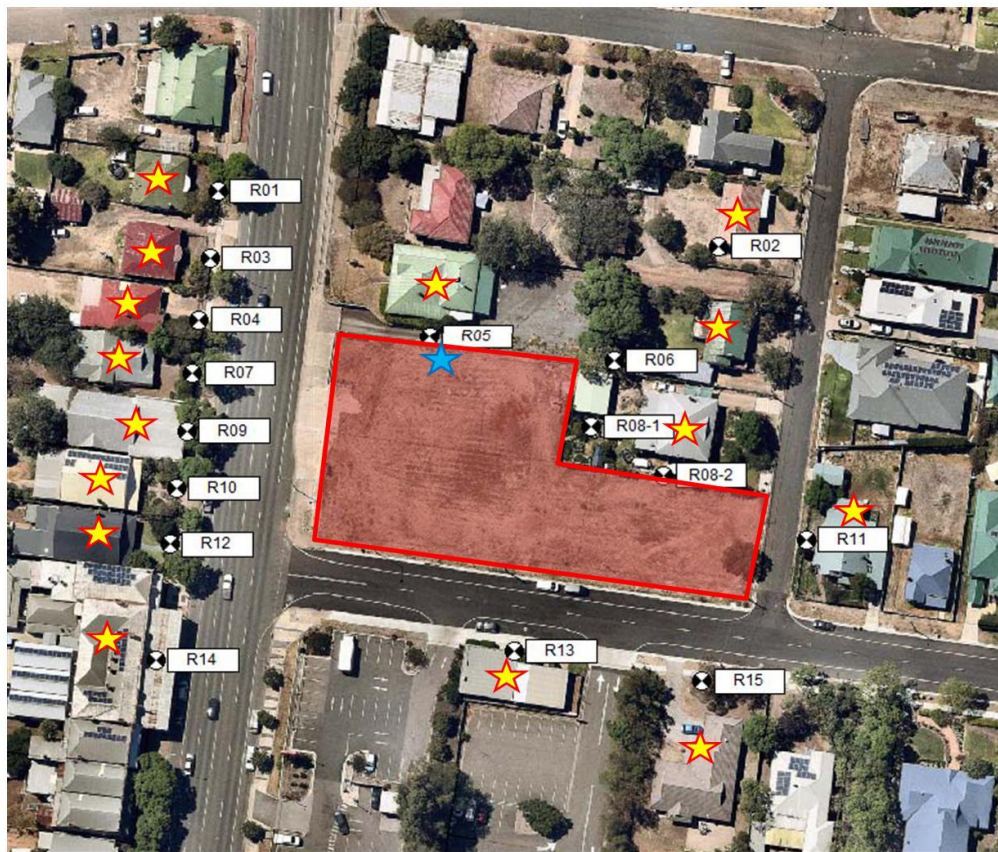
Figure 1 Site (□), measurement location (★) and identified noise sensitive receivers (★)

Receiver ID	Receiver type	Distance and direction from site boundary
R01	Residential	40 m NW
R02	Residential	40 m NE
R03	Residential	32 m NW
R04	Residential	30 m W
R05	Commercial	Adjacent N
R06	Residential	7 m NE
R07	Residential	31 m W
R08-1	Residential	Adjacent E
R08-2	Residential	Adjacent N
R09	Commercial	32 m W
R10	Commercial	31 m W
R11	Residential	9 m E
R12	Residential	31 m WSW
R13	Commercial	20 m S
R14	Commercial	37 m SW
R15	Residential	21 m SE

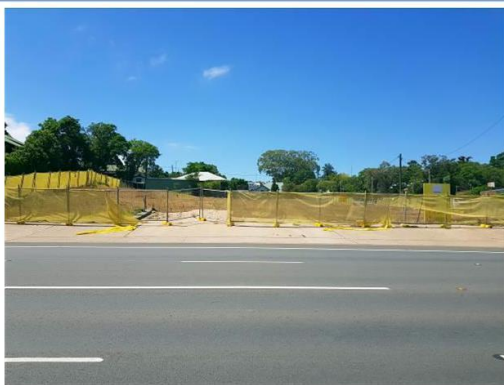
Photo 1. Site overview facing east.

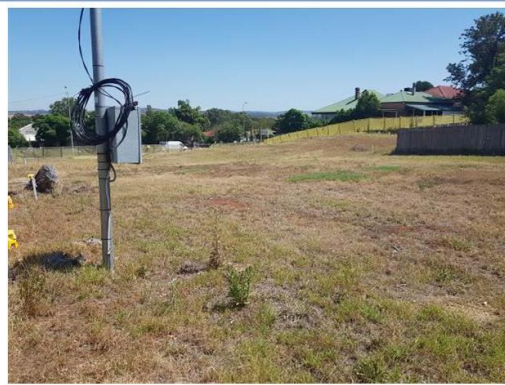
Photo 2. Overview of western half of Site. Photo identifies hummocky topography that was evident across the Site

The Site was observed to have a gentle overall slope towards the west and Bridge Street. However, it was also noted that the Site was uneven and hummocky moving from the north boundary to the south boundary. This hummocky topography of depressions and mounds across the Site is considered to have been generated as a result of demolition and excavation works associated with the previously identified, removed and validated UPSS System and Oil Storage System.

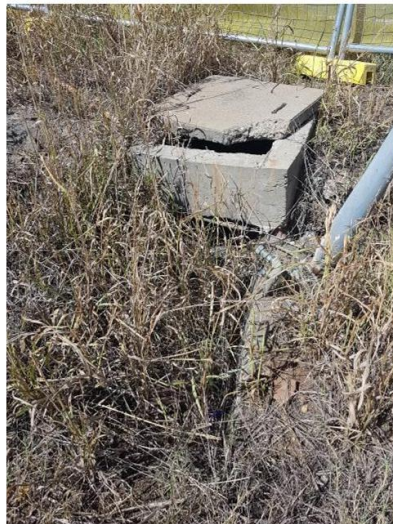
Photo 3. Old infrastructure associated with previous operations on site. Located along central southern boundary of site, adjacent previous oil-storage area.

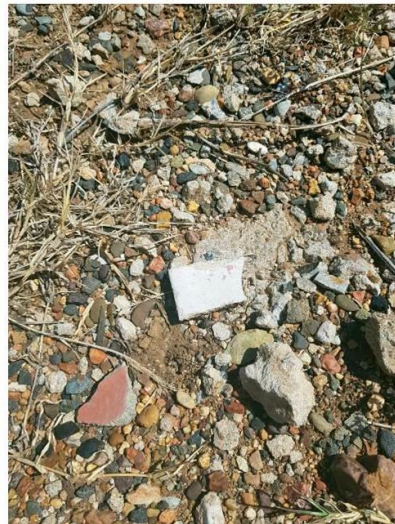
Photo 4. Positive ACM fibre-cement fragment found in the north-western portion of the Site.

Due to the presence of confirmed ACM fragments identified during the Site inspection completed by Prensa on 8 March 2019, as well as the previously identified fragments of this material referred to in the environmental reports reviewed, it is considered that the Site is potentially impacted by asbestos contamination (particularly on the surface). Therefore, it is recommended that additional assessment be undertaken at the Site to delineate the vertical and lateral extent of asbestos contamination across the Site. This will aid in determining the most practicable approach to managing or remediating the asbestos contamination present on Site. Additionally, the presence of a suspected TIT which is located within the hardstand at the entry to the Site from Bridge Street may require additional assessment to determine its role in previous activities undertaken at the Site and the potential use or requirement for remediation based on proposed future works and use of the Site.

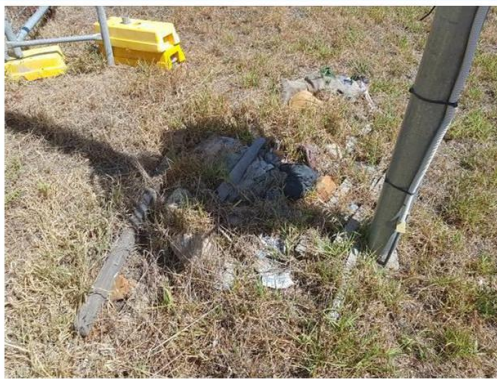
Photo 5. Building debris and waste materials

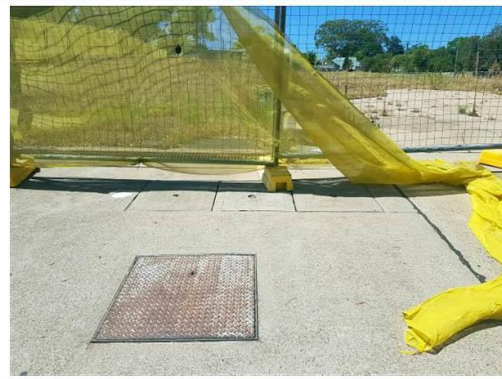
Photo 6. Triple Interceptor Trap (TIT) at Site entry when entering from Bridge St.

At the time of the inspection, the Site comprised vacant land with the Site boundaries clearly identified by temporary construction fencing. The Site comprised sporadic vegetation cover and building rubble and debris including concrete pieces, glass fragments, metal, PVC and terracotta pipework, corrugated roofing sheets, ceramic tile fragments, chicken wire netting, wood sheets and insulated electrical wiring. It was also noted that the western boundary line of the Site comprised hardstand that operated as the driveway entry to the Site from Bridge Street. A suspected TIT was observed to be present at this entry point to the Site.

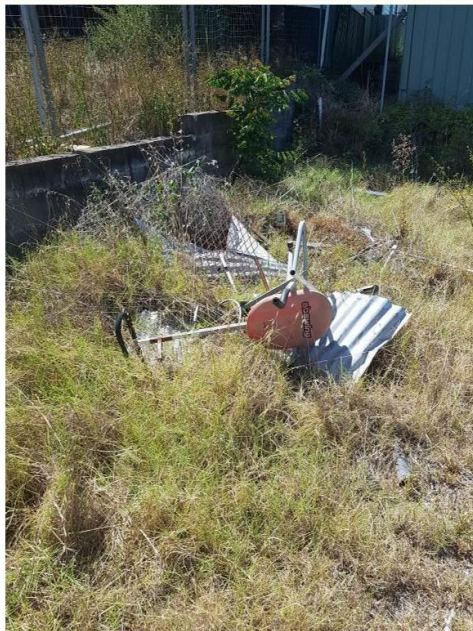
Photo 7. General waste piled in north-eastern corner of Site.

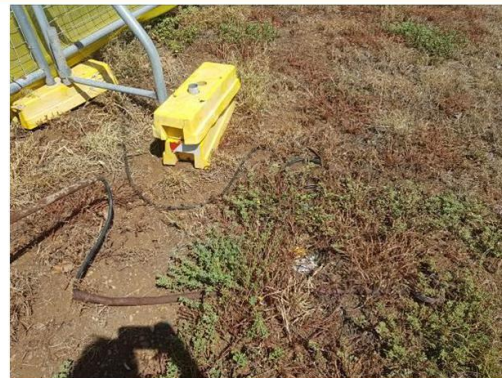
Photo 8. Old electrical wiring located along central southern boundary of Site.
