**STAGE 1 PRELIMINARY SITE
INVESTIGATION,
CORNER OF TURNER STREET
AND BELL STREET,
DENMAN NSW
CM+ ARCHITECTS**

16 APRIL 2021
121024
VERSION 2

**Stage 1 Preliminary Site Investigation –
Corner of Turner Street and Bell Street, Denman NSW**

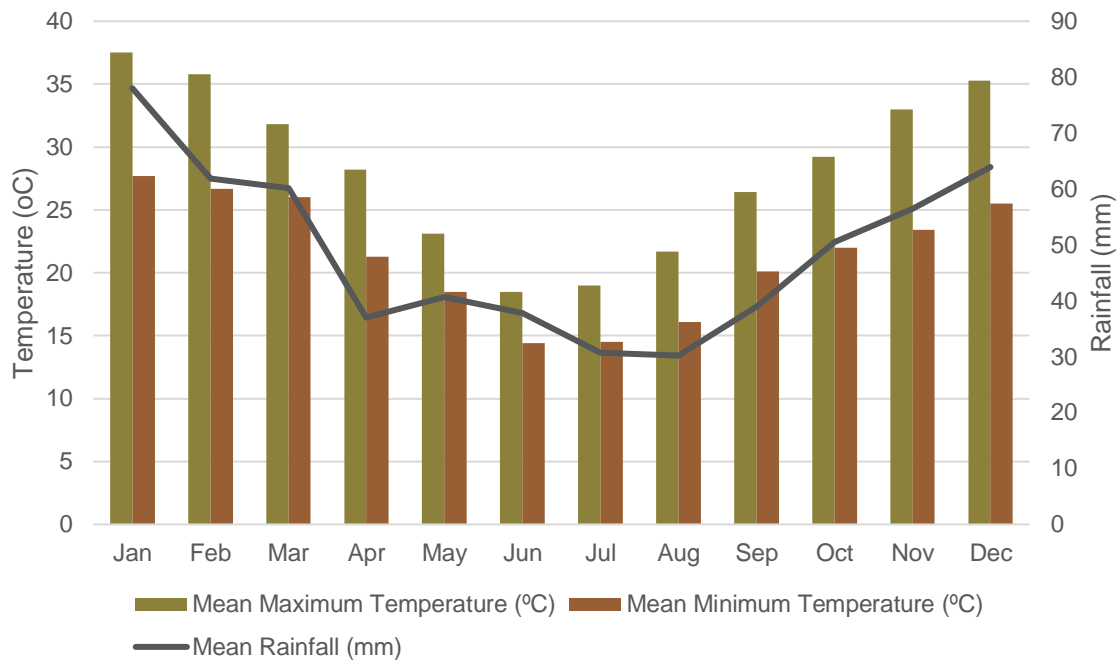
The average yearly rainfall in the area is approximately 617.7 mm with year 2018 only receiving 387.8 mm, the lowest recorded yearly average from Muswellbrook (St. Heliers) – weather station. The maximum recorded temperature was in the last year reaching 46.5°C on 12 February 2017. Average monthly climate data is presented in **Chart A**.

Chart A: Average monthly climate data for Muswellbrook (St. Heliers)

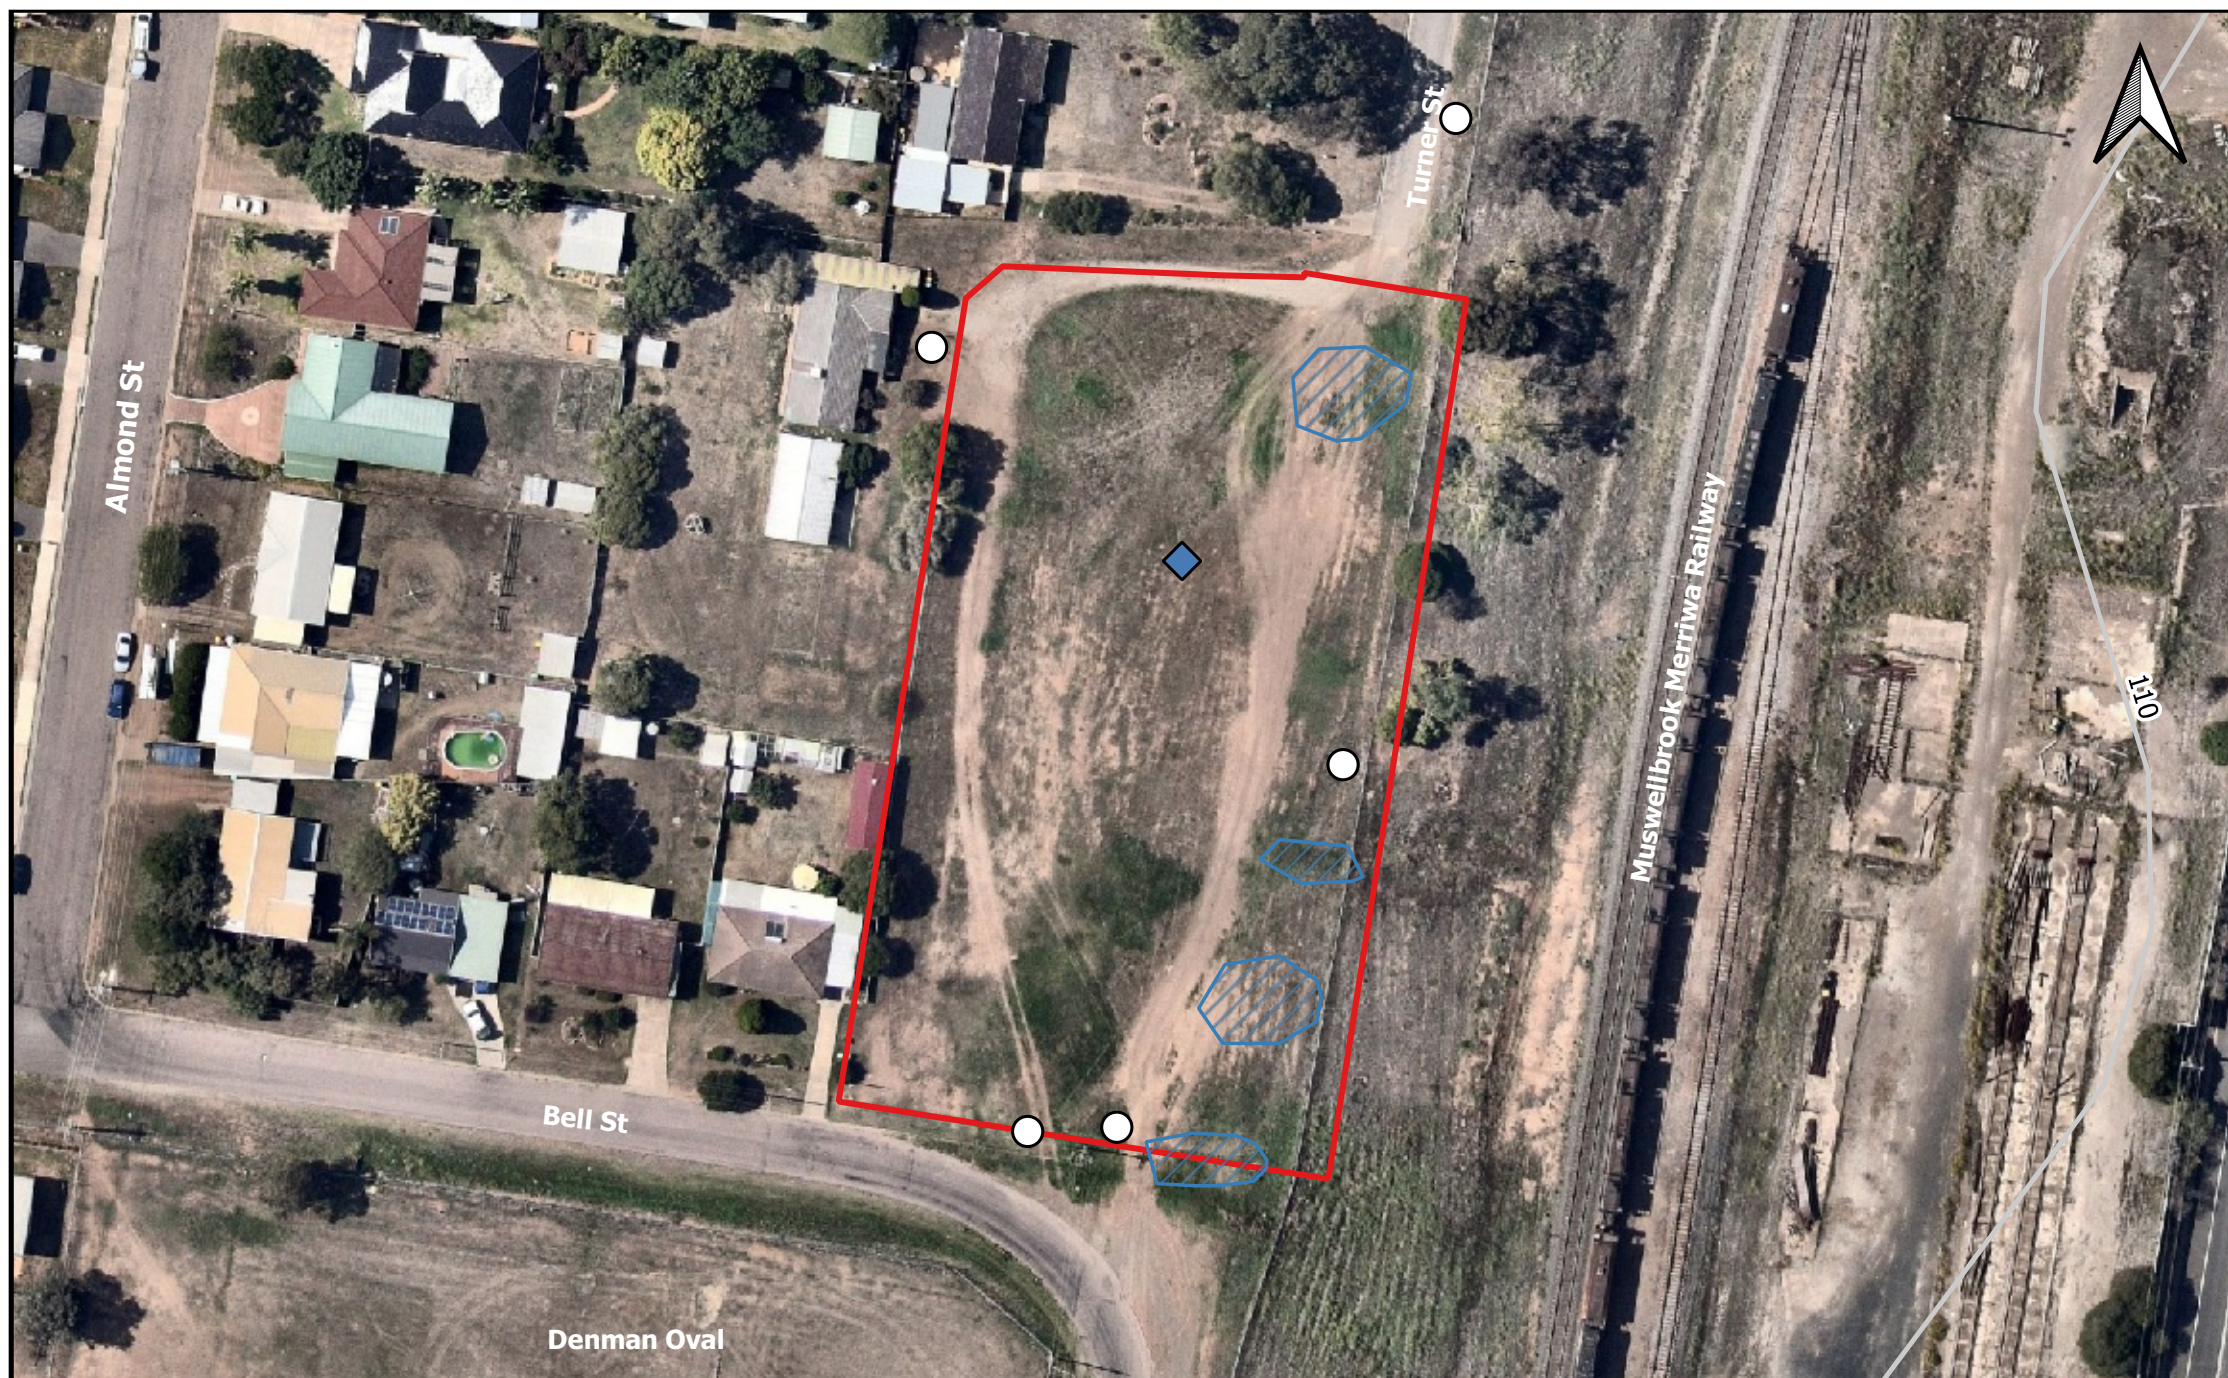
Figure 2

A site inspection was undertaken by Environmental Earth Sciences on 18 March 2021 to assess the current site condition. The site inspection coincided with a heavy rainfall event. Photographs of the site are presented in plates provided in **Appendix F**. Refer to indicative locations of features illustrated on **Figure 2**.

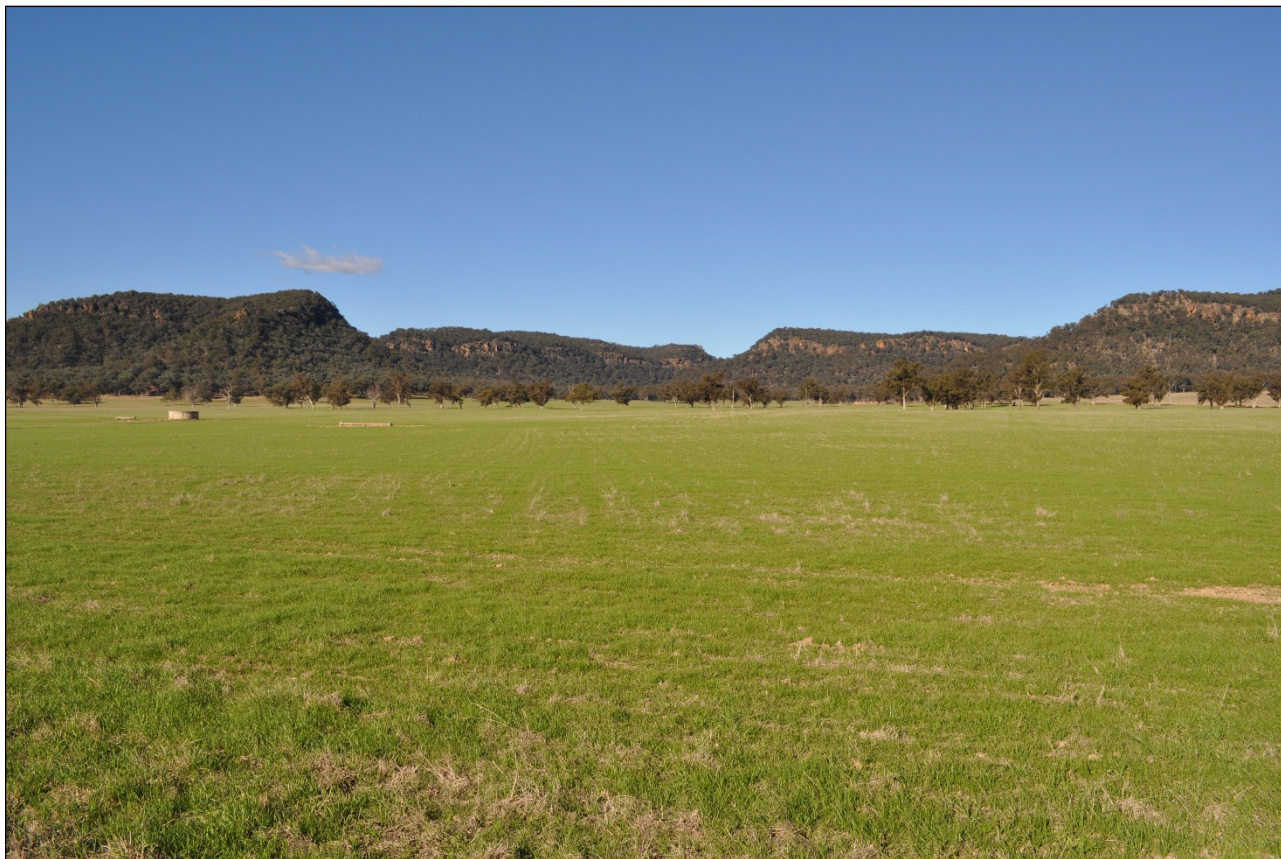
APPENDIX A: SANDY HOLLOW SOIL LANDSCAPE

Landscape— Gently undulating plain to undulating rises comprised of drainage plains and footslopes on Triassic and Permian sedimentary rocks and derived colluvium in the central western part of the Hunter Region. Slopes <10%, local relief <30 m, elevation 100 - 300 m. Extensively cleared open-forest and woodland.

Soils— Moderately deep to deep (50 - <150 cm), rapidly drained Tenosols and Rudosols (Earthy Sands and Siliceous Sands); moderately deep to deep (50 - <150 cm), well-drained Red Kandosols (Red Earths); and very deep (150 - 500 cm), imperfectly drained Red, Yellow and Brown Sodosols (Red Brown Earths, Red and Yellow Solodic Soils).

Qualities and limitations— localised recharge zone, localised discharge zone, localised salinity hazard, localised gully erosion hazard, widespread sheet erosion hazard, widespread high run-on, localised poor drainage, widespread seasonal waterlogging, localised flood hazard.

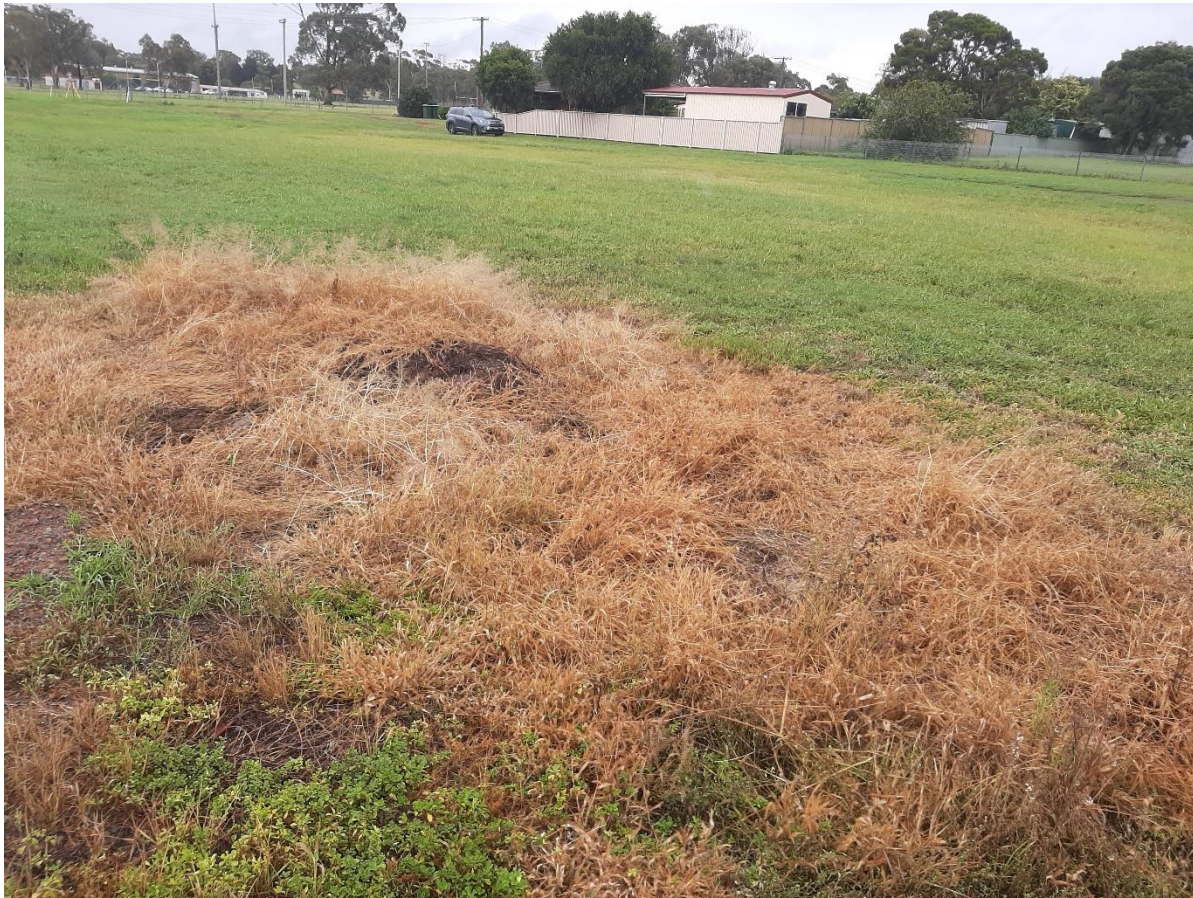
A stockpile of fill material was observed in the middle of the site, estimated to be approximately ~6 cubic metres (m³) in volume. This was based on the following approximate dimensions:

The stockpile as observed to comprise generally brown sandy soil with gravels of mixed lithology (e.g. road base (DGB20), concrete, clay tile and bricks). No odour or suspected asbestos-containing material (ACM) was identified. The grass under and immediately

surrounding the stockpile was noticeably in poor condition evidenced by yellow colour (refer to **Plates 5 - 7** in **Appendix F**).

Photo Plate 5: Stockpile of fill material at centre of site with surrounding dead grass - facing southwest.

- Stockpile:
 - Stockpile of uncontrolled material was observed onsite (approximately 6 m³), comprised of possible uncontrolled fill material.
 - As there is currently no information on physical / chemical properties of this stockpile the CSM assigned a risk status of MEDIUM.

It is recommended to conduct further detailed assessment of the physical and chemical properties of uncontrolled stockpiled material, undertaken either prior to commencement of development or during development. Results and findings should be used to inform management options for either onsite reuse or offsite management as solid waste. Based upon volume estimates of ~ 6 m³ collection of three samples would be recommended to chemically characterise this material for potential reuse and/or offsite management as solid waste in accordance with the minimum sampling requirements of ASC NEPM (2013).

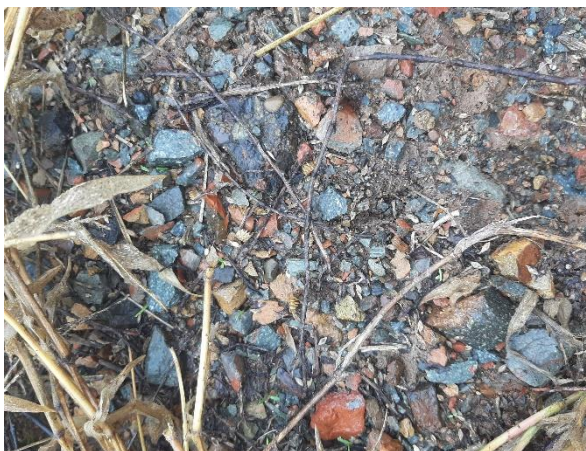
Photo Plate 6: Fill material in stockpile consisting of brown sandy soil, mixed gravel, road base material, pieces of brick etc.

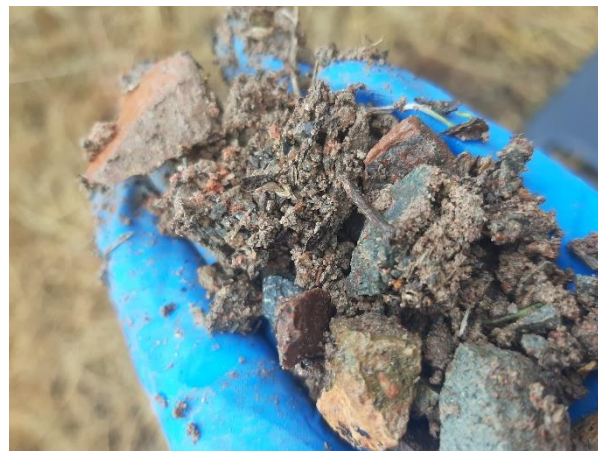
Photo Plate 7: Fill material of mixed gravel in stockpile.

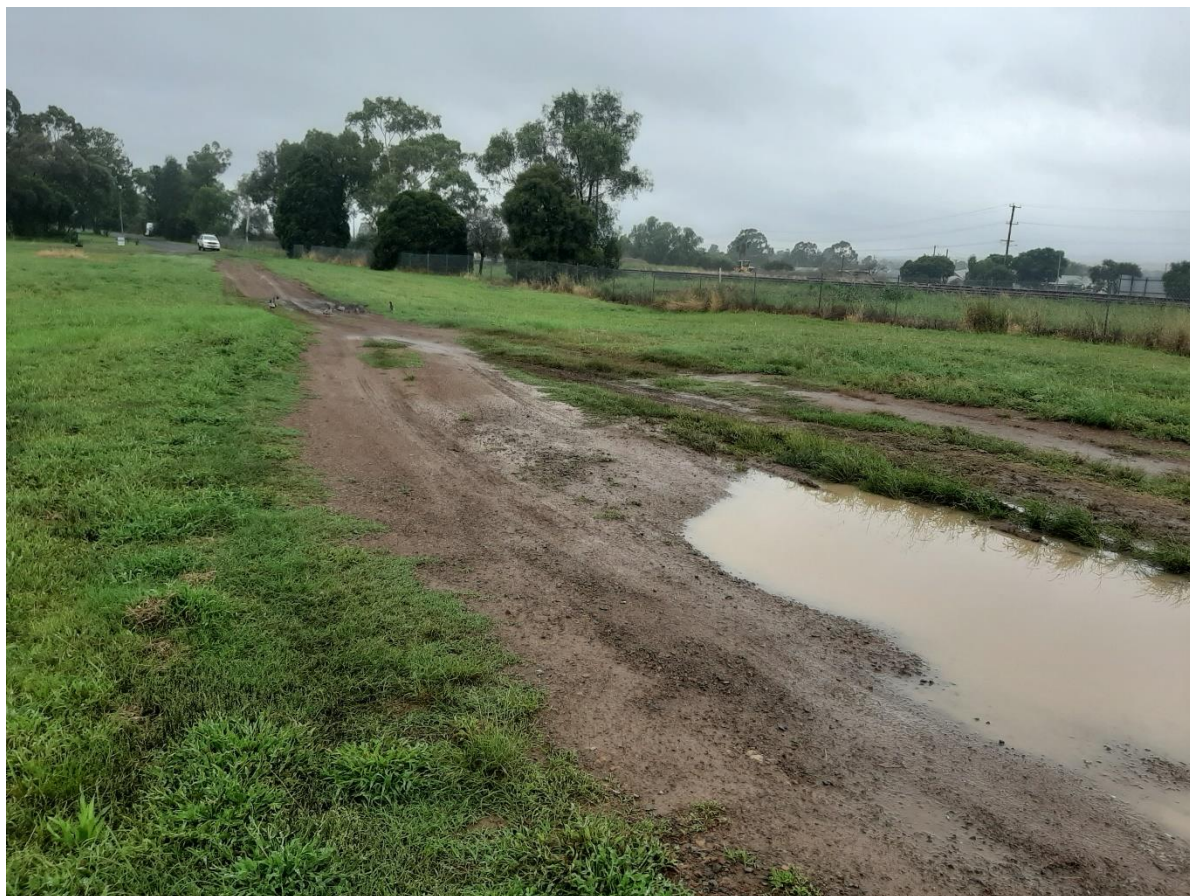
Photo Plate 8: Eastern portion of site facing north showing water logging.

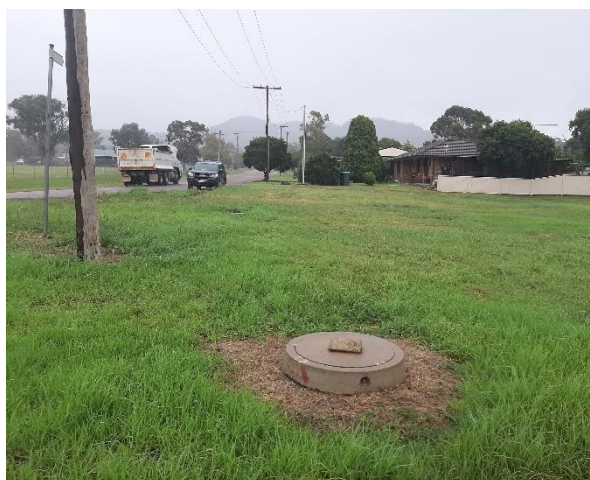
The site has a rectangular shape and is situated immediately west of Muswellbrook-Merriwa Railway corridor with residential buildings to the north and west. At the time of the inspection, the site was grassed with no trees or shrubs, however it is understood that the fence of the rail corridor may not be representative of the lot boundary. Inside the rail corridor, vegetation was predominantly grass but also included trees along the fence line. The site is surrounded by residential buildings to the north and west. It was noted that the undulations on the site had resulted in areas of standing water in the north and east of the site (refer to **Plates 1 – 4, 8 in Appendix F**). Three circular lidded concrete pits were observed on site and two just off-site, presumed to act as subsurface drainage (refer to **Plate 9 in Appendix F**).

Photo Plate 9: Subsurface concrete drainage pit in southwestern corner of site – facing west.

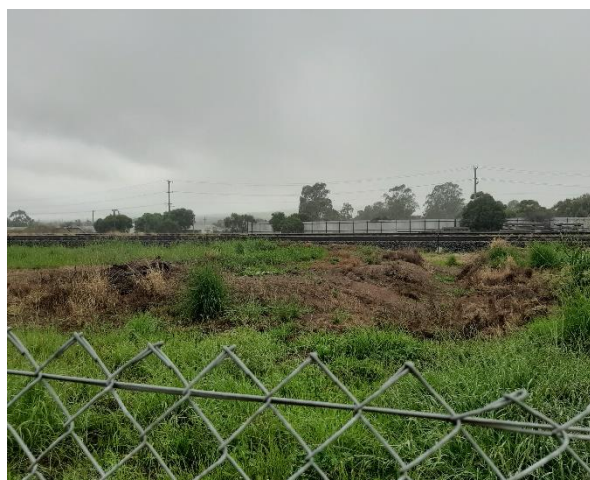
During site inspection long freight trains were noted to carry coal in uncovered wagons on a regular basis between mines of the upper Hunter Valley and the coal terminal at Newcastle. The rail track within the adjoining rail corridor is 30 m from the eastern site boundary.

Photo Plate 10: Facing east across the fence towards rail line, showing train with uncovered coal wagons. Scrap metal and other fill material in railway corridor.
