## Re: Muswellbrook Pumped Hydro Energy Storage – Upper Reservoir Aboriginal Heritage Management

# 1. Introduction

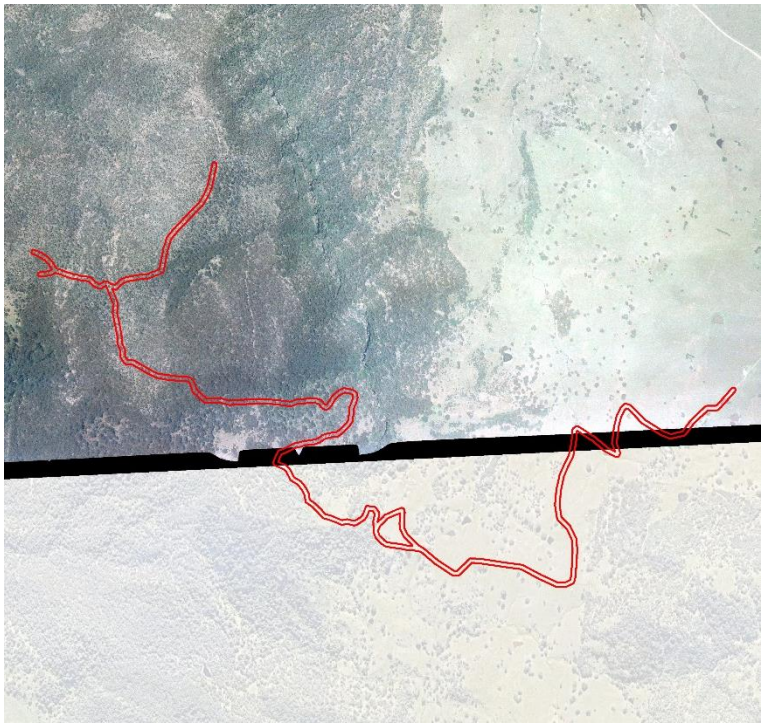
<p>Figure 4. Historical aerial of the study area (hard red line), 1972. Source: Nearmap (2022).</p>
1989	<ul style="list-style-type: none"> <li>Tree thinning across the top of Bells Mountain. The property owner said anecdotally that a bushfire went through in the 1980s.</li> </ul>

<p>Figure 5. Historical aerial imagery of the study area (hard red line), 1989. Source: Nearmap (2022).</p>

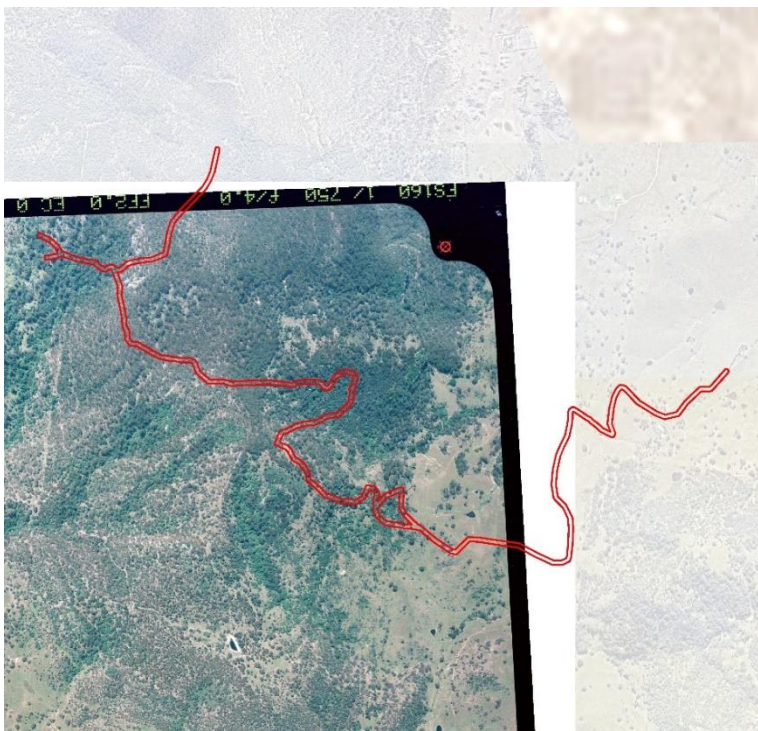
Year	Description	Historical Aerial
1993	<ul style="list-style-type: none"> <li>Regrowth present along the eastern side of the mountain.</li> </ul>

<p>Figure 6. Historical aerial imagery of the study area (hard red line), 1993. Source: Nearmap (2022).</p>
1998	<ul style="list-style-type: none"> <li>Foliage regrowth post thinning.</li> <li>Tree removal for tracks and transmission lines present.</li> <li>Regrowth present.</li> </ul>

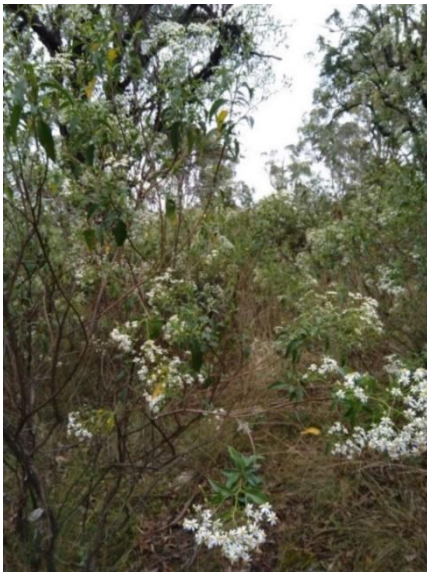
Figure 14 Photo demonstrating thick vegetation cover limiting access and GSV.

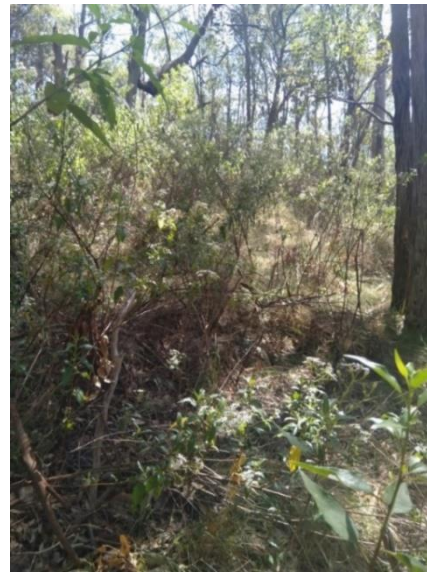
Figure 15 Photo of the general vegetation across the survey area.

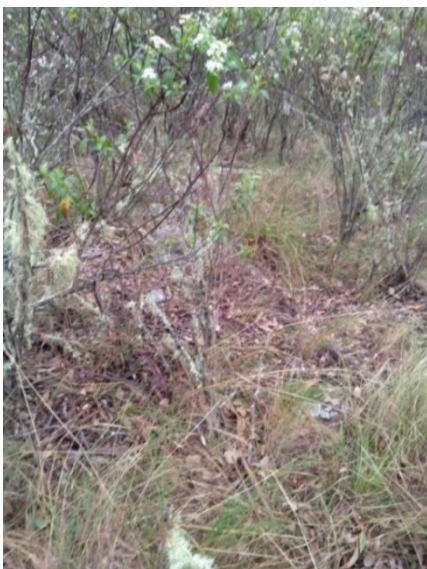
Figure 16 Photo of the general groundcover in the study area.

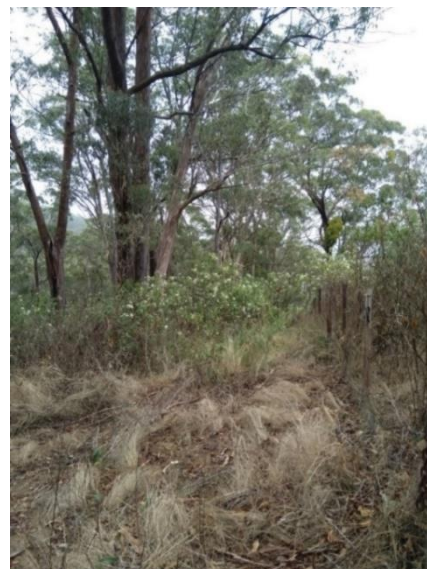
Figure 17 Example vegetation in the study area. Cleared areas bordered by sticky hop bush.

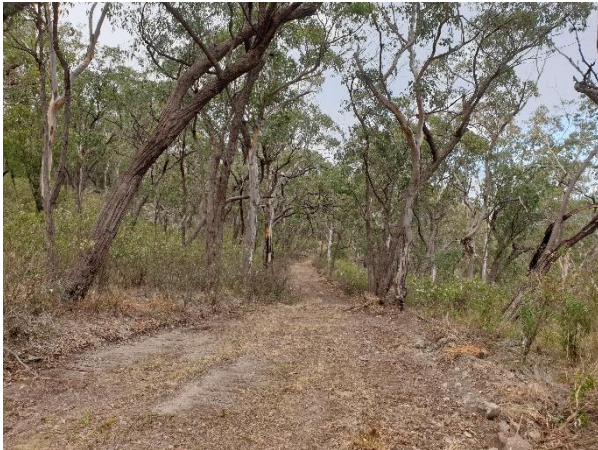
Figure 18 Photo demonstrating a recently slashed access track, taken in May 2023.

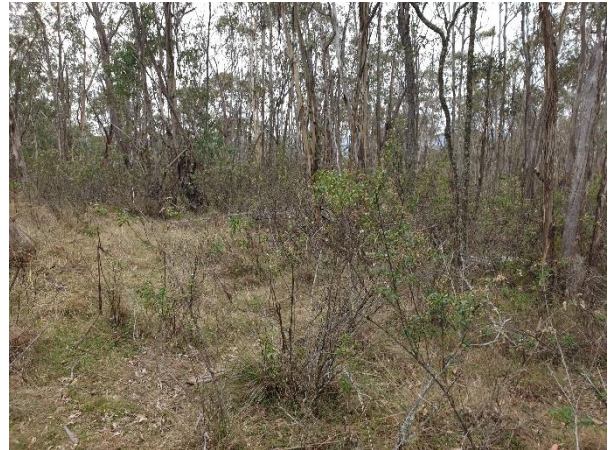
Figure 19 Photo of the general vegetation off-track, taken in May 2023.

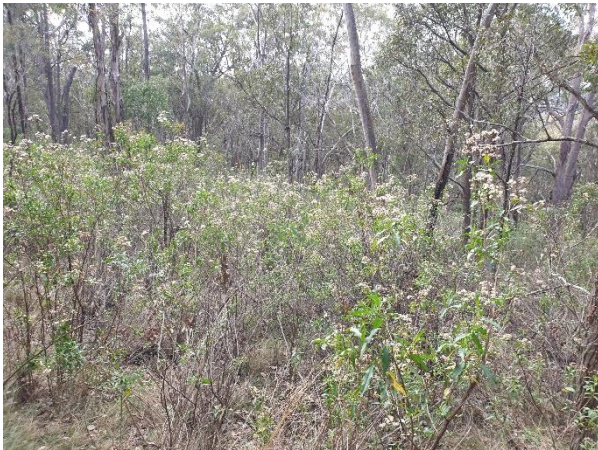
Figure 20 Photo of sticky bush still prevalent in areas of the study area, taken in May 2023.

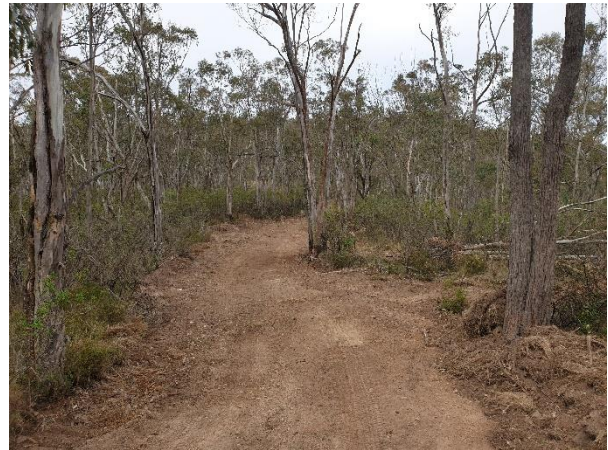
Figure 21 Photo of track recently cleared of sticky bush and grass cover, taken in May 2023.

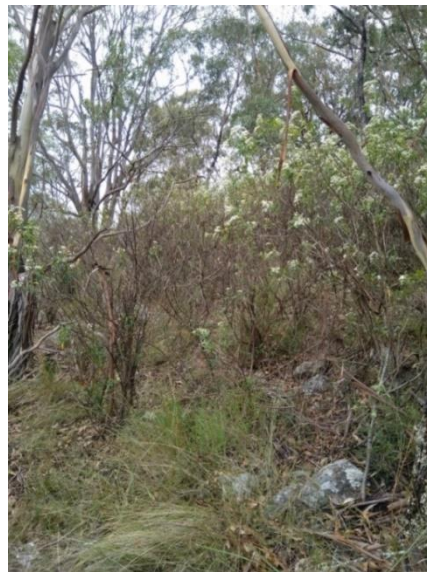
The general area had very poor GSV (0-10%) due to dense scrub, leaf litter, and grass cover. Some small to medium natural cobbles were visible in places, as well as large boulders, but no Aboriginal objects were identified in the area that was accessible. Based on the shallow soil profile, there is low potential for in situ subsurface Aboriginal archaeology to be disturbed by the proposed works. Similarly, there is low potential for surface Aboriginal archaeological material to be disturbed by the proposed works in this vicinity.

Figure 22 Facing west, looking uphill towards the location of BH7 and TP8.

Figure 23 Facing south-west, looking uphill in the vicinity of BH7 and TP8.

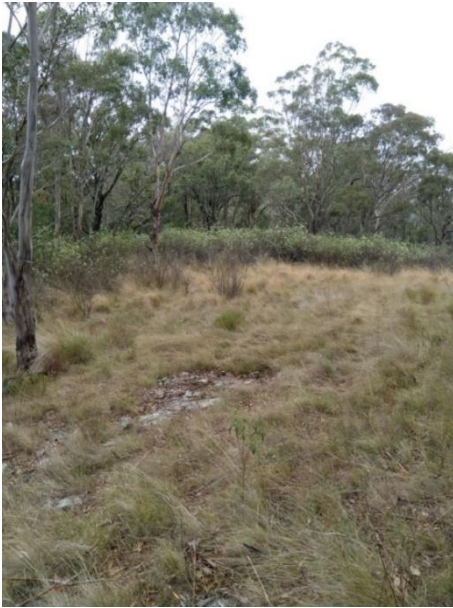
Figure 26 Cleared grassy area along the planned access track to BH7 and TP8, facing south-east.

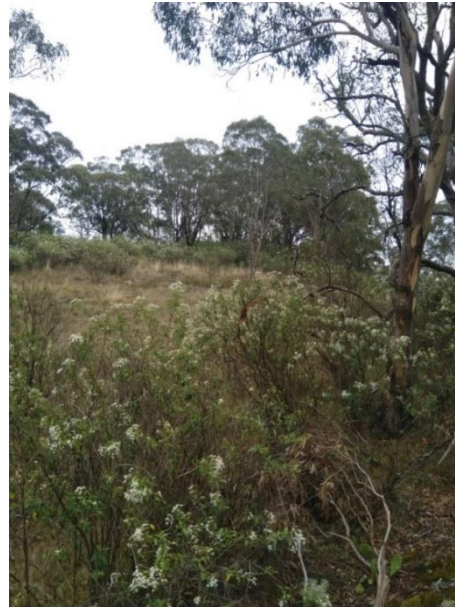
Figure 27 Facing east towards cleared grassy area along planned access track to BH10.

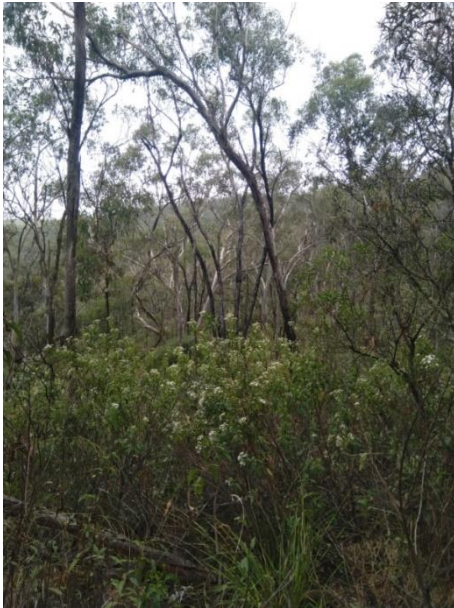
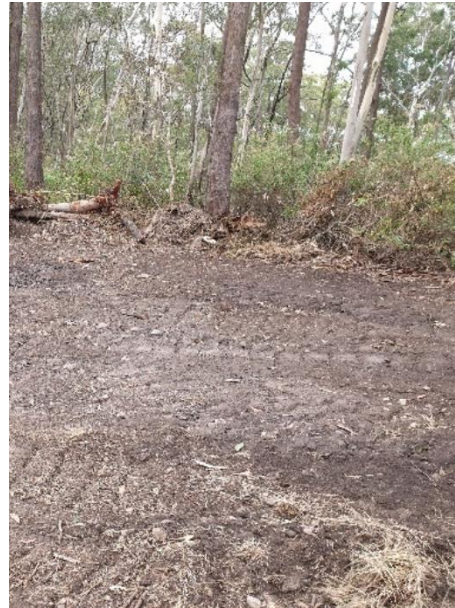
No Aboriginal artefacts or places were identified during the inspection of the general area along the access track near BH6 and TP9. It is evident that the access track had already experienced a high level of disturbance prior to the inspection due to previous clearing in the vicinity.

In areas of ground surface exposure, medium sub-angular and rounded cobbles were visible at times through the ground cover. No artefacts were identified.

Figure 28 General location of BH6 and TP9. Facing south-west.

Figure 29 General location of the access track, facing south towards BH6 and TP9 (off track).

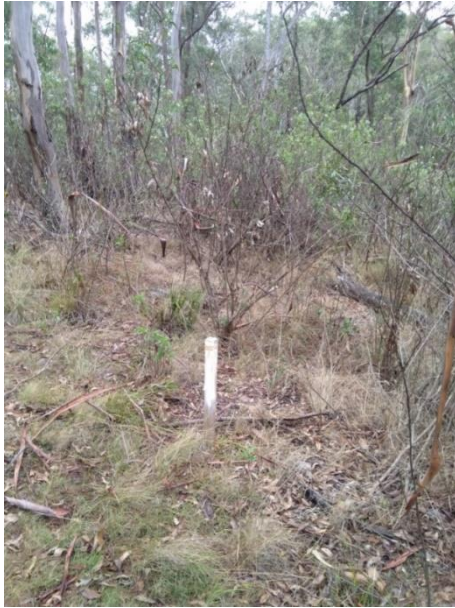
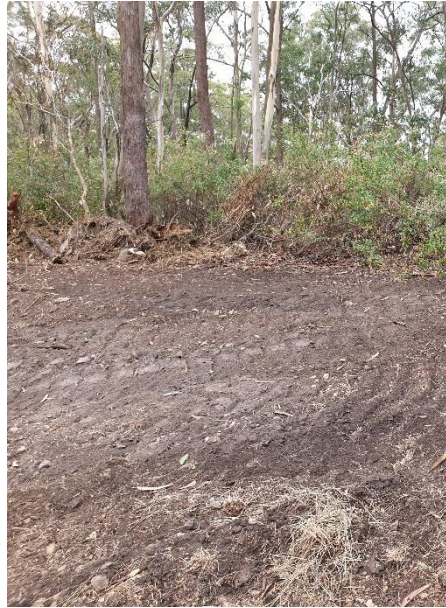
The soils in this area were particularly shallow with exposed conglomerate outcropping and medium sub-angular cobbles on the surface. The surrounding vegetation consisted of immature trees and sticky bush.

No Aboriginal artefacts or places were identified during the inspection of this borehole, although ground surface visibility was mixed with areas of no visibility and areas of exposed conglomerate outcropping with good visibility. Based on the shallow soil profile, and observed levels of disturbance, there is low potential for in situ subsurface Aboriginal archaeology to be disturbed by the proposed works there. Similarly, there is low potential for surface Aboriginal archaeological material at these locations to be disturbed by the proposed works.

Figure 30 Location of BH4, facing north.

Figure 31 General location of BH4, post clearing, facing south. Photo taken in May 2023.

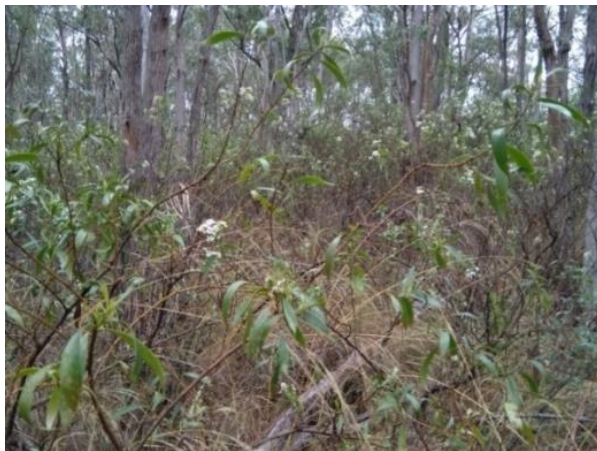
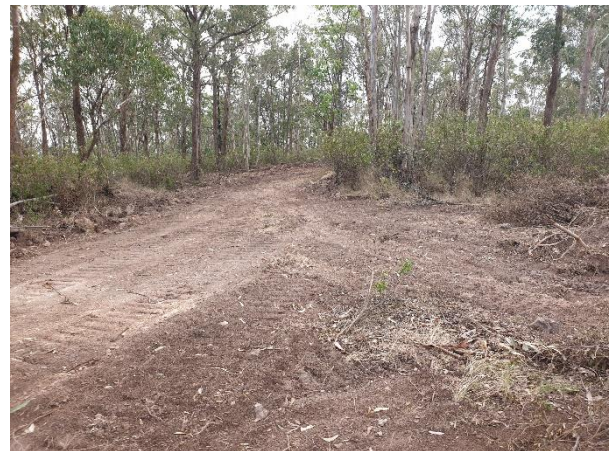
BH2 and TP11 are located together just east of a pre-cleared track bordered by dense sticky hop bush approximately 2m high and scrub. Clearing prior to the May survey resulted in excellent GSV. No artefacts were identified in this area.

Figure 32 General vegetation in vicinity of BH2 and TP11, facing east.

Figure 33 General area of access track near BH2 and TP11, facing south, **taken in May 2023.**

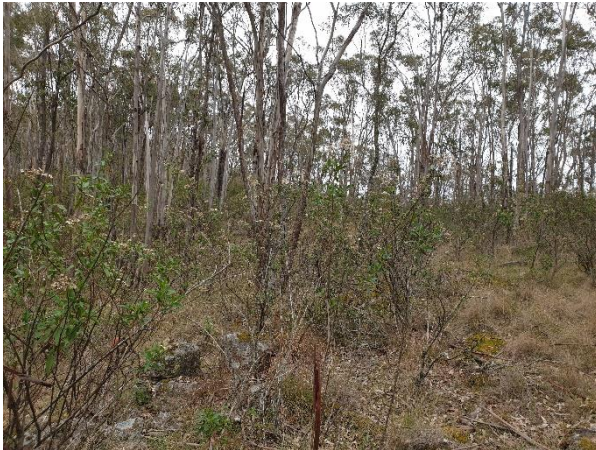
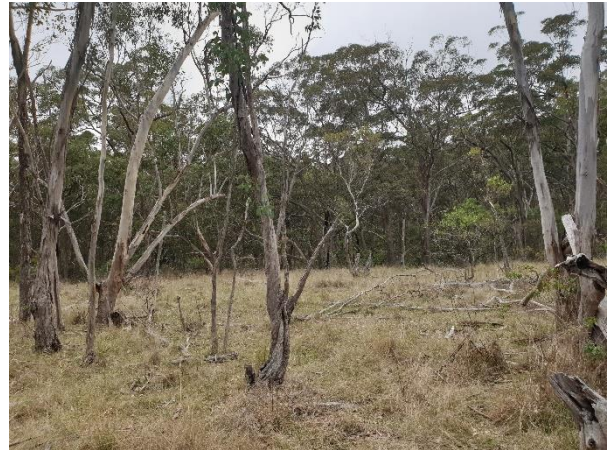
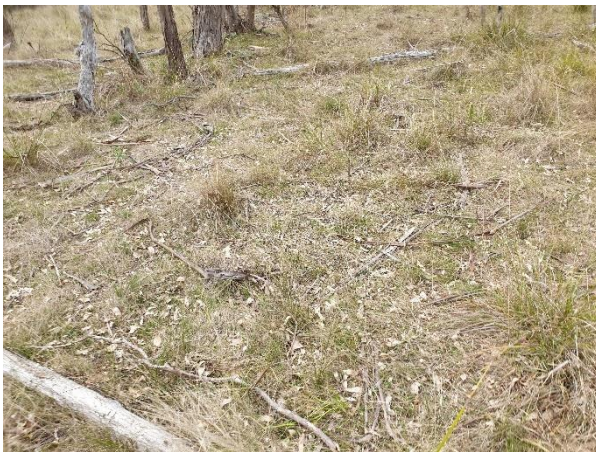
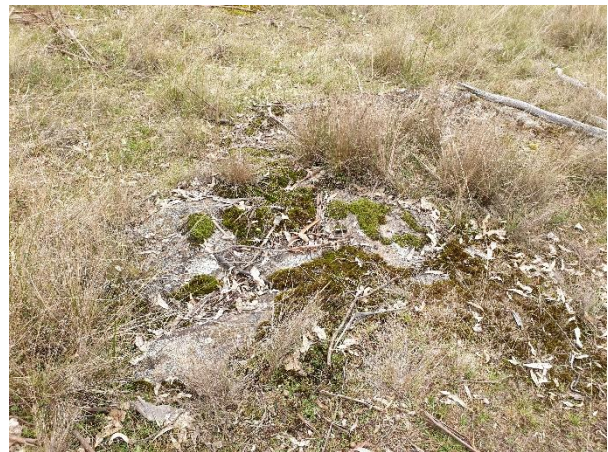
BHU3 is located approximately 95m east of the pre-existing track in a grassy clearing of open woodland. Due to thinning of vegetation, it was possible to traverse an access route perpendicular to the path and survey the borehole location. GSV was generally fair (~30%) with grass cover and leaf litter, and some exposed rocky surfaces. No artefacts were identified.

Figure 34 General vegetation along access route to BHU3, facing north.

Figure 35 Location of BHU3, facing south-east.

Figure 36 Average GSV at BHU3 location

Figure 37 Exposed rock in vicinity of BHU3

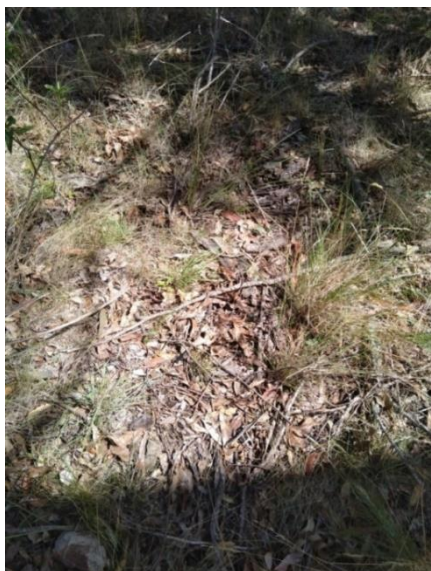
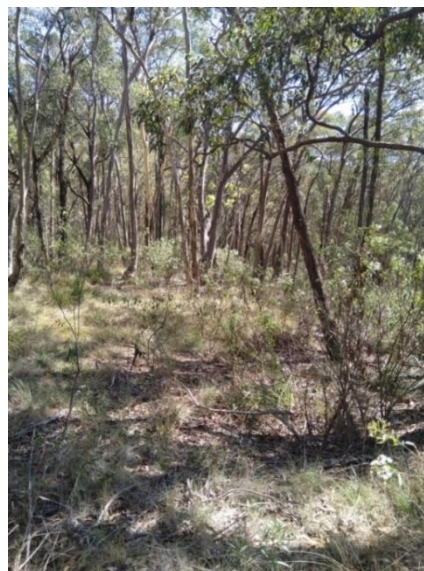
Figure 38 General GSV around BHU1.

Figure 39 General area around BHU1, south-west.

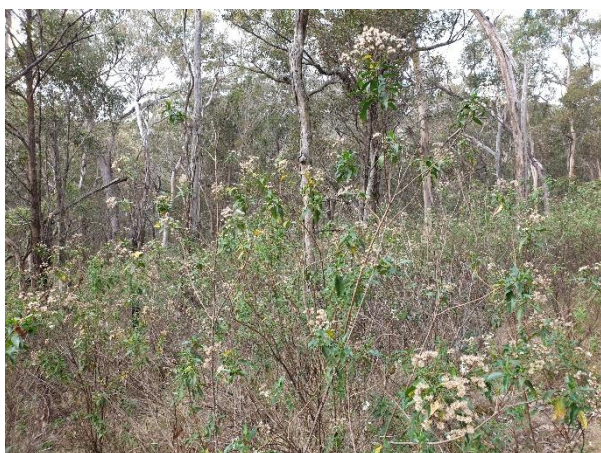
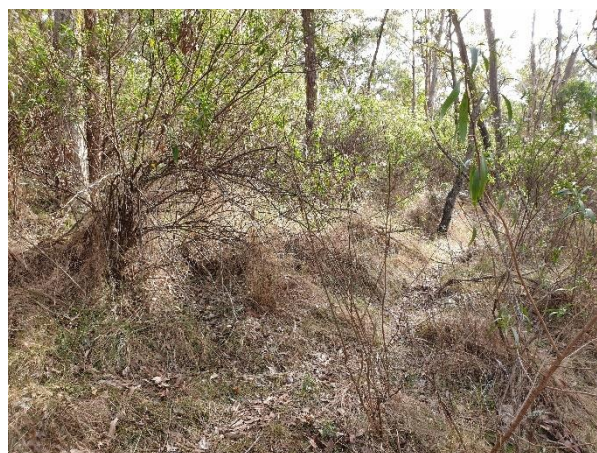
BHU2 is located on a steep slope above the gully. It is surrounded by vegetation consisting of some mature ironbark trees and immature gum trees. A dense stand of sticky bush restricted access to the borehole location from the west. From the east, access was still difficult with no GSV. The location of the borehole is surrounded by sticky bush and grass cover, with very poor GSV. No Aboriginal artefacts, culturally modified trees, or Aboriginal places were identified in this area.

Figure 40 Sticky bush in vicinity of BHU2, facing south.

Figure 41 Facing north-east, in location of BHU2.

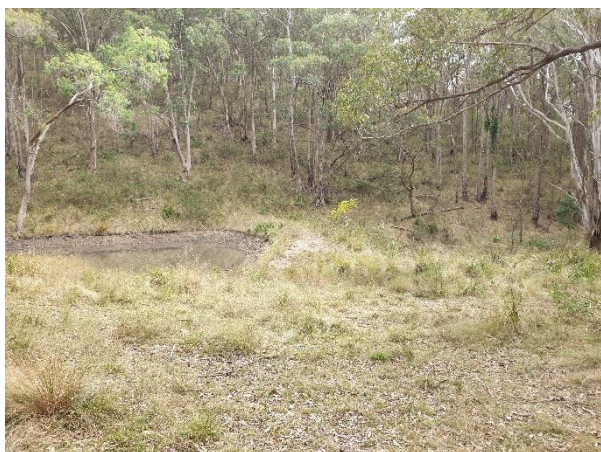
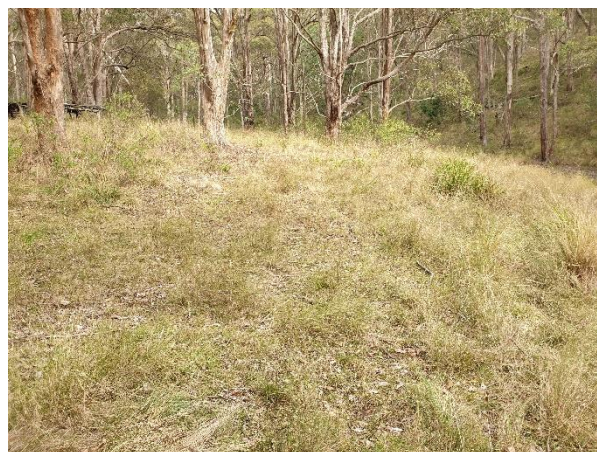
BHU5 is located at a man-made dam in a clearing in the vicinity of a pre-existing track. GSV was poor to fair (~10-30%) with grass cover and leaf litter. No artefacts were identified.

Figure 42 General location of BHU5, facing north

Figure 43 General ground cover at BHU5, facing west

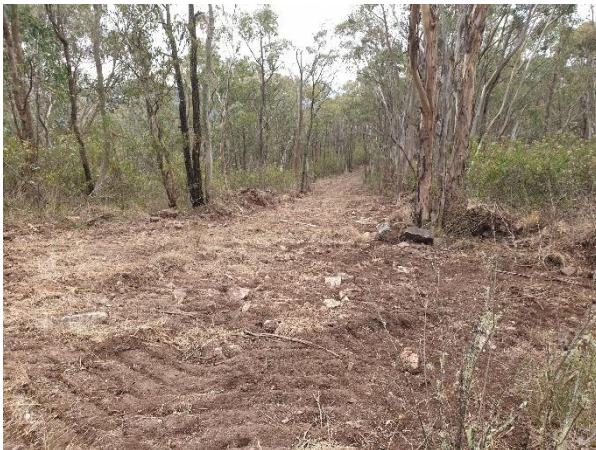
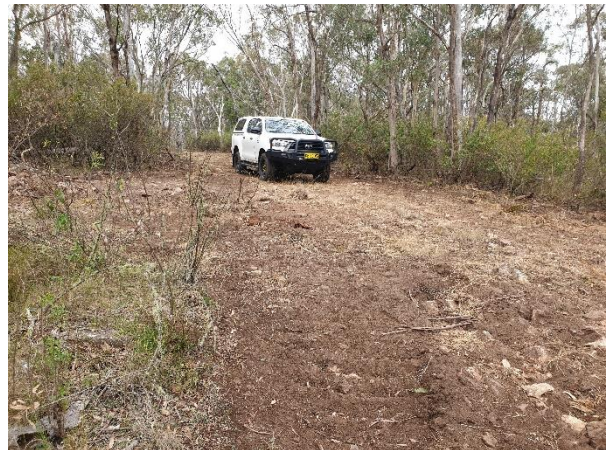
BH1 is located on a pre-cleared track in open woodland forest on the eastern side of Bells Mountain. Due to recent clearing, GSV in this vicinity was excellent. Some sub-angular conglomerate cobbles were observed. The wider area was surveyed however access was restricted by dense sticky hop bush approximately 2m high bordering the track. No artefacts were observed in this area.

Figure 44 General location of BH1, facing north.

Figure 45 General location of BH1, facing south.

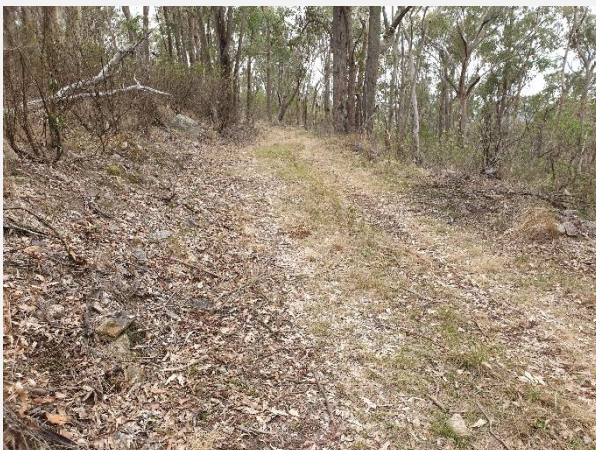
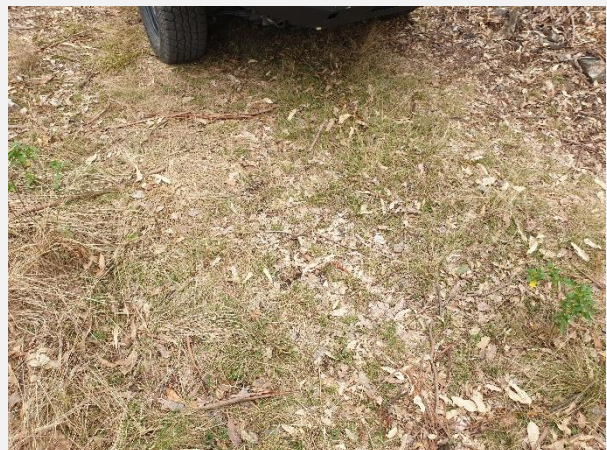
BHU4 and TP12 are located north of BH1 on the pre-cleared track. GSV in this area was fair (~30%) with short grass and leaf litter, however off-track access was restricted by dense vegetation. There was also a steep slope on the eastern side of the track. No artefacts were identified.

Figure 46 General location of BHU4 and TP12, facing north-east.

Figure 47 Average ground cover at BHU4 and TP12.
