Report on
Geotechnical Investigation and Preliminary Salinity
Assessment

Proposed School
Lot 100, DP1261496, Maitland Street, Muswellbrook,
NSW

Project 91601.03
July 2024

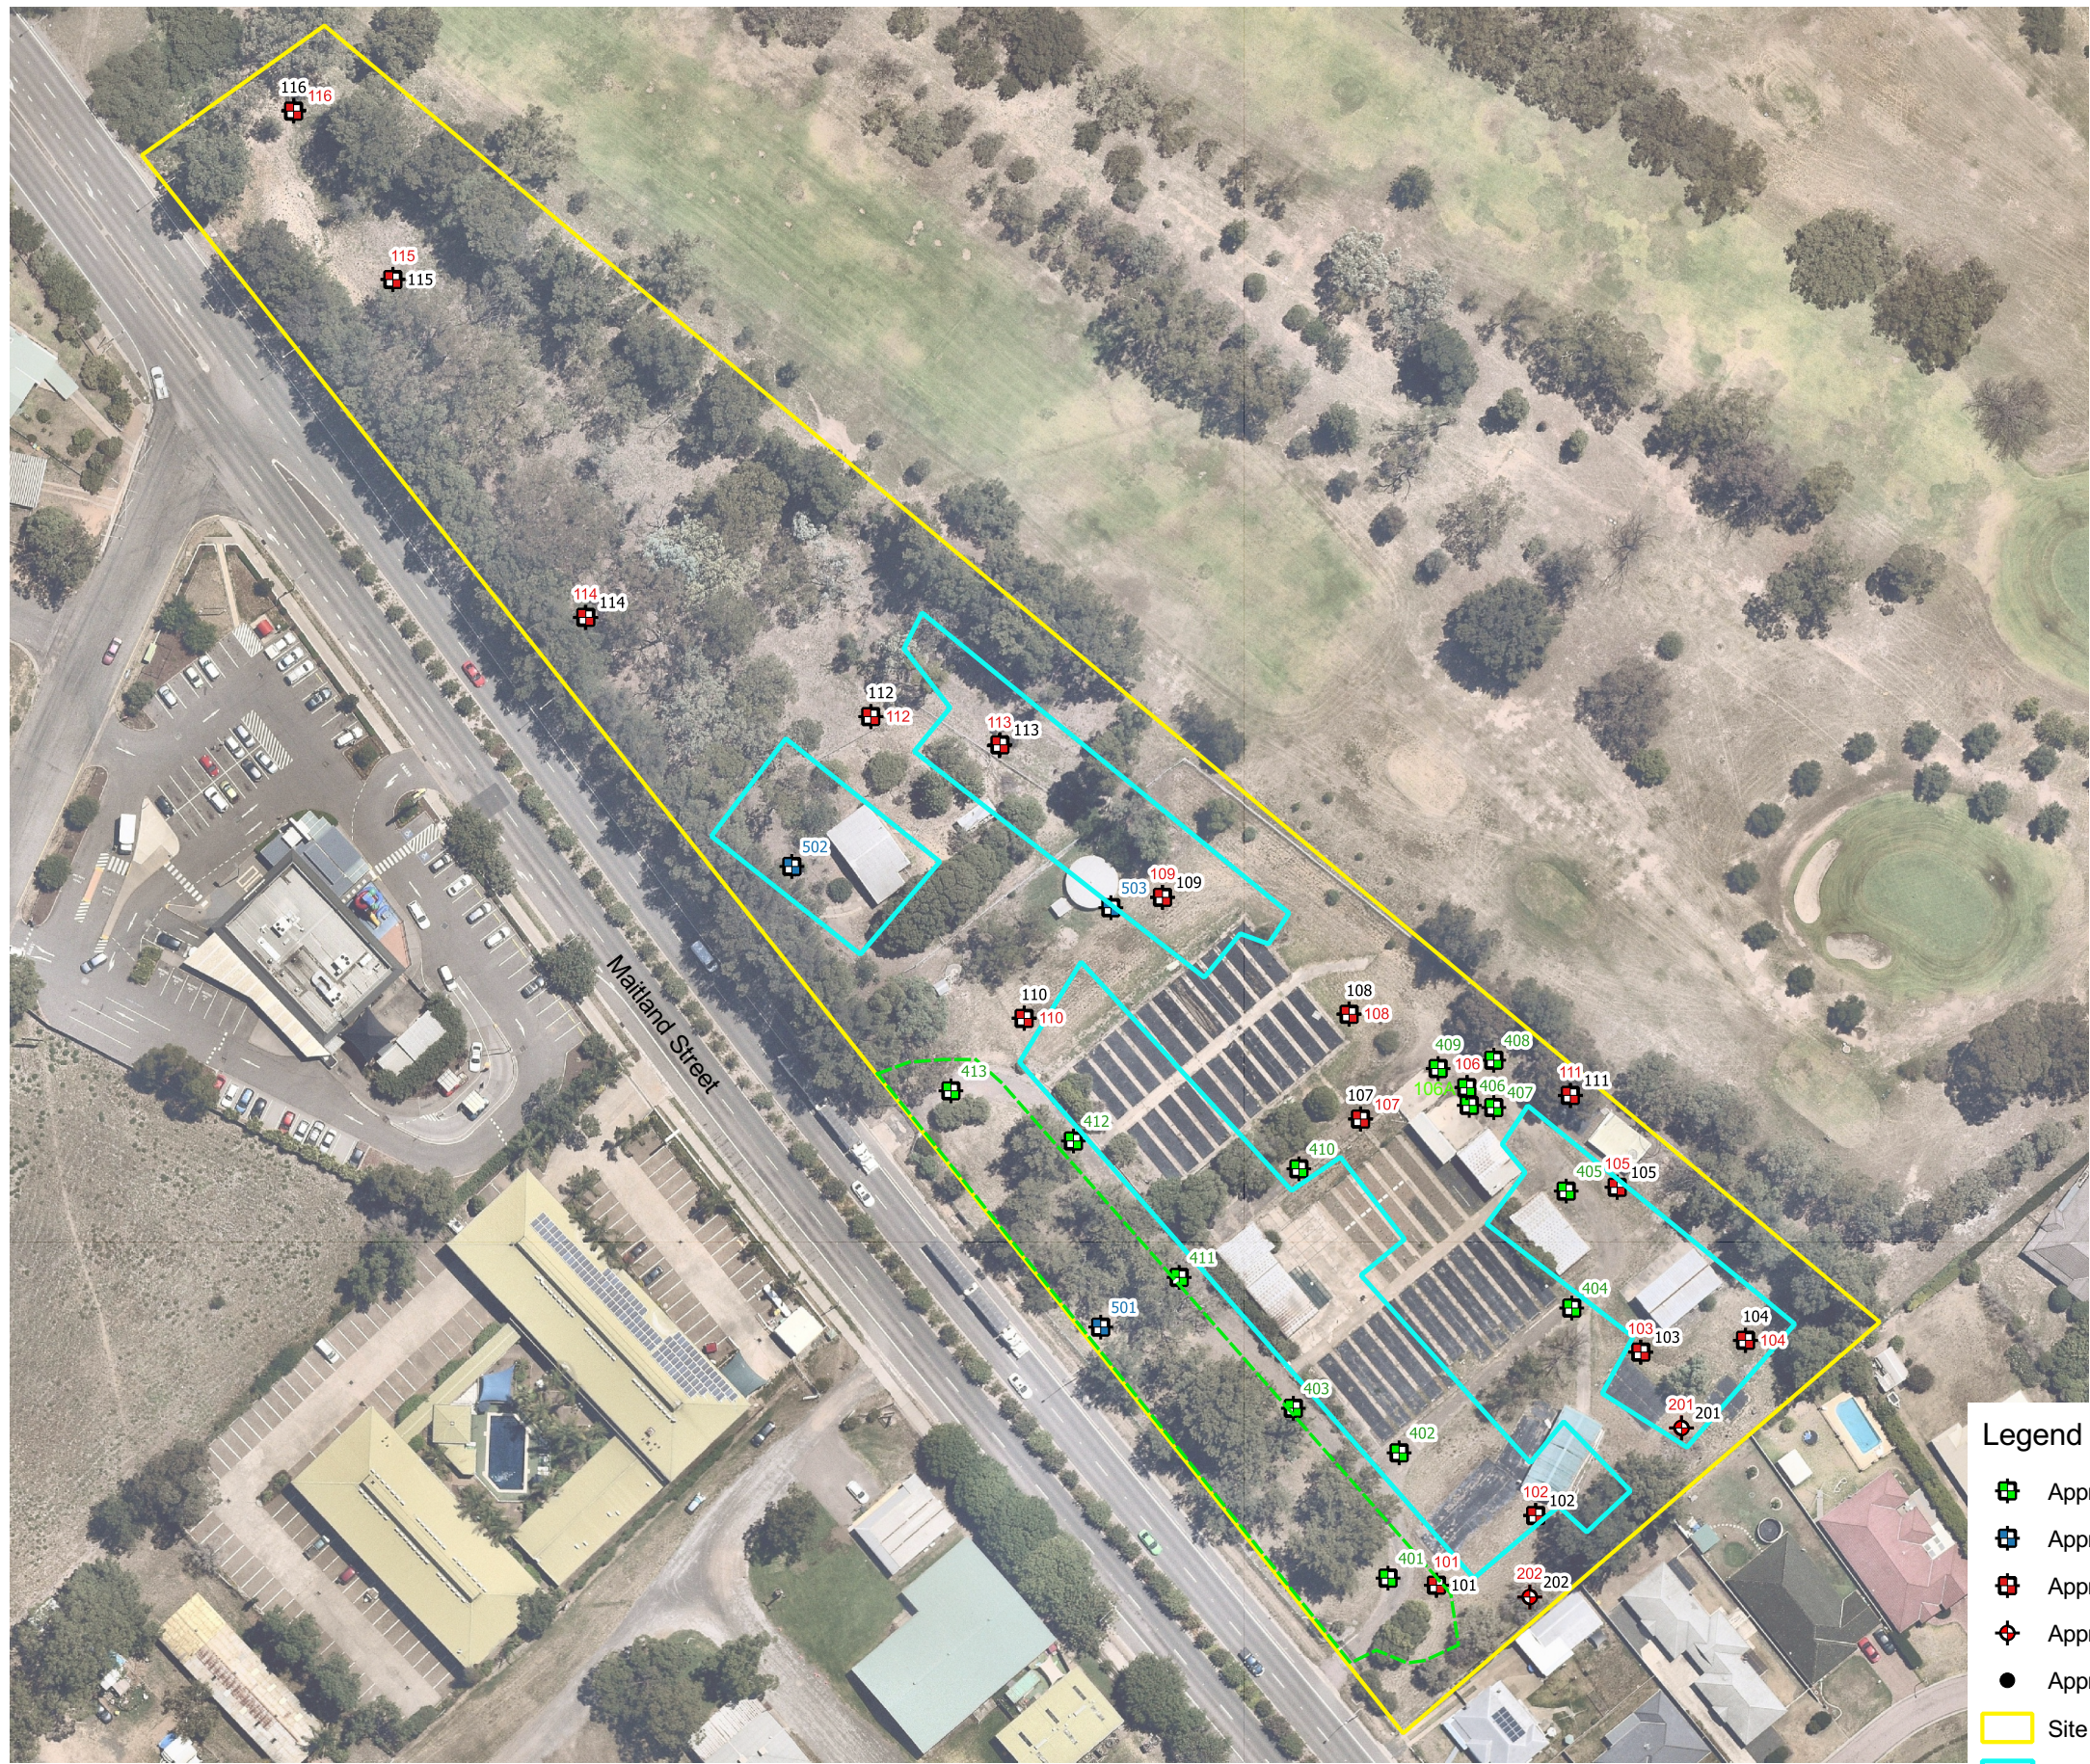
Drawing 1 – Test Location Plan
19055-NBRS-DR-A-DA14 – Stage 1 Site Plan

Drawing adapted from Nearmap Image dated 13.1.2019
