Preliminary & Detailed  
Contamination  
Assessment

252 Coal Road,  
Muswellbrook, NSW.

NEW22P-0092-AA  
12 July 2022

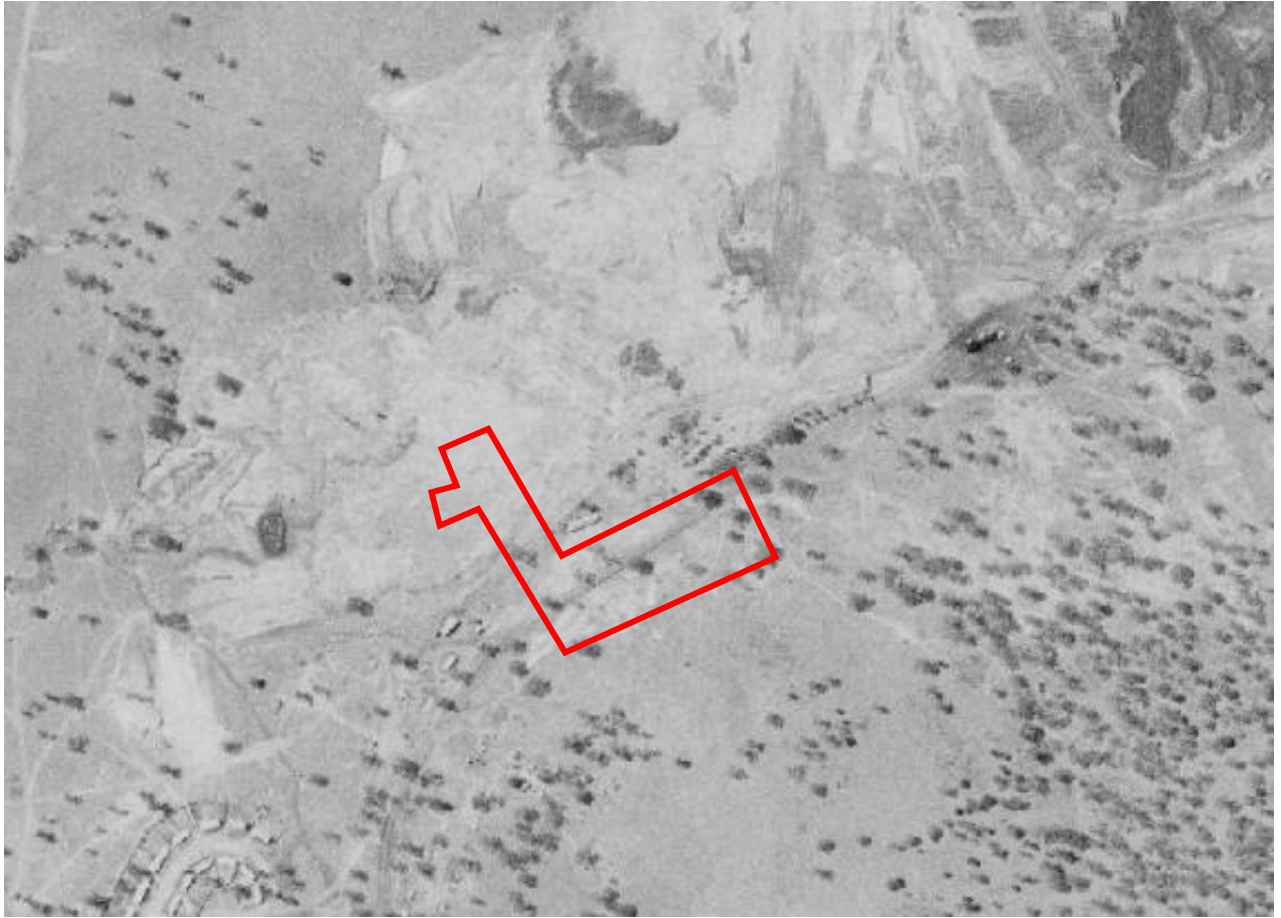
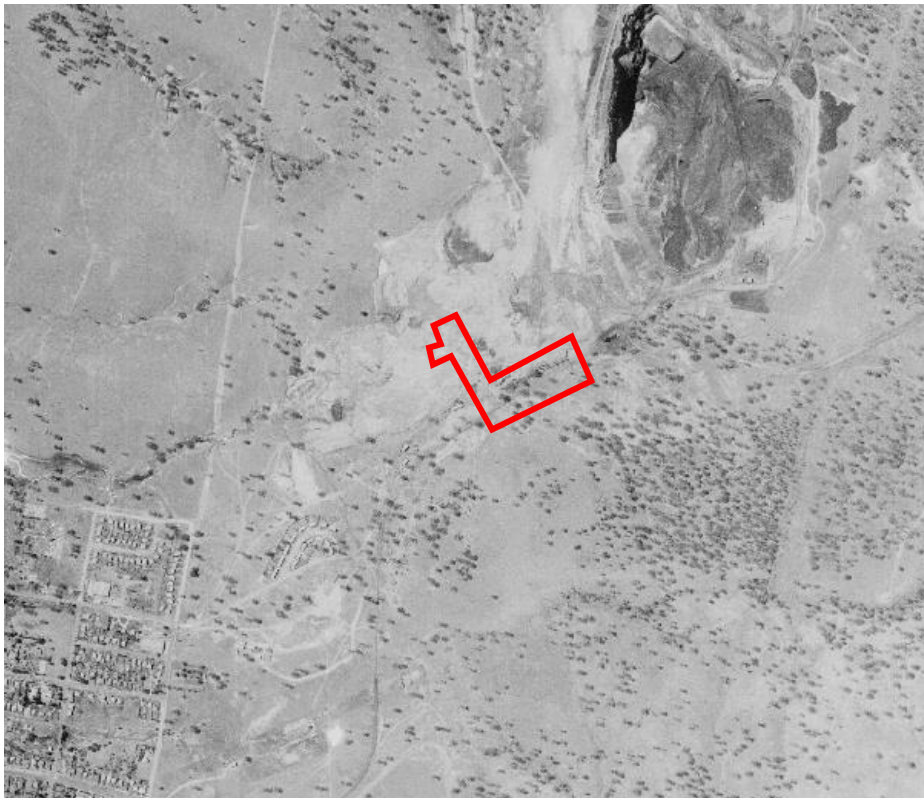
1958

Some disturbed land and possible filling was observed across the site dating back to 1958. A potential rail line was also present running in an east west direction through the central and southern portion of the site, likely associated with former coal mining located to the north east of the site. The former railway line appeared to be removed and replaced with a swale drain in the early 1990s. From the early 1990's to the present day the site has been generally vacant vegetated land used for the storage of unknown materials and equipment. During the site walkover large areas of filling and stockpiles were observed across the site. Anecdotal information suggests that the filling and stockpiles was likely mining overburden produced by Muswellbrook Coal Company.

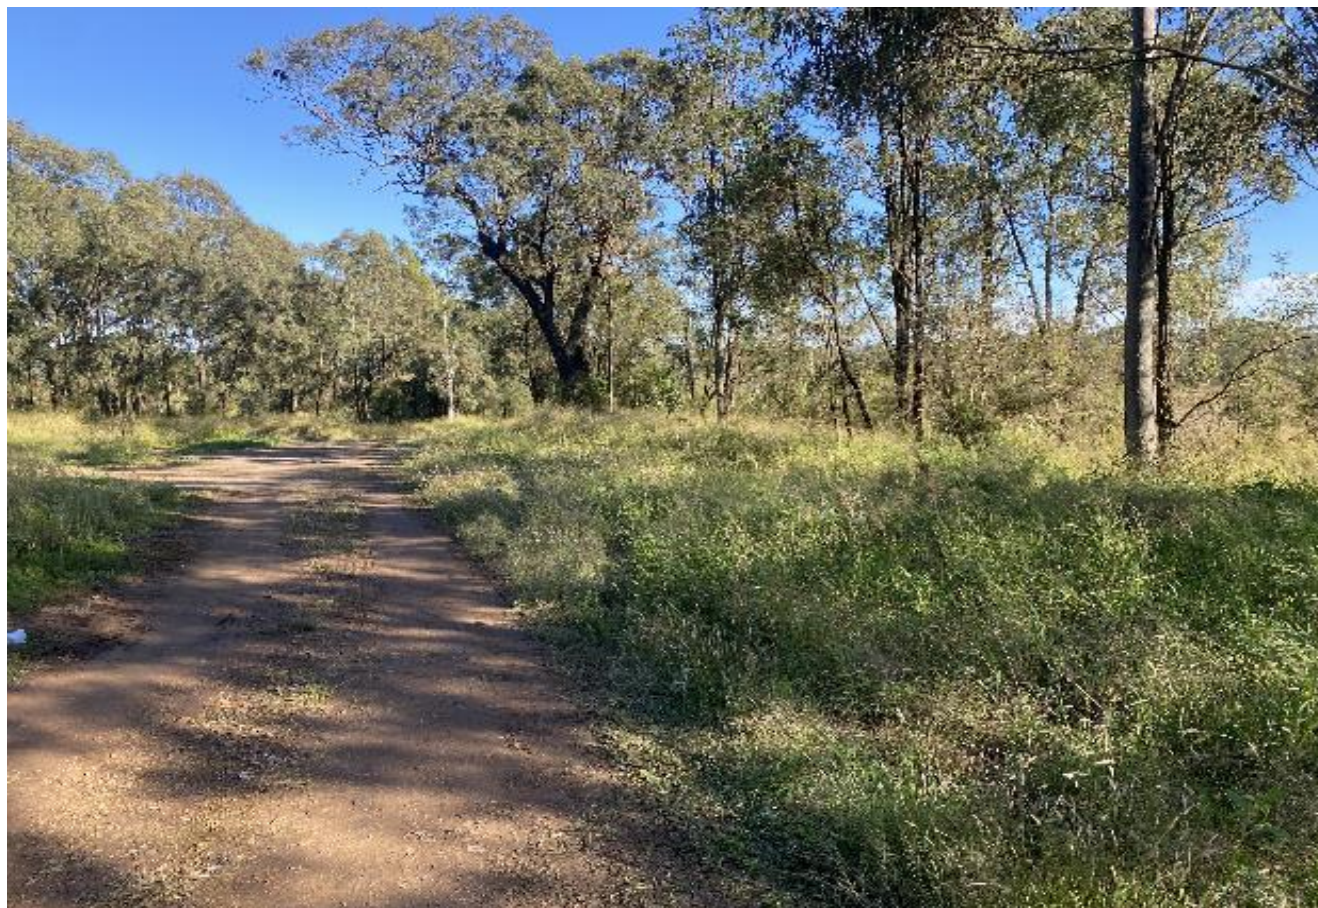
- The majority of the site was observed to be vegetated with thick grass with some small to large sized trees observed scattered across the site (see Photographs 1 to 3);
- Two access roads were observed in the southern portion of the site, running approximately east-west and one access road was observed in the northern portion of the site running north-south. The access roads were observed to be constructed of a sandy gravel roadbase

Photograph 1 - Showing general site conditions, facing west from the south-eastern portion of the site.

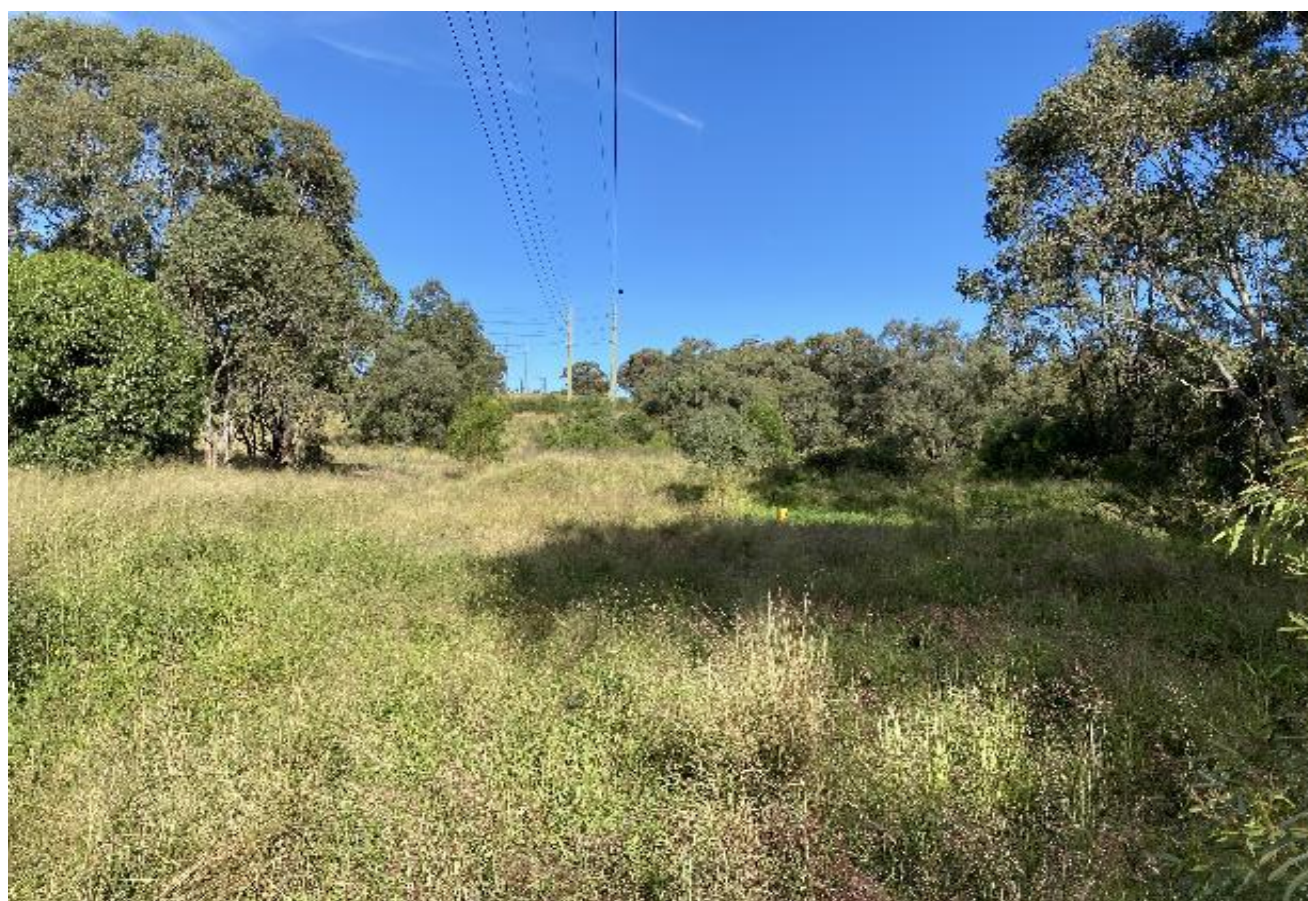
Photograph 2 - Showing general site conditions, facing south from the northern portion of the site.

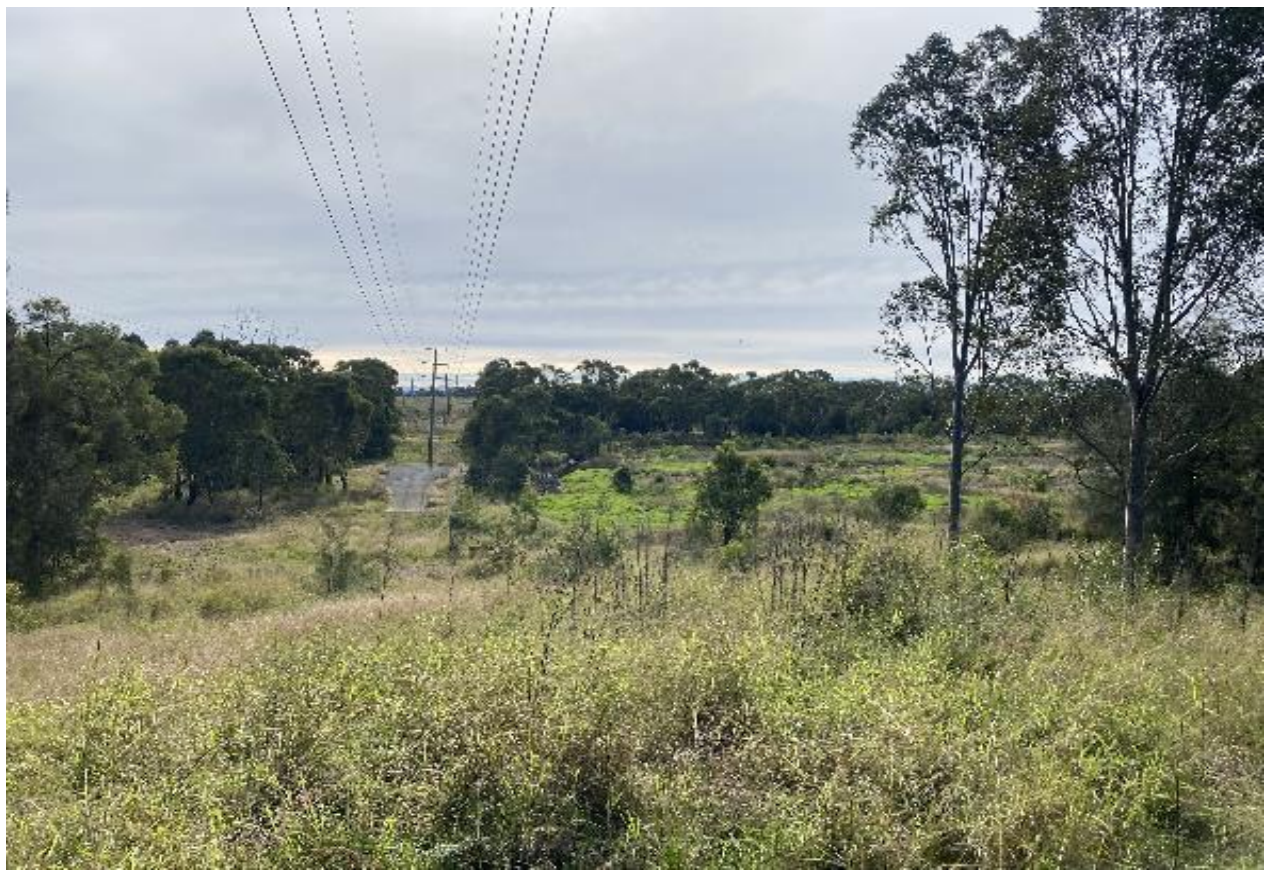
Photograph 3 - Showing general site conditions, facing north from the southern portion of the site.

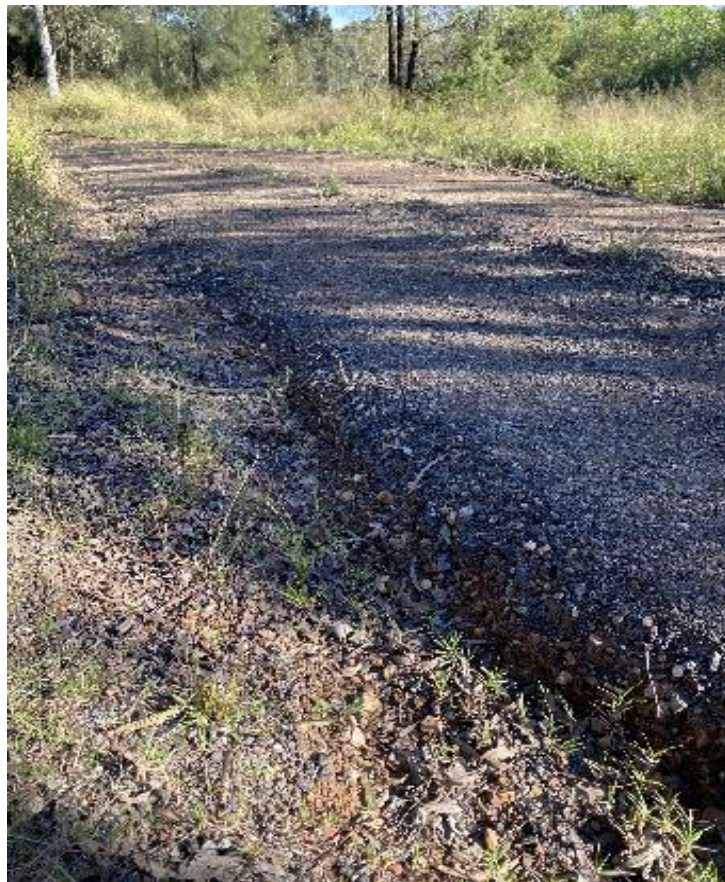
material. Some asphalt was also observed in areas of the access roads (see Photographs 4 and 5);

Photograph 4 - Showing roadbase material in access roads.

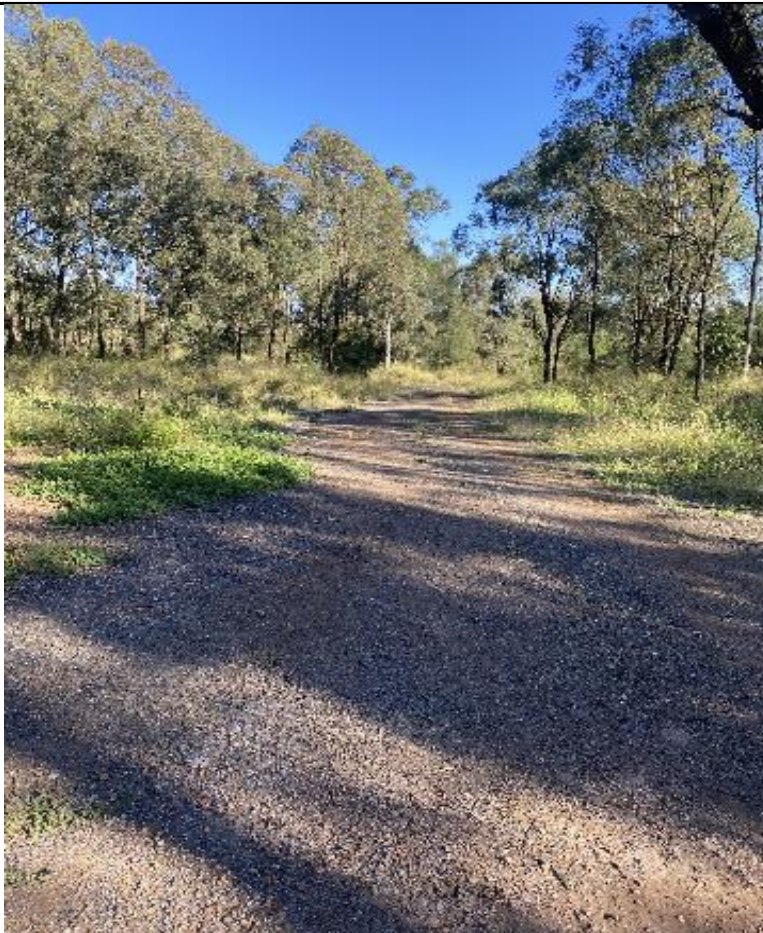
Photograph 5 - Showing access road observed in the southern portion of the site.

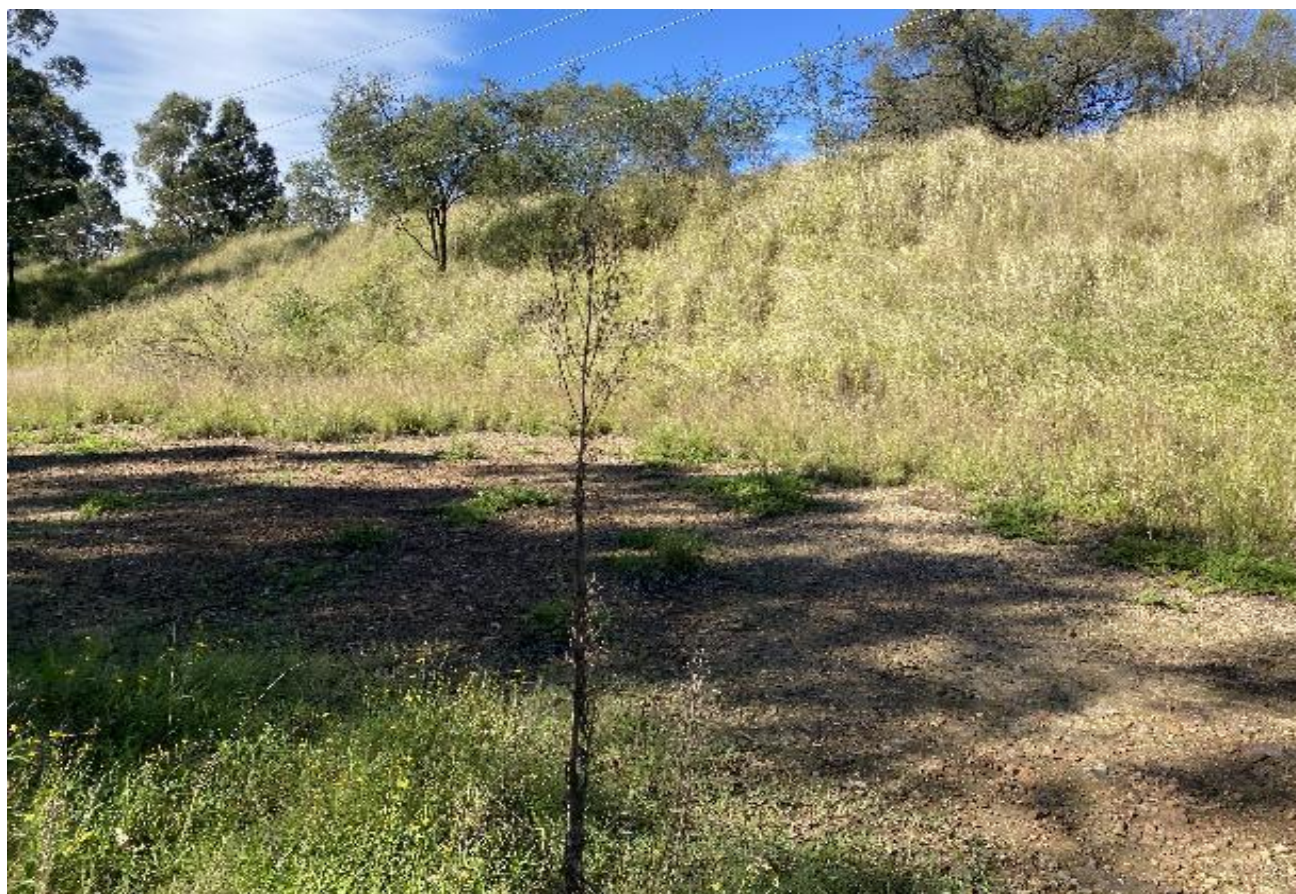
- Several stockpiles and areas of filling were observed across the site and comprised the following (see Photograph 6 to 10):
  - SP1 - Approximately 23,000m<sup>3</sup>, comprising silty clayey gravel, brown, observed along the southern boundary.

The material observed within the stockpiles was observed to be consistent with the natural site soils on the site/surrounding area and likely overburden from former mining activities carried out on/adjacent to the site.

Photograph 6 - Showing SP1.

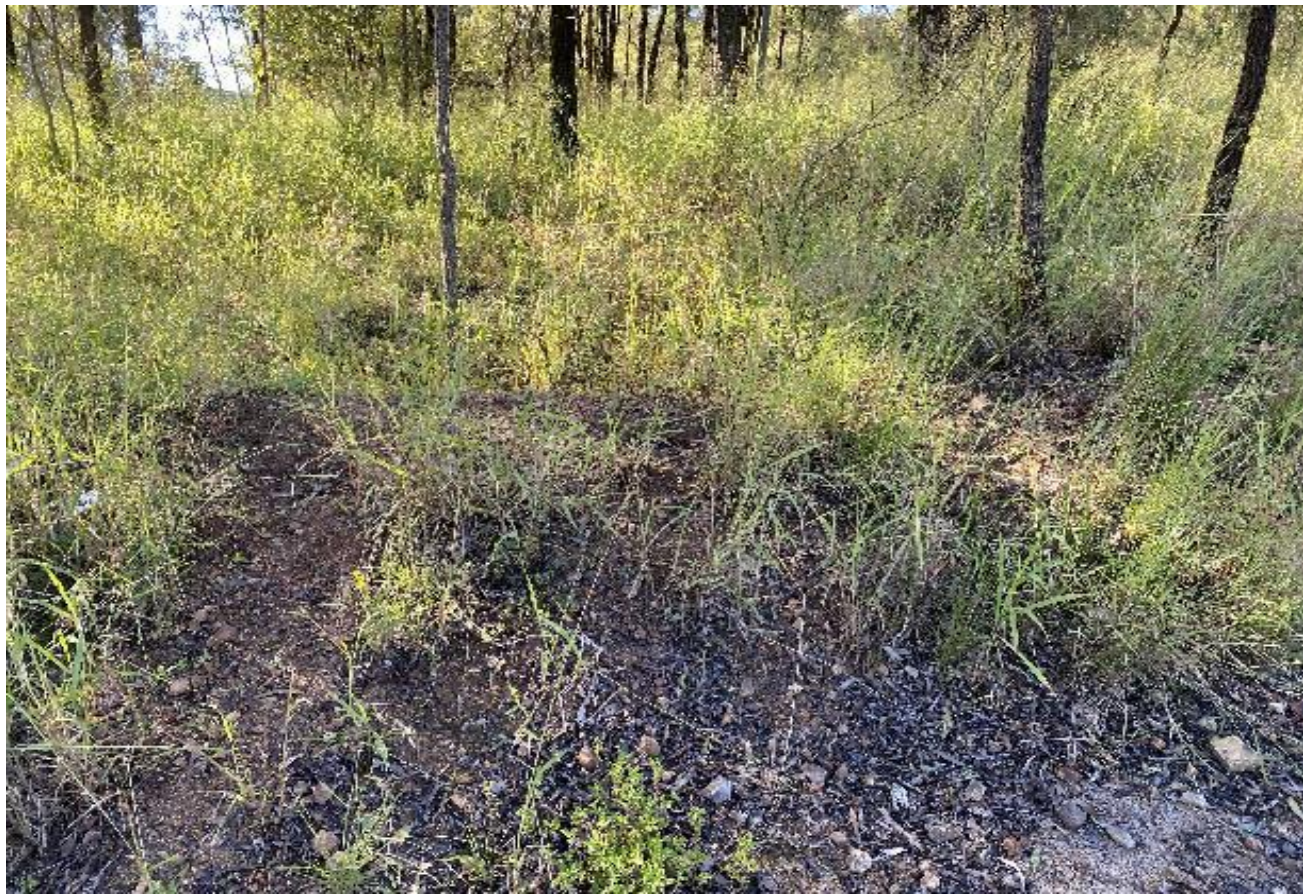
- SP2 – Approximately 10m<sup>3</sup>, comprising gravelly clay, with some sand, brown to orange-brown, observed in the central-southern portion of the site.

Photograph 7 - Showing SP2.

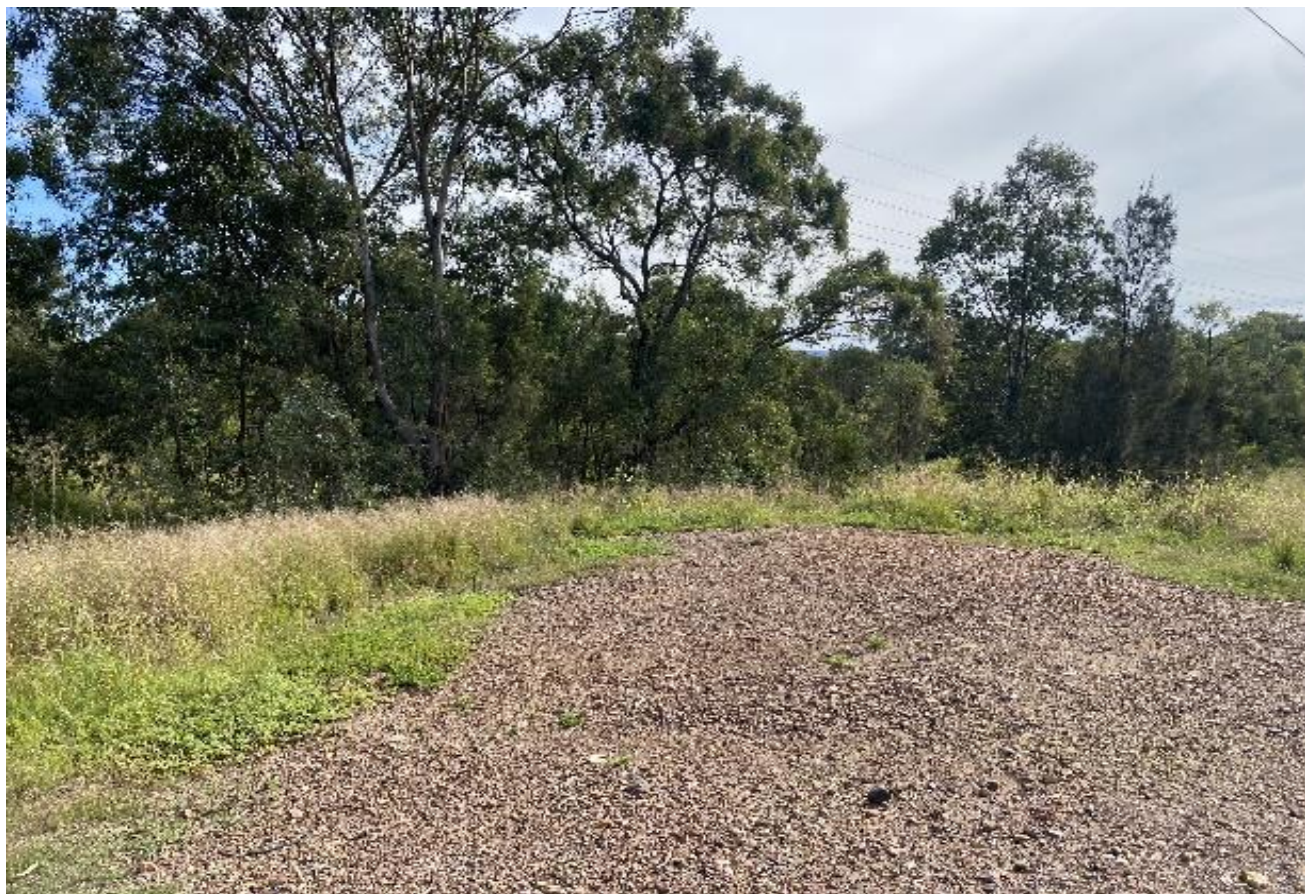
- Filling Area 1 – Approximately 1,200m<sup>2</sup> comprising sandy gravel, grey to dark grey with brown and trace black, observed in the south-western portion of the site.

Photograph 8 - Showing Filling Area 1.

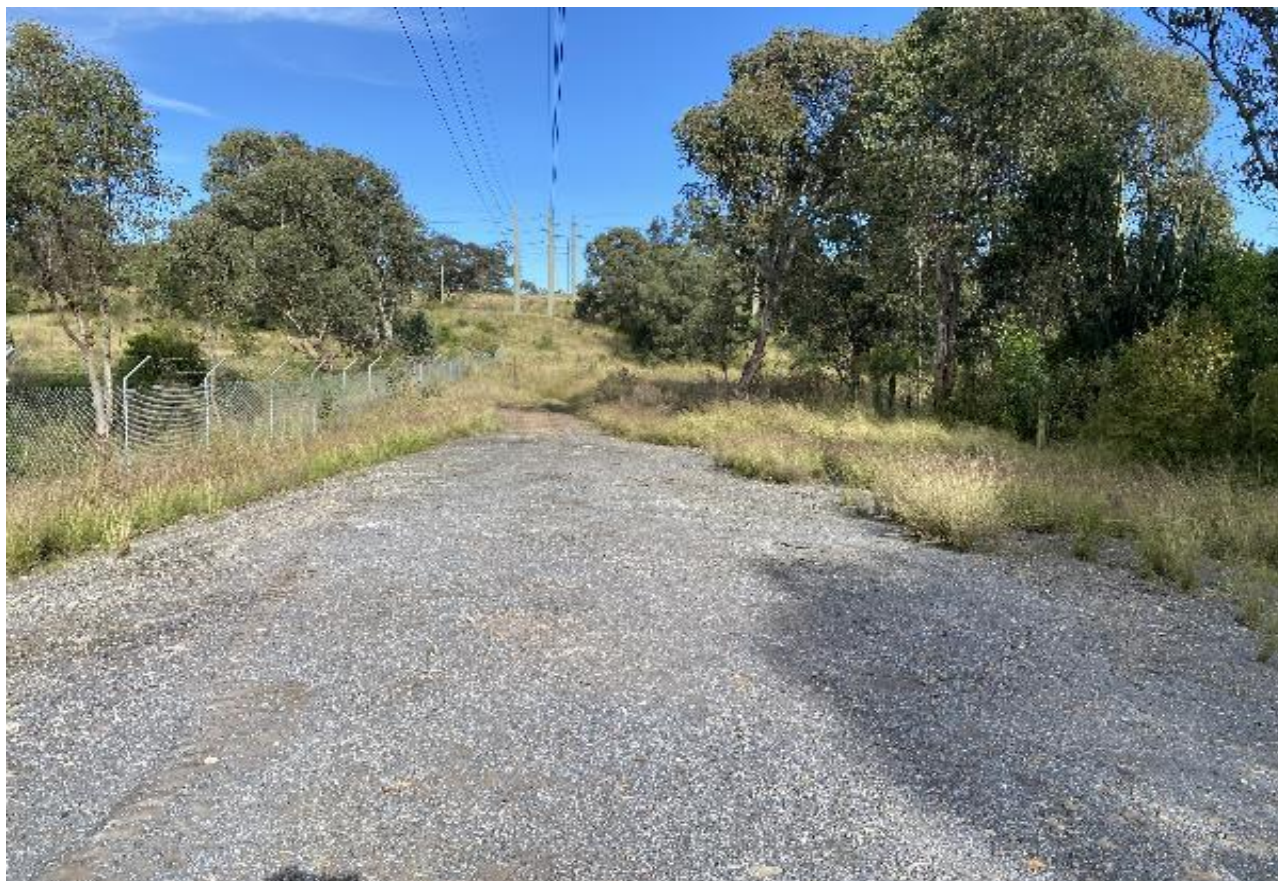
- Filling Area 2 – Approximately 750m<sup>2</sup>, comprising sandy gravel, coal chitter and siltstone, medium to cobble sized, dark grey-brown to brown and some black, observed in the northern portion of the site.

Photograph 9 - Showing Filling Area 2.

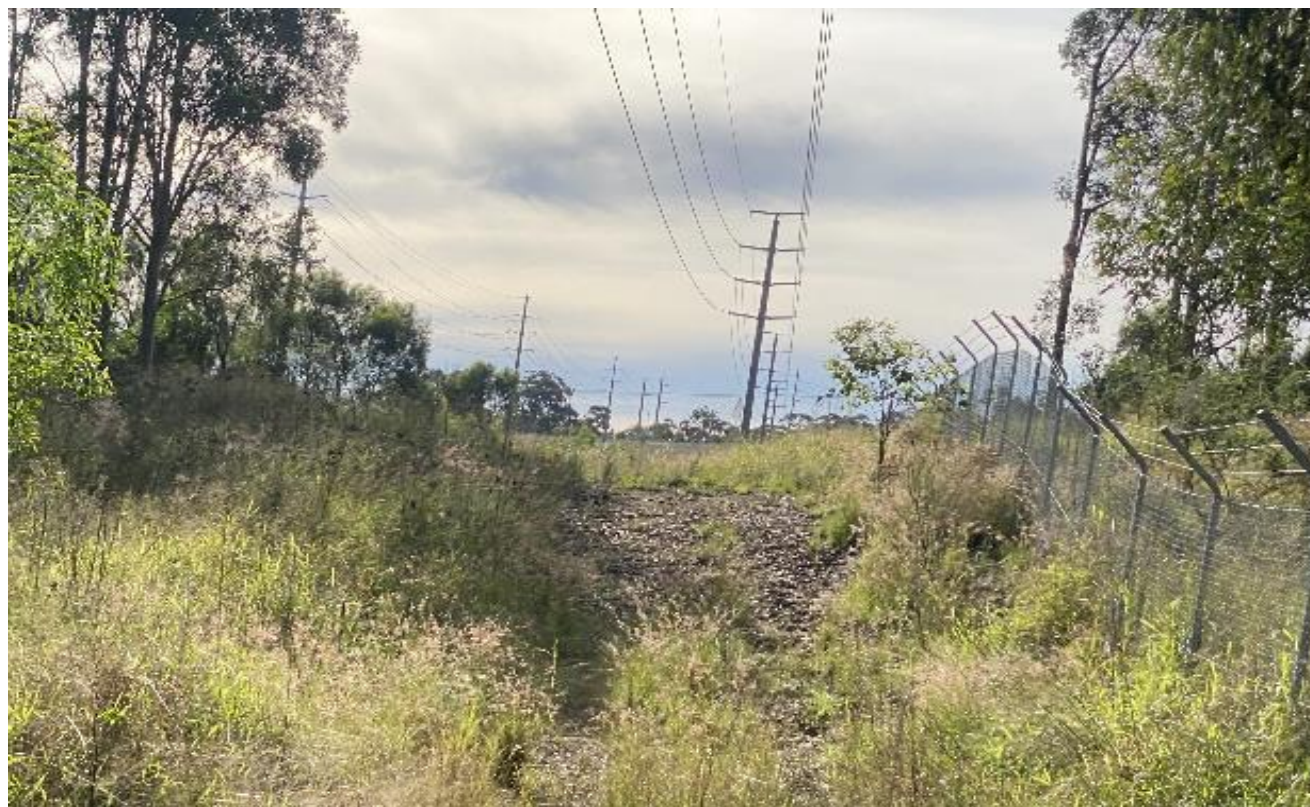
- Filling Area 3 – Approximately 830m<sup>2</sup>, comprising sandy clay and gravelly clay, brown with some pale brown to pale orange, observed in the northern portion of the site.

Photograph 10 - Showing Filling Area 3.

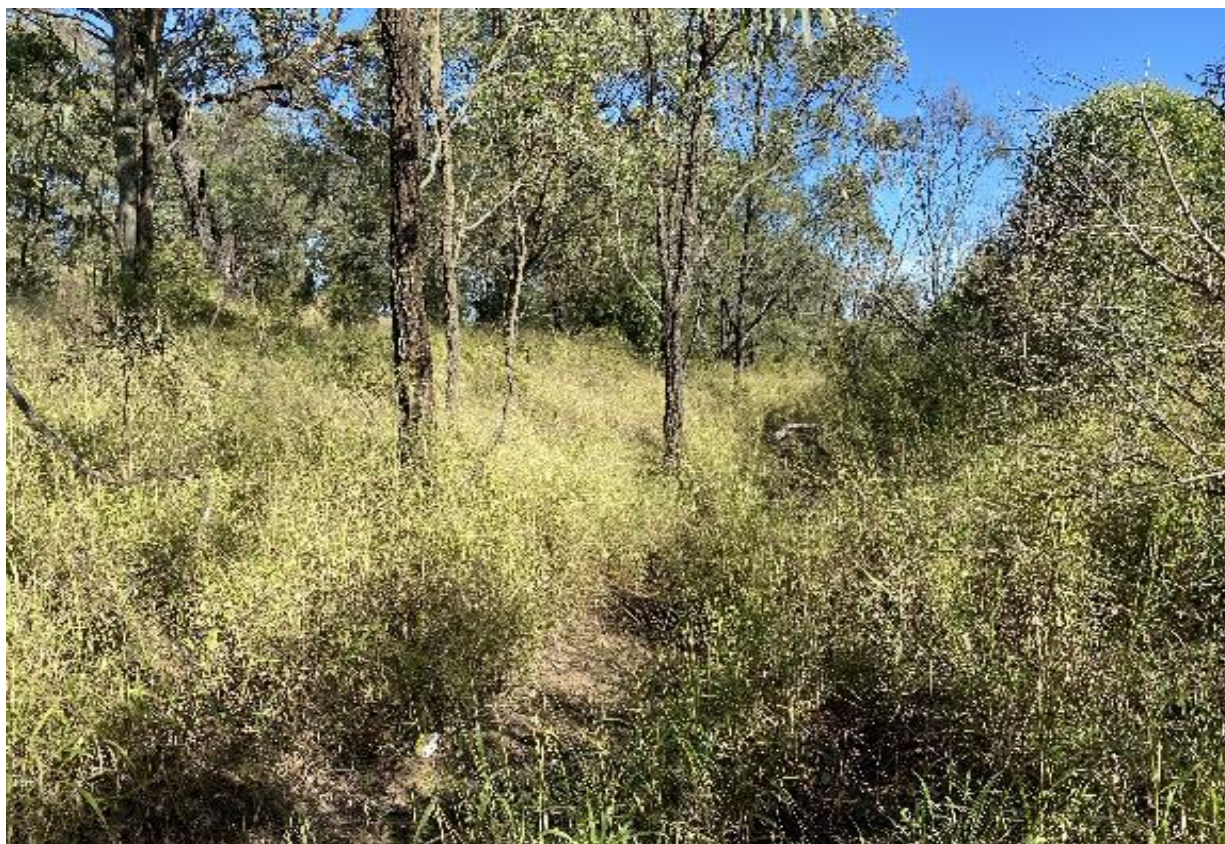
- A power line easement was observed running north south along the western boundary of the site (see Photograph 10);
- A swale drain was observed to be running along the northern boundary of the southern portion of the site (in the vicinity of the former railway). The swale drain was observed to run to a concrete culvert then west off the site (See Photograph 11);

Photograph 11 - Showing swale drain.

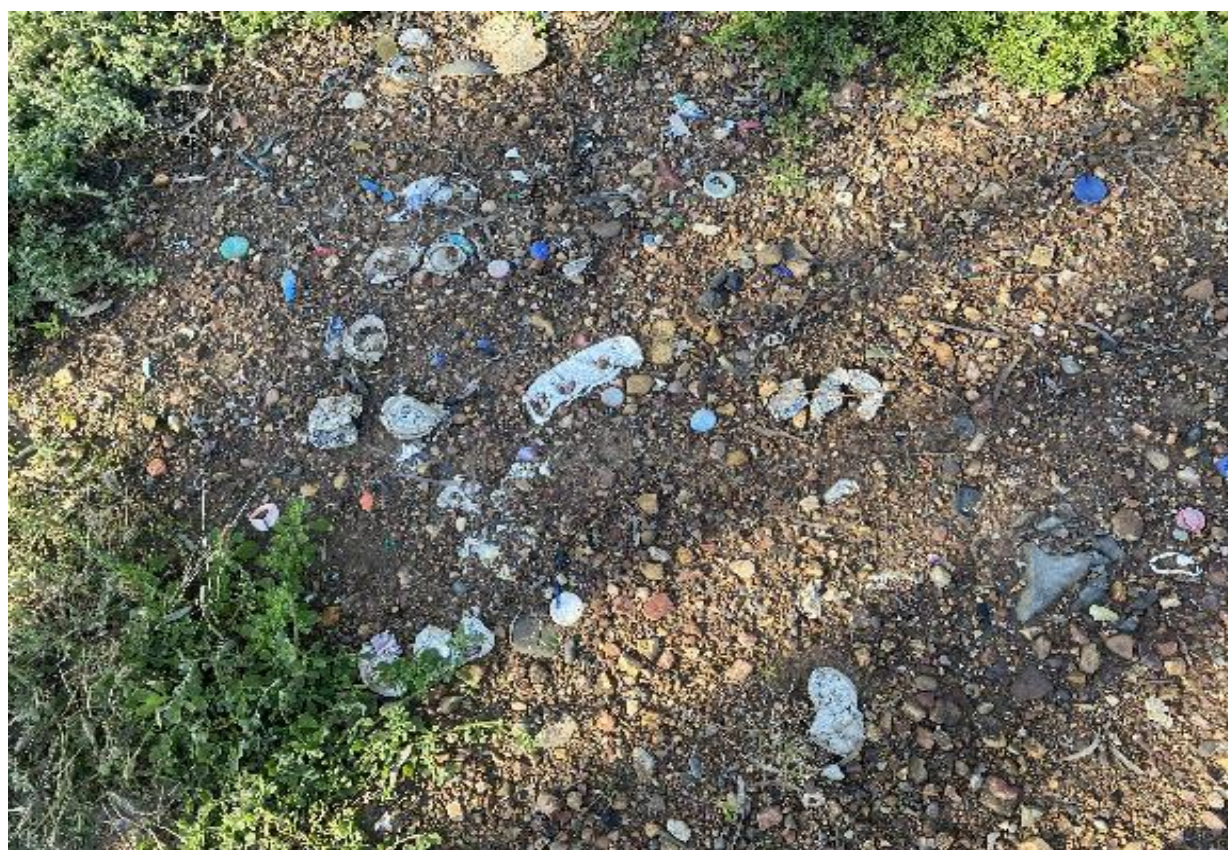
- Some concrete rubble and general rubbish such as plastic, cans etc was observed to be scattered across the southern portion of the site (see Photograph 12);

Photograph 12 - Showing scattered rubbish.

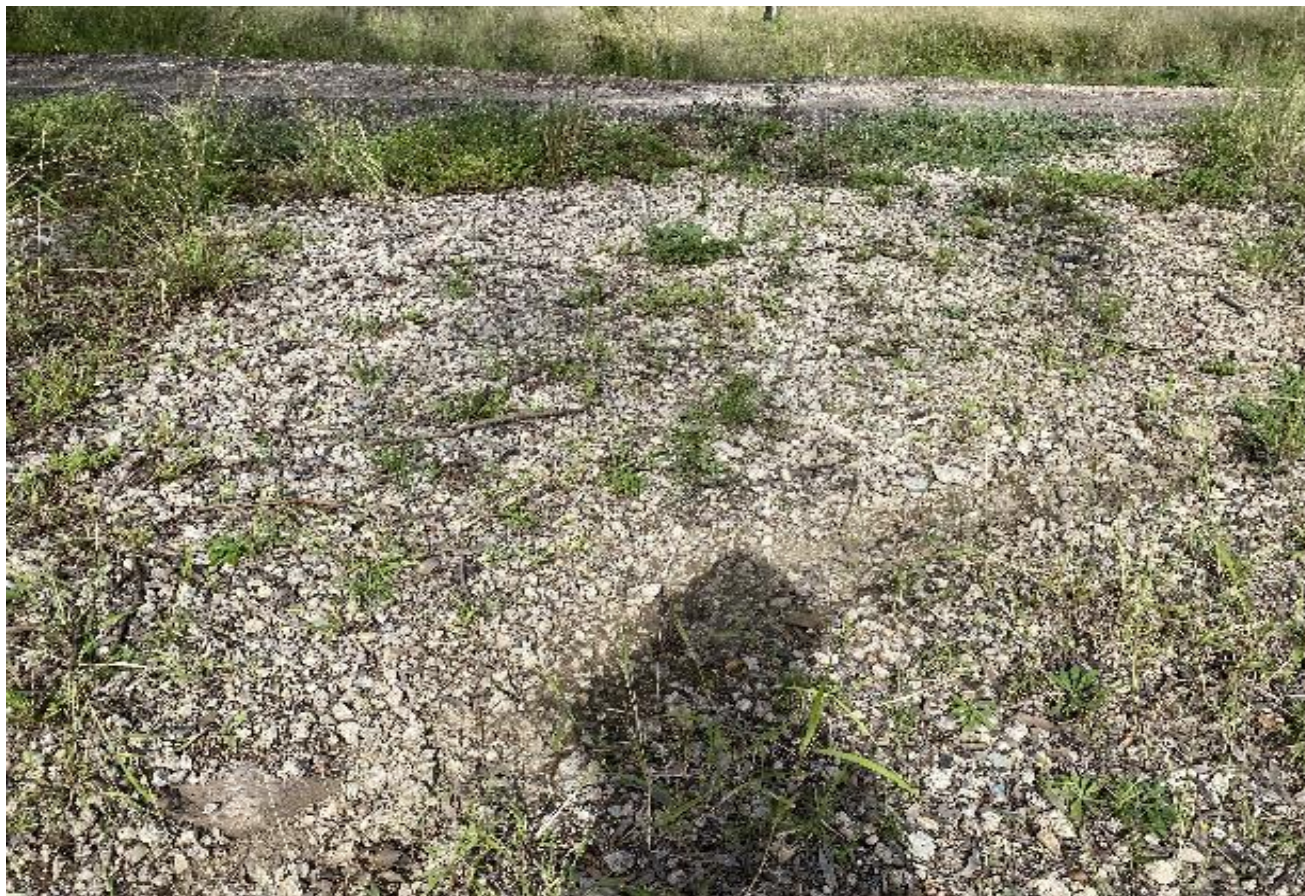
- A thin surface layer of concrete rubble was observed in the southern portion of the site. The concrete rubble area was approximately 80m<sup>2</sup> and appeared to be used as a hard stand for vehicles moving between the two access tracks in the southern portion of the site (see Photograph 13) and;

Photograph 13 - Showing thin layer of concrete rubble.

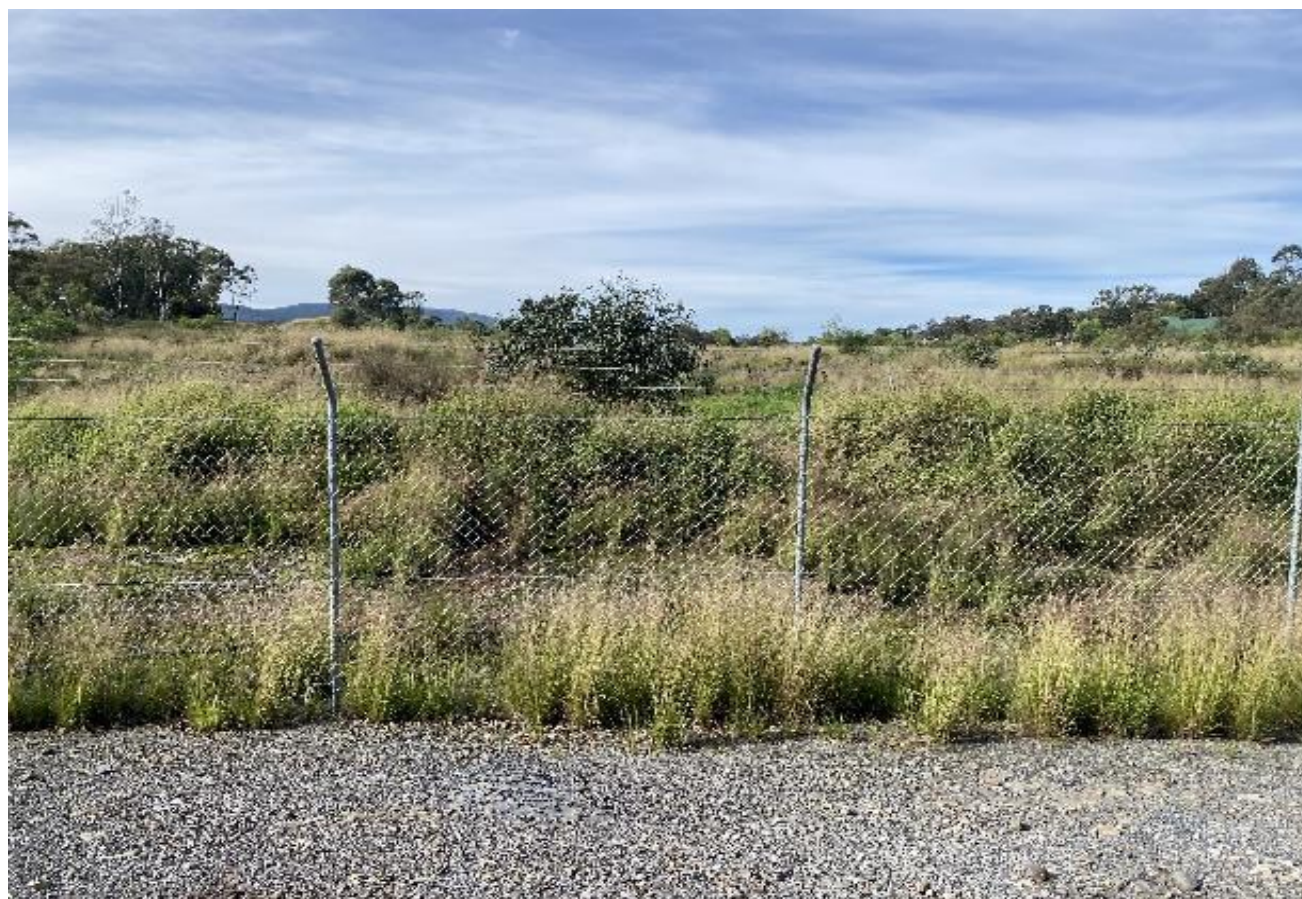
- Muswellbrook Waste and Recycling Facility was observed to the immediate east of the site (see Photographs 14 and 15).

Photograph 14 - Showing Muswellbrook Waste and Recycling Facility, facing east from the northern portion of the site.

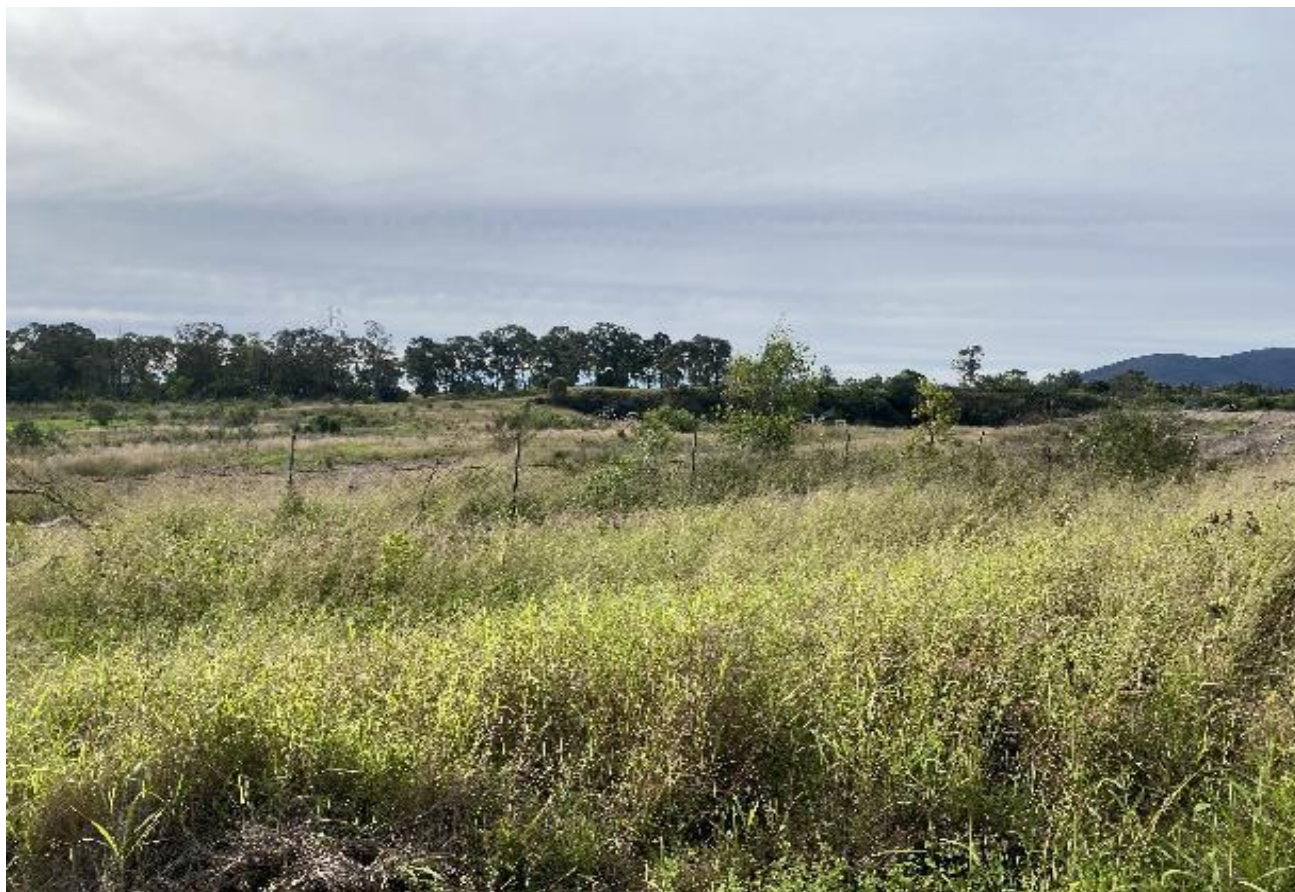
Photograph 15 - Showing Muswellbrook Waste and Recycling Facility, facing north from the southern portion of the site.
