Proposed Community
Infrastructure Depot -
Geotechnical Assessment

Lot 1 DP819014, No. 252 Coal
Road, Muswellbrook

NEW22P-0092-AB
29 June 2022

**RE: PROPOSED COMMUNITY INFRASTRUCTURE DEPOT
No. 252 COAL ROAD, MUSWELLBROOK NSW
GEOTECHNICAL ASSESSMENT**

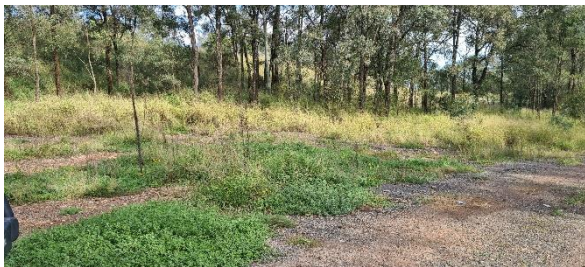
Photograph 1: From near BH04, facing southwest. Fill mound just visible in background behind tree line.

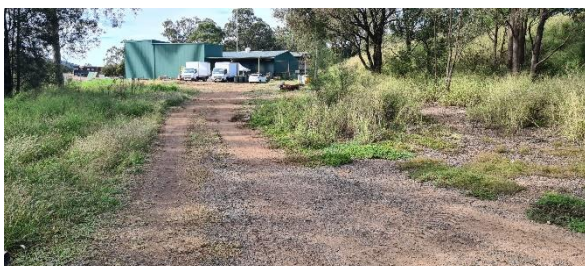
Photograph 3: From near BH04, facing east. Showing existing recycling sheds in background.

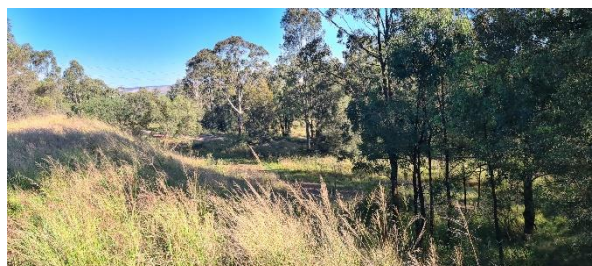
Photograph 4: From top of existing fill mound ('stockpile 1' – approximately 5.5m in height), approximately 15m south of BH04, facing northwest.

The site was formerly part of an open cut coal mine operation. Historic filling was observed during site investigations, including two large fill stockpiles located on the southern side of the lot: 'Stockpile 1' - up to 5.5m in height and about 200m long; and, 'Stockpile 2' - up to 5m in height and about 120m long. Fill platforms were observed in places generally located along the powerline easement, with a few small dam areas generally located in the western area.

- It should be noted that only very limited discrete sampling of the large stockpiles (i.e. 'Stockpile 1' - up to 5.5m in height and about 200m long; and, 'Stockpile 2' - up to 5m in height and about 120m long) has been carried out. Further investigation, sampling and testing of stockpiles should be conducted to confirm suitability for any proposed re-use prior to, or at the time of construction.

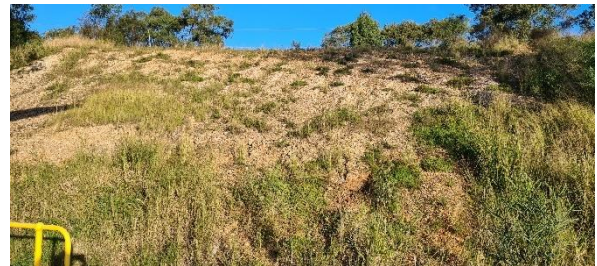
Photograph 10: From base of (Clay) Fill stockpile, located east of the site.
