**RE: FLOOD RISK ASSESSMENT FOR PROPOSED DEVELOPMENT AT 105 MERRIWA ROAD,
DENMAN, 2328**

BMT Commercial Pty Ltd ("BMT") has been commissioned by Hunter Development Brokerage Pty Ltd to undertake a flood risk assessment (FRA) for the proposed development of the BESS facility at 105 Merriwa Road, Denman.

1 Introduction

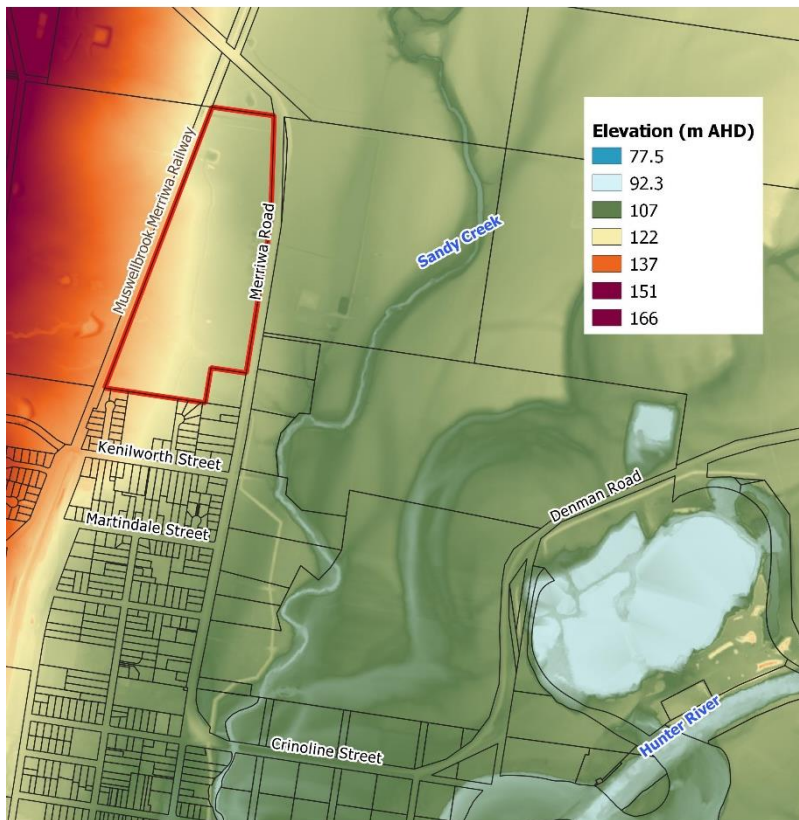
Figure 1.1 shows the locality map and existing topography. The Site (Lot 23 DP 1731407) is located within the Muswellbrook Local Government Area (LGA) on the Hunter River floodplain at Denman, between Dalswinton and Mangoola. The Site is bounded by the Merriwa Road to the east, Muswellbrook Merriwa Railway to the west, rural properties to the north and south, and an Infrastructure Substation to its south-east corner.

Site topography, as defined by the available LiDAR and survey data, ranges from 110m AHD along the eastern boundary, sloping up to 117m AHD at the south-west corner.

Figure 1.1 Site Locality and Topography

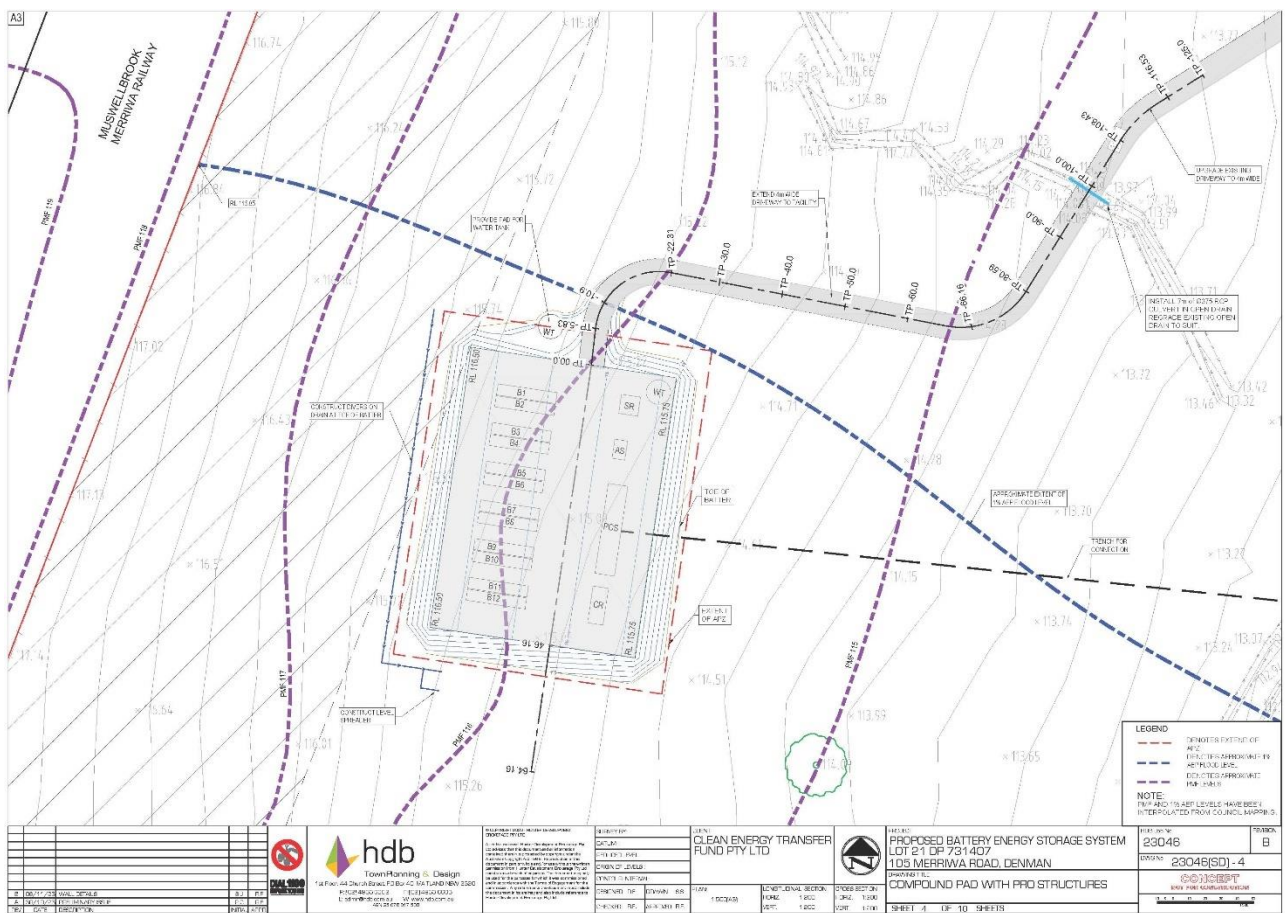
Figure 1.2 Proposed Site Plan and PMF Flood Levels (HDB, 2023).

Flood data through the Site for the 1% and 5% AEP events have been provided by Council in the Site's Flood Certificate and are shown in Table 1.3 and Table 1.4. PMF levels analysed in this assessment were provided by HDB in the Site's Plan (Figure 1.2).

The BESS pad design level ranges from 115.75 m AHD along the eastern boundary to 116.50 m AHD along the western boundary. Based on interpolating the PMF flood levels shown in Figure 1.2, the BESS pad is expected to be flood-free during the PMF event.

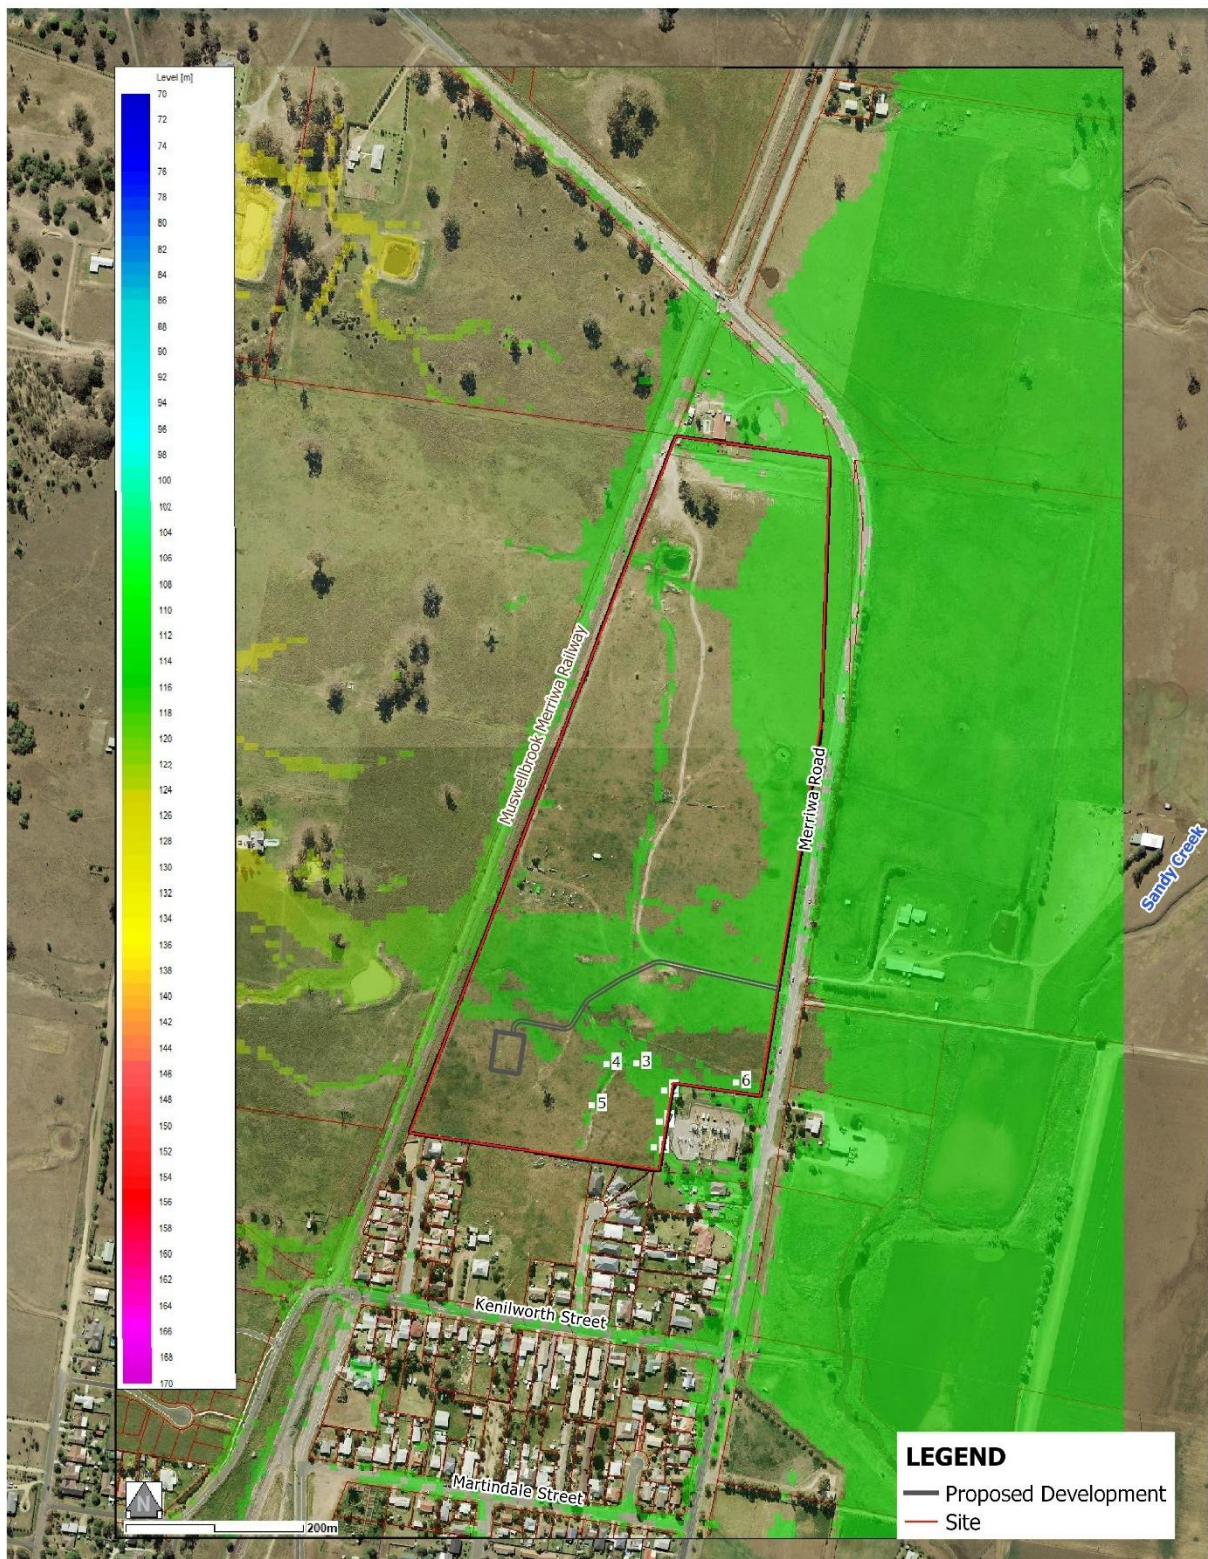
Figure:
A-1

Figure A.1 Existing Conditions - 1% AEP Peak Flood Level

Title:
Peak Flood Level - 1% AEP

Table 1.4 Key Point location flood data. Location points are shown in Annex Figures A-1 to A-3.

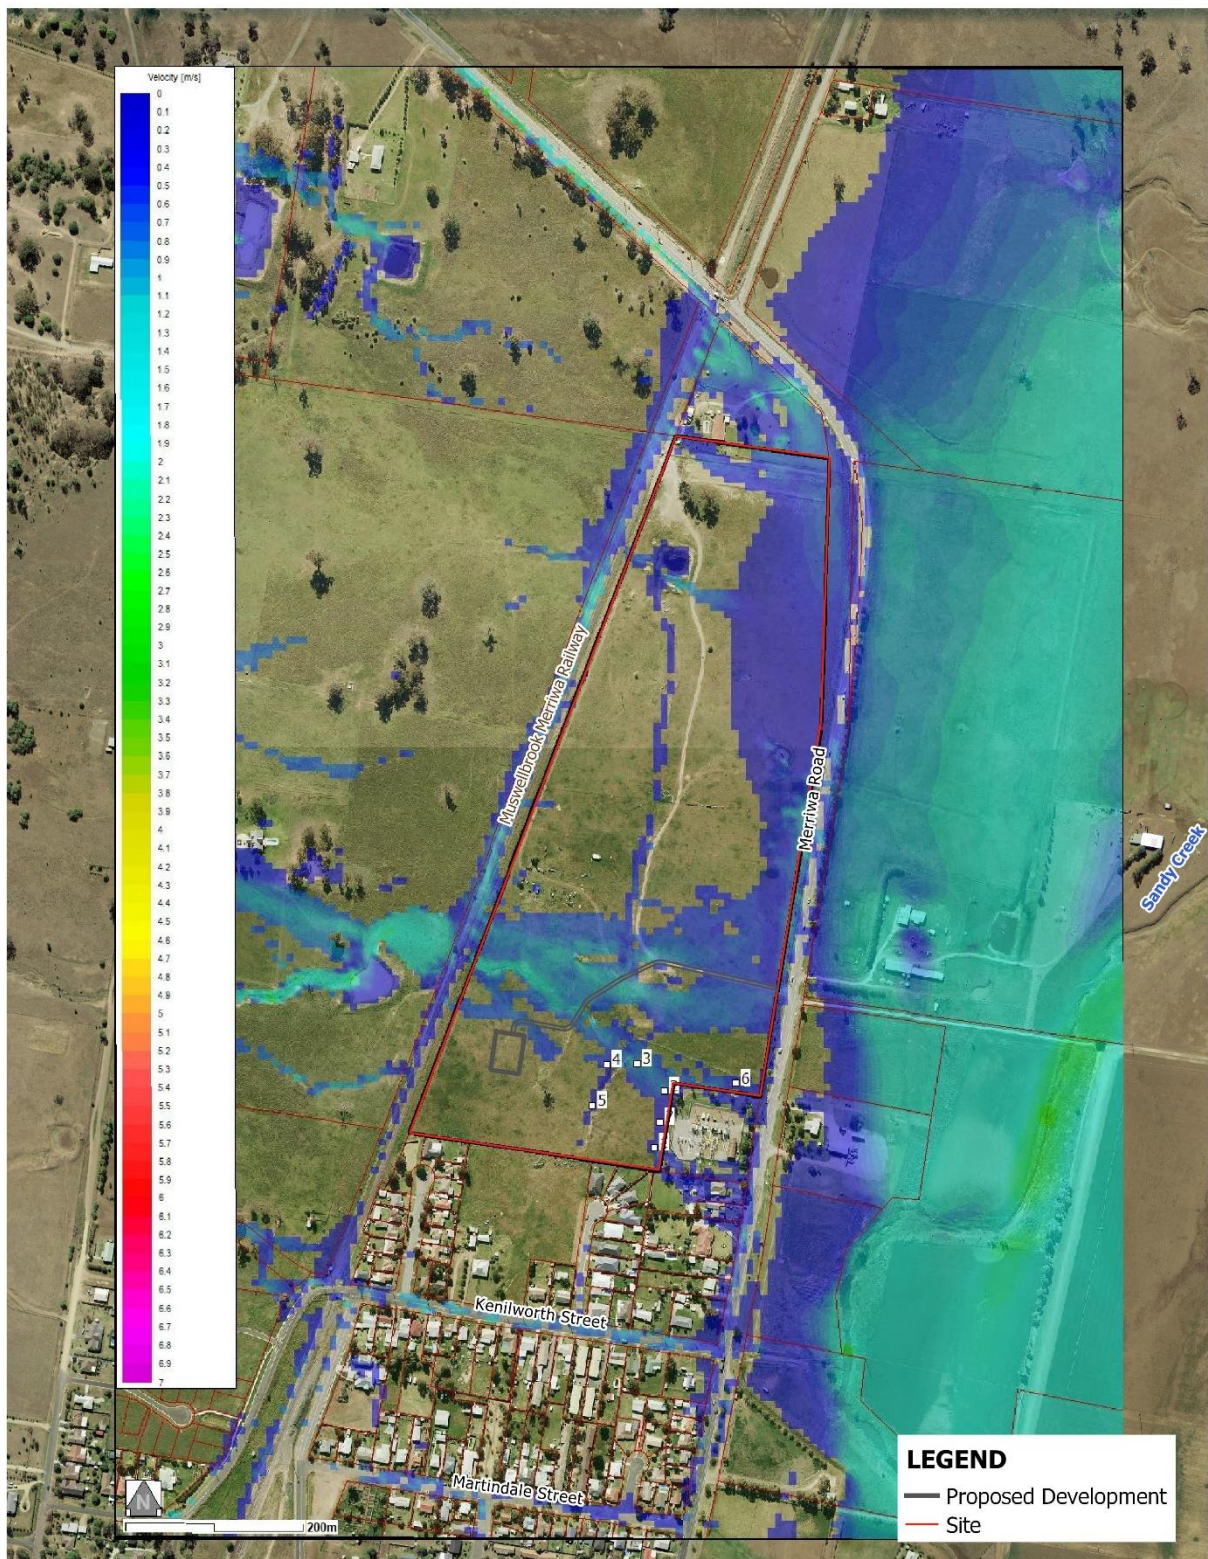
Figure:
A-2

Figure A.2 Existing Conditions - 1% AEP Peak Flood Velocity

Title:
Peak Flood Velocity - 1% AEP

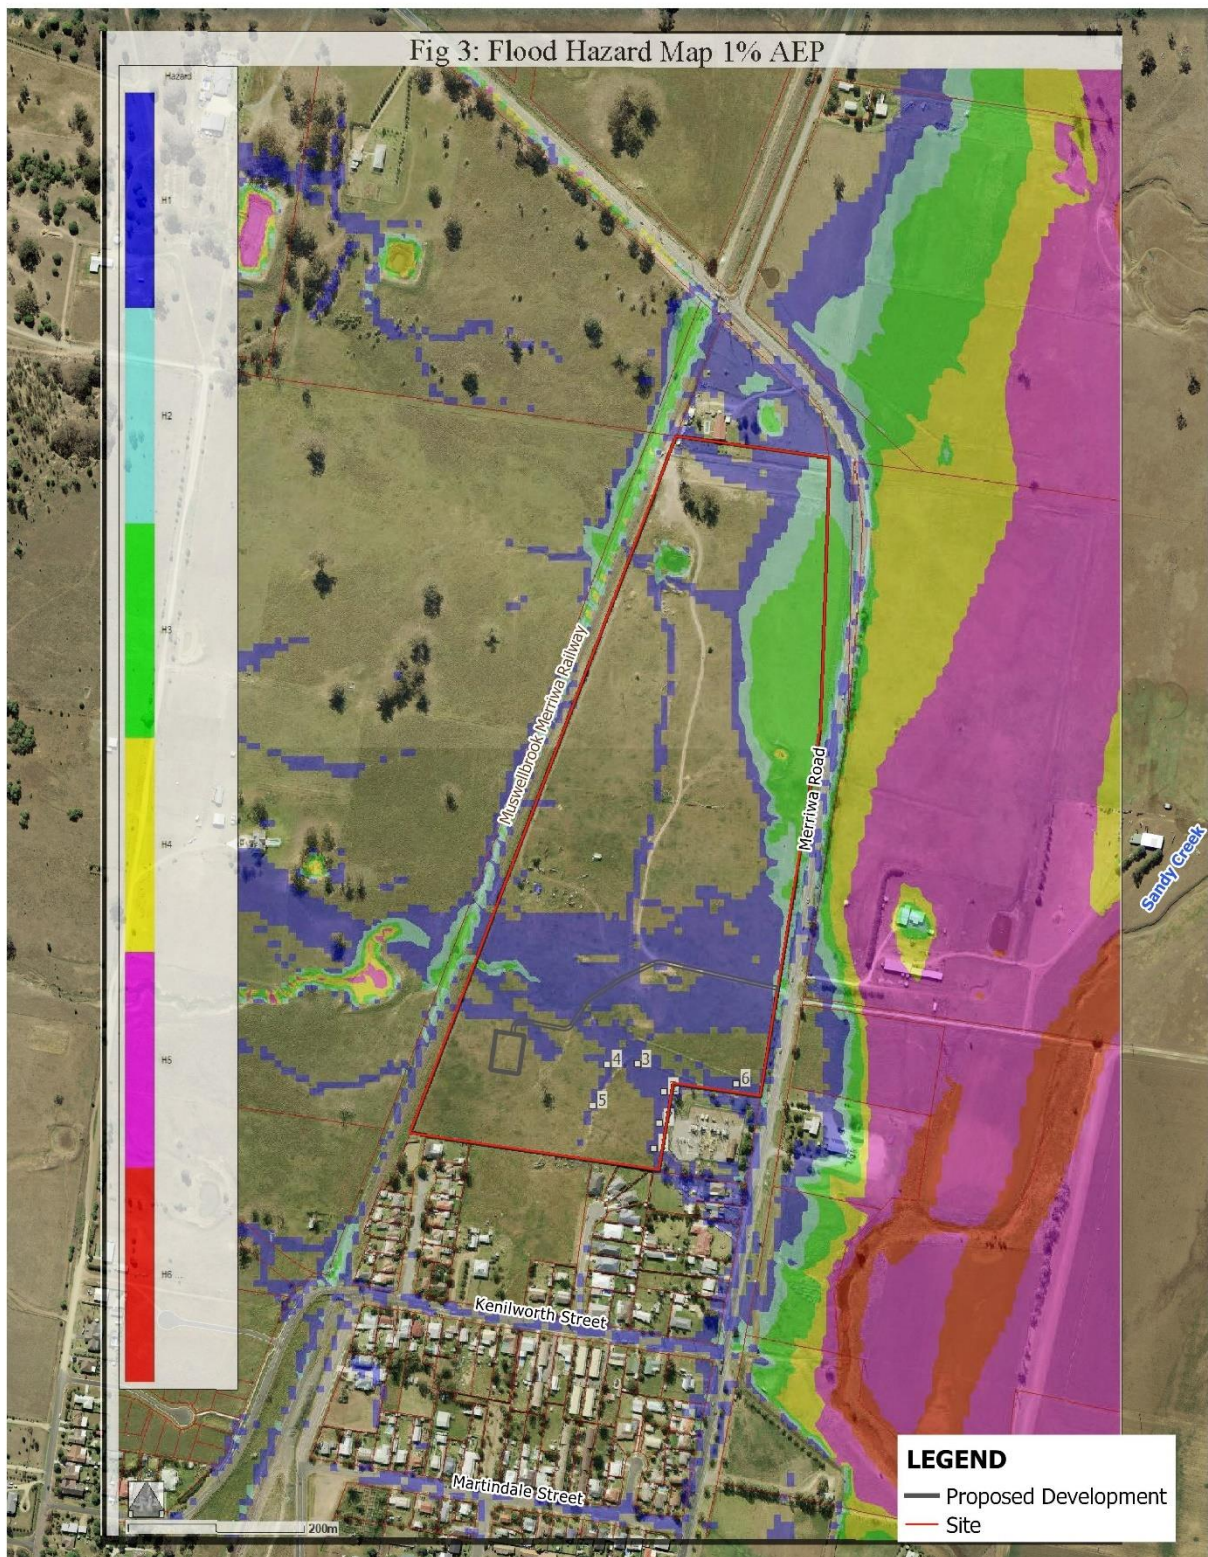
Figure:
A-3

Figure A.3 Existing Conditions - 1% AEP Peak Flood Hazard

Title:
Peak Flood Hazard - 1% AEP

In the 1% AEP, the peak flood hazard along the majority of the proposed driveway extent is H1, indicating conditions that are generally safe for people and vehicles. However, H3 hazards are present at the access point where the driveway meeting Merriwa Road indicating flood conditions that are unsafe for vehicles, children, and the elderly (Figure A-3).
