Muscle Creek Flood Study

For: Muswellbrook Shire Council January 2017

Project Name:	Muscle Creek Flood Study	
Project Number:	PA1233	
Report for:	Muswellbrook Shire Council

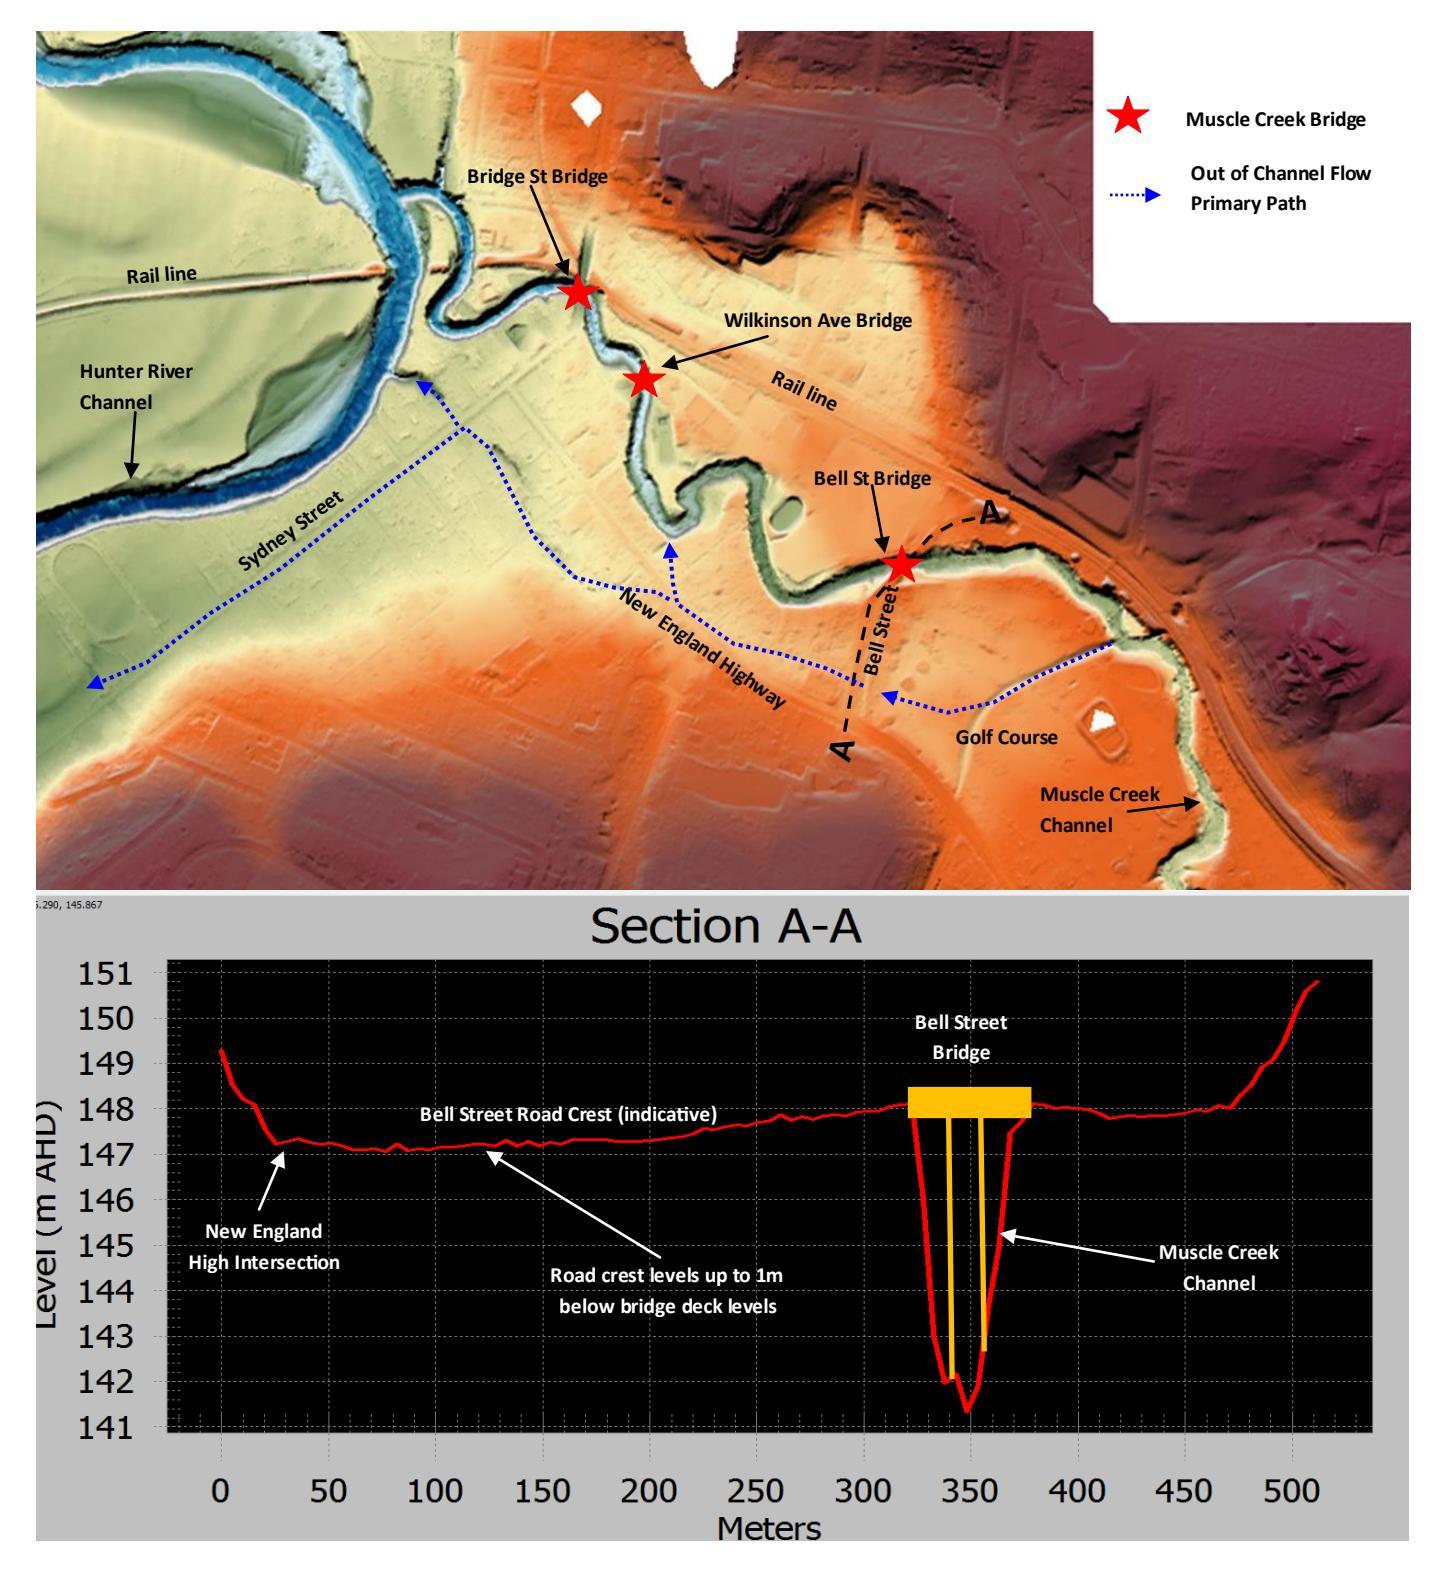
Plate 2-1- Floodplain Features

Plate 2-1 locates the above-mentioned floodplain features. **Plate 2-1** also includes a floodplain cross-section along the Bell Street alignment. This section shows that the Bell Street Bridge soffit levels are approximately 800mm higher than the Bell Street road levels near the New England Highway Intersection. Accordingly, flows in excess of the channel capacity at the bridge location are expected to overflow Bell Street at the low point indicated on the section, which is approximately 200m to the south of the channel.

Muscle Creek flows centrally through the township of Muswellbrook before joining the Hunter River. The Muscle Creek channel is approximately 50m wide (top of bank to top of bank) and 6 to 7 m deep. The channel banks are vegetated with moderately dense to dense vegetation, comprising a mixture of native and exotic species. **Photos 1** and **2** show typical sections of the Muscle Creek Channel. There are three bridge crossings within the study area located on Bell Street, Wilkinson Avenue and Bridge Street. These bridges are shown in **Photos 3** to **5** respectively. Council has recently completed rehabilitation works on the channel area downstream of the Wilkinson Avenue Bridge. **Photo 6** shows the upstream portion of the recently rehabilitated area.

During flood events, inundation is known to occur within the Muswellbrook Golf Course, which is located upstream of Bell Street. Flood waters from the golf course area are known to overtop Bell Street and flow through residential areas located between Bell Street and Wilder Street before reentering the channel. Surface levels suggest that some flood waters will also flow down the New England Highway. If a Muscle Creek flood event occurs in conjunction with a Hunter River flood event, widespread flooding is expected to occur in the area downstream of Bell Street. This would be primarily associated with backwater flooding from the Hunter River.

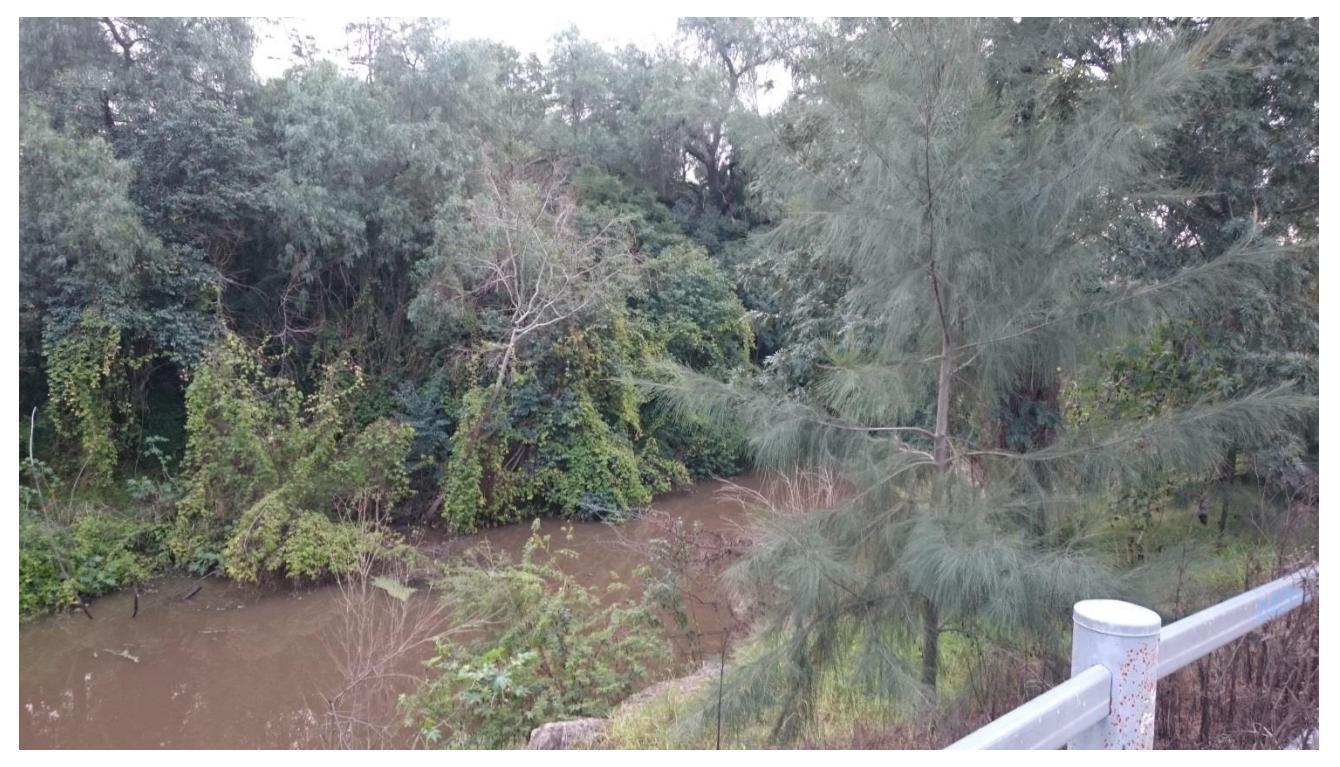
Photo 1 shows a typical section of the Muscle Creek Channel that comprises dense vegetation on the channel banks.

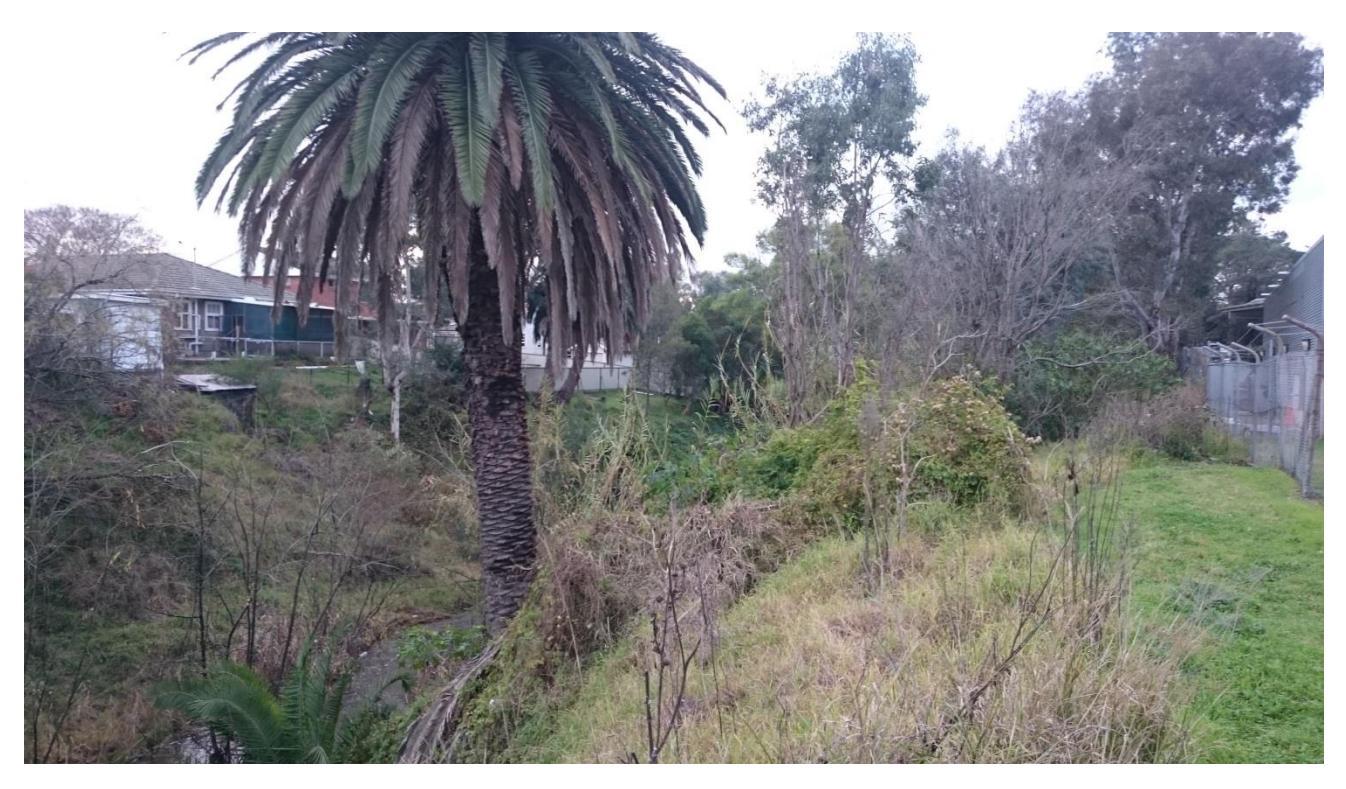
Photo 2 shows a typical section of the Muscle Creek Channel that comprises moderately dense vegetation on the channel banks.

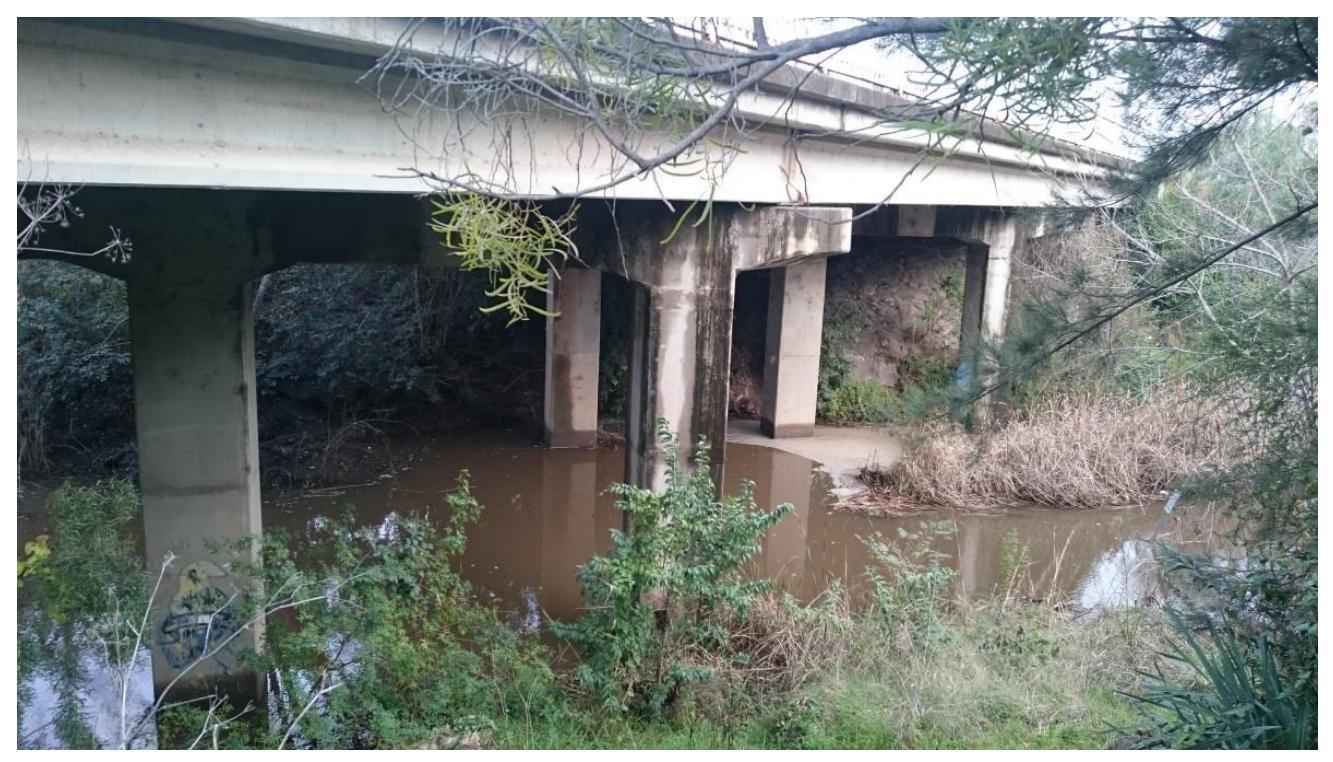
Photo 3 shows the Bell Street Bridge (looking upstream)

The Bell Street, Wilkinson Avenue and Bridge Street bridges were deemed to be key hydraulic controls and were represented in the model using 2D layered flow constriction cells. The 2D layered flow constriction cells enable unique blockage factors and form losses to be applied to the following bridge layers:

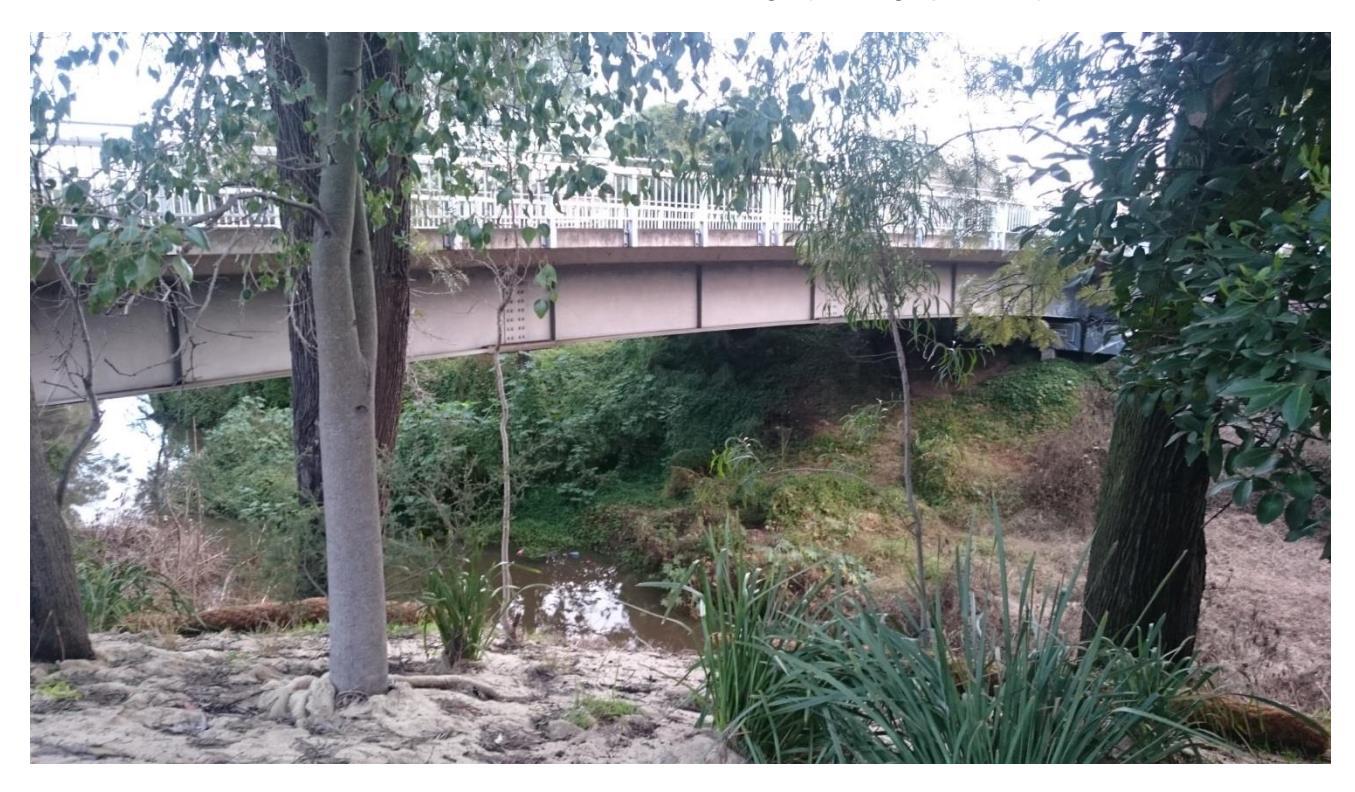
Photo 4 shows the Wilkinson Avenue Bridge (looking upstream)

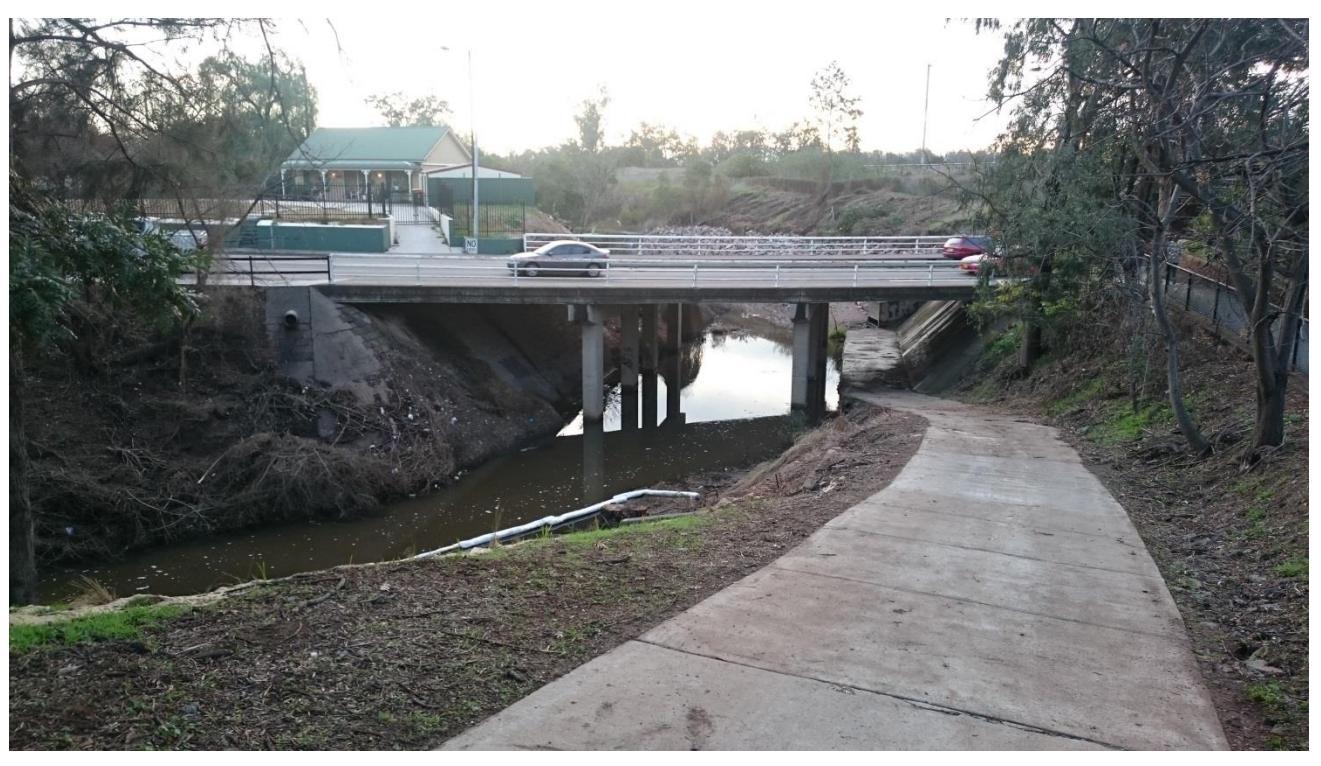
Photo 5 shows the Bridge Street Bridge (looking downstream)

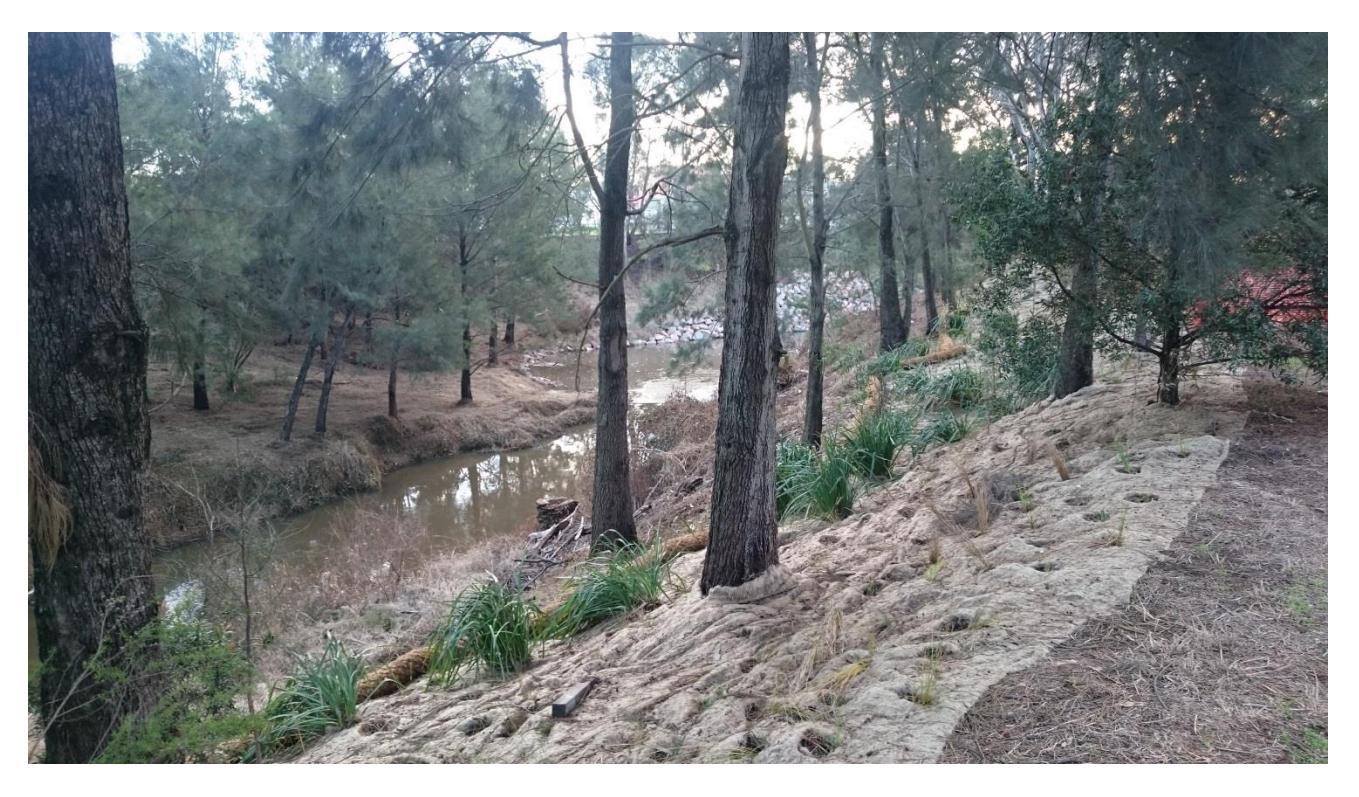
Photo 6 shows the rehabilitated section of channel that is located between the Wilkinson Avenue and the Bridge Street Bridges.

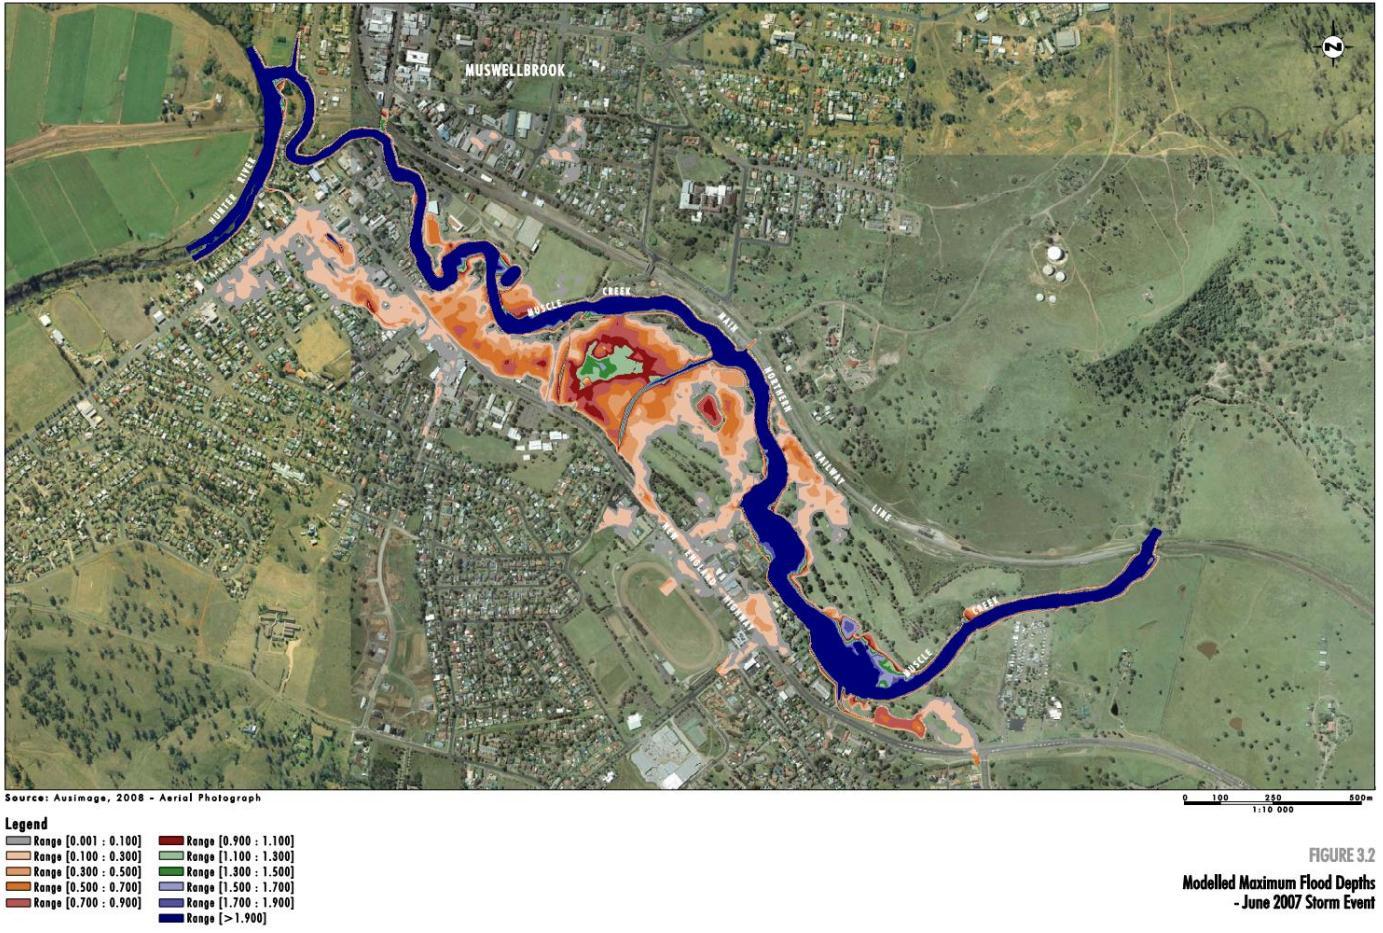
d Maximum Flood Depths - June 2007 Storm Event

A substantial flood event occurred in Muscle Creek in June 2007. A review of available rainfall data was undertaken by Umwelt who estimated the event to be similar to a 2% AEP event (Umwelt, 2009). It is understood that substantial out of channel flooding occurred within the Muswellbrook Golf Course and that some flood waters spilt over Bell Street and flowed through residential areas located between Bell Street and Wilder Street before re-entering the channel (Umwelt, 2009). Anecdotal observations from the June 2007 event are documented in Table 2 of the Umwelt report (2009). This table is reproduced as **Appendix B**. **Plate 2-2** shows the estimated June 2007 flood extent (Umwelt, 2009).

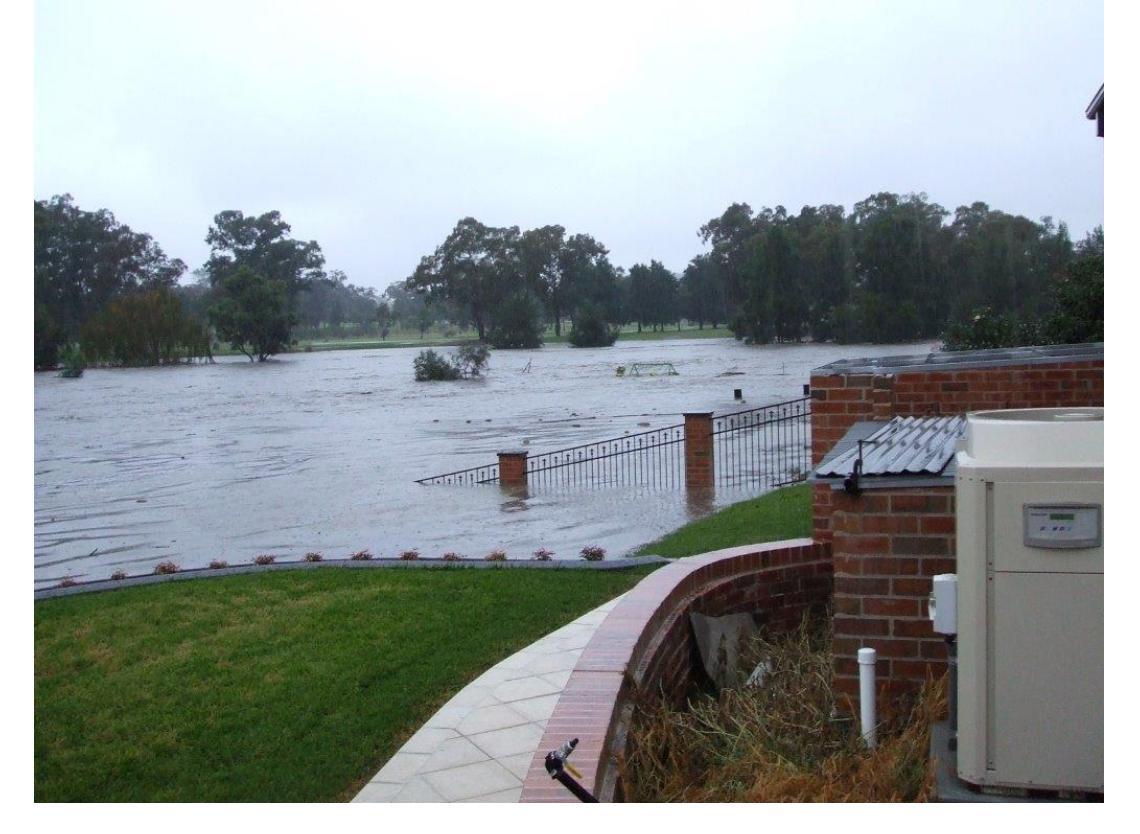
Photo 7 shows flooding in the backyards of properties located on St Andrews Place (upstream of the golf course).

Some photographs of the June 2007 flood were provided by local residents who responded to a community survey that was issued as part of the FRMS in June 2016. Photo 7 shows flooding in the backyards of properties located on St Andrews Place and Photo 8 shows flood damage inside a garage located on Gyarran Street.

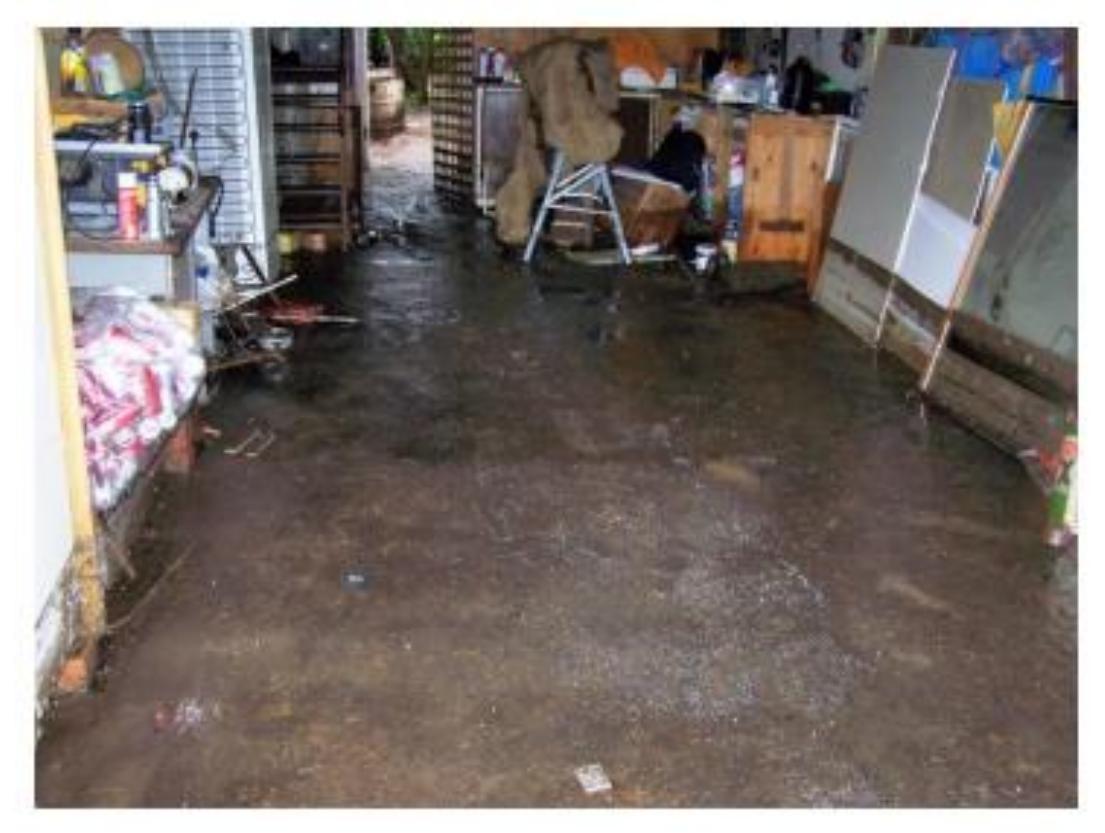
Photo 8 shows flood damage in a garage on Gyarran Street

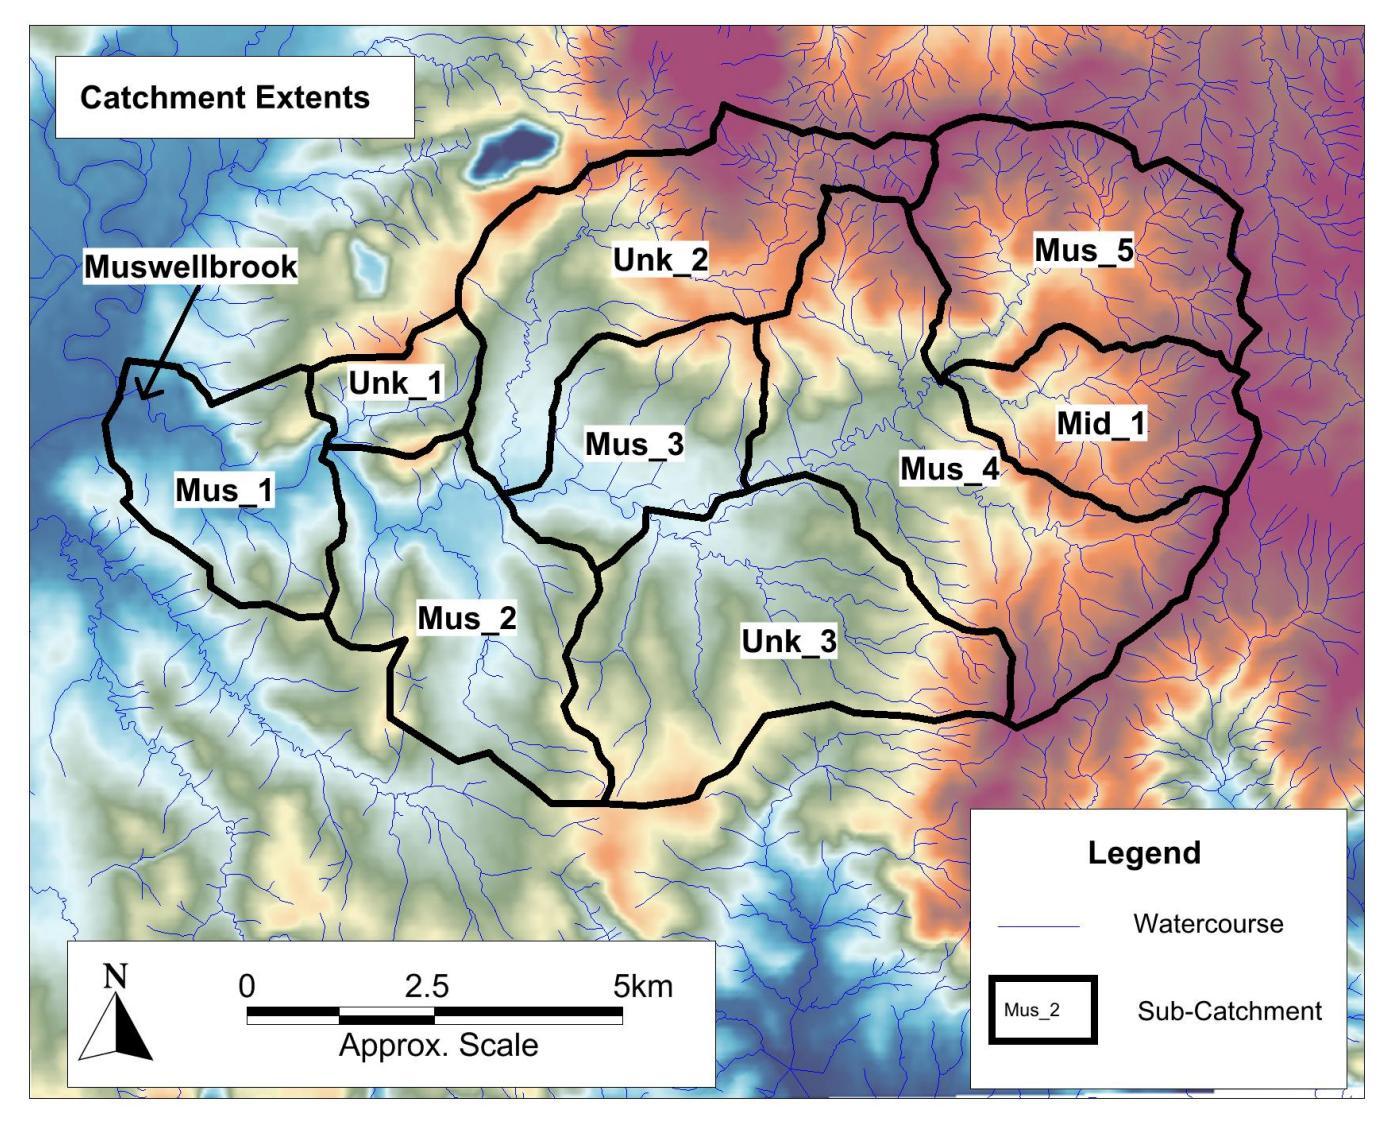
Plate 4-1 – Muscle Creek sub-catchment extents.

A hydrologic model of the catchments of Muscle Creek Catchment was developed using the XP-RAFTS modelling platform. The total catchment area was divided into 9 sub-catchments that were differentiated based on the topographic characteristics of the catchment. **Plate 4-1** shows the adopted sub-catchment extents.

- **Impervious Area**: Only the lower sub-catchment (Mus_1) comprises material areas of urban land use. The extent of impervious areas within this catchment was estimated from aerial photography.

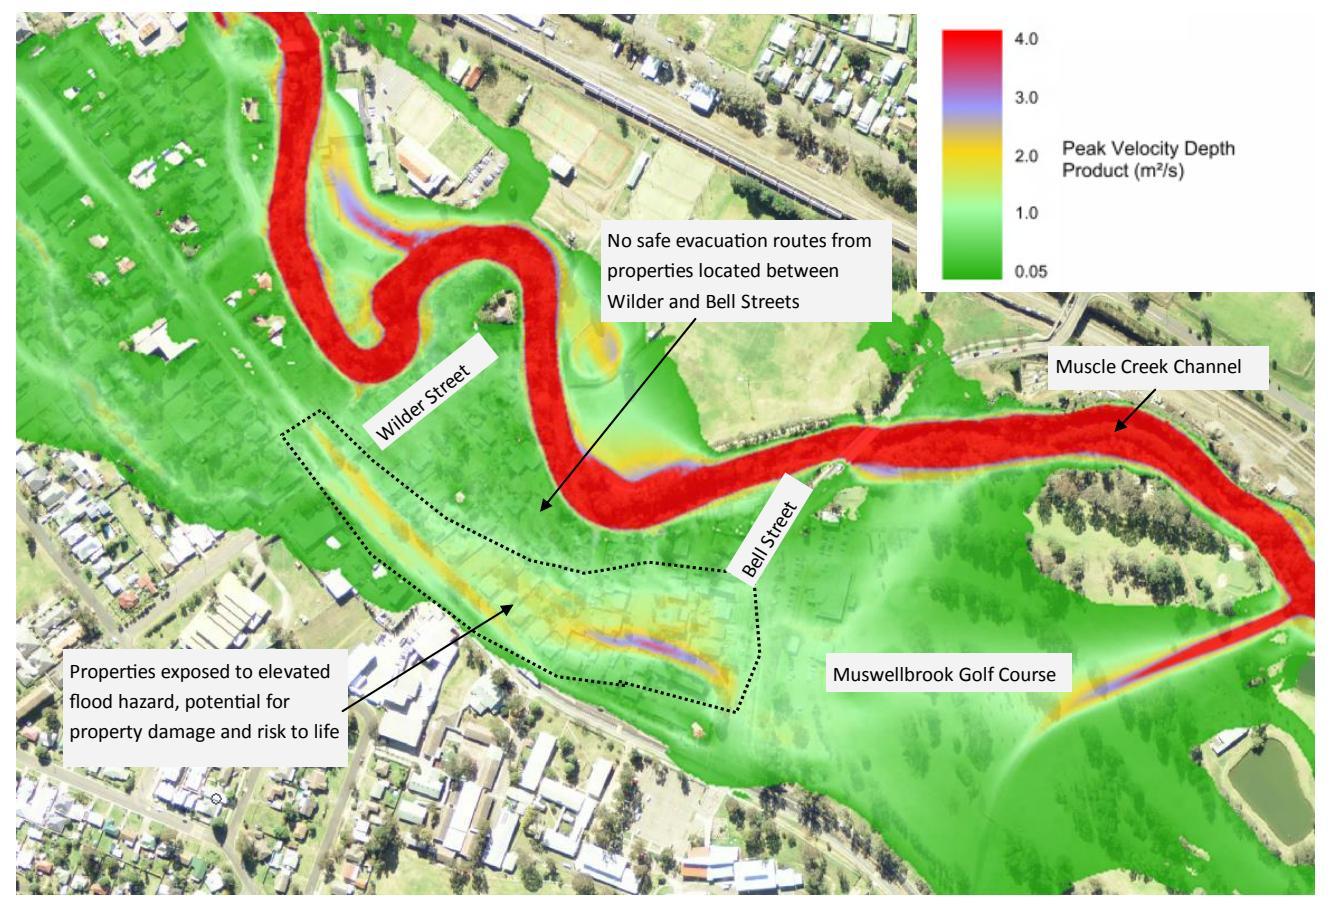
Plate 5-1 – Flood Hazard Profile for the 0.2% AEP event

Plate 5-1 shows the flood hazard profiles for the 0.2% AEP event, noting properties exposed to high flood hazards (i.e $VD > 1m^2/s$). It is also noted that properties located between Bell Street and Wilder Street will be bound by high hazard flood waters that would restrict the safe evacuation of residents during the peak of the event.

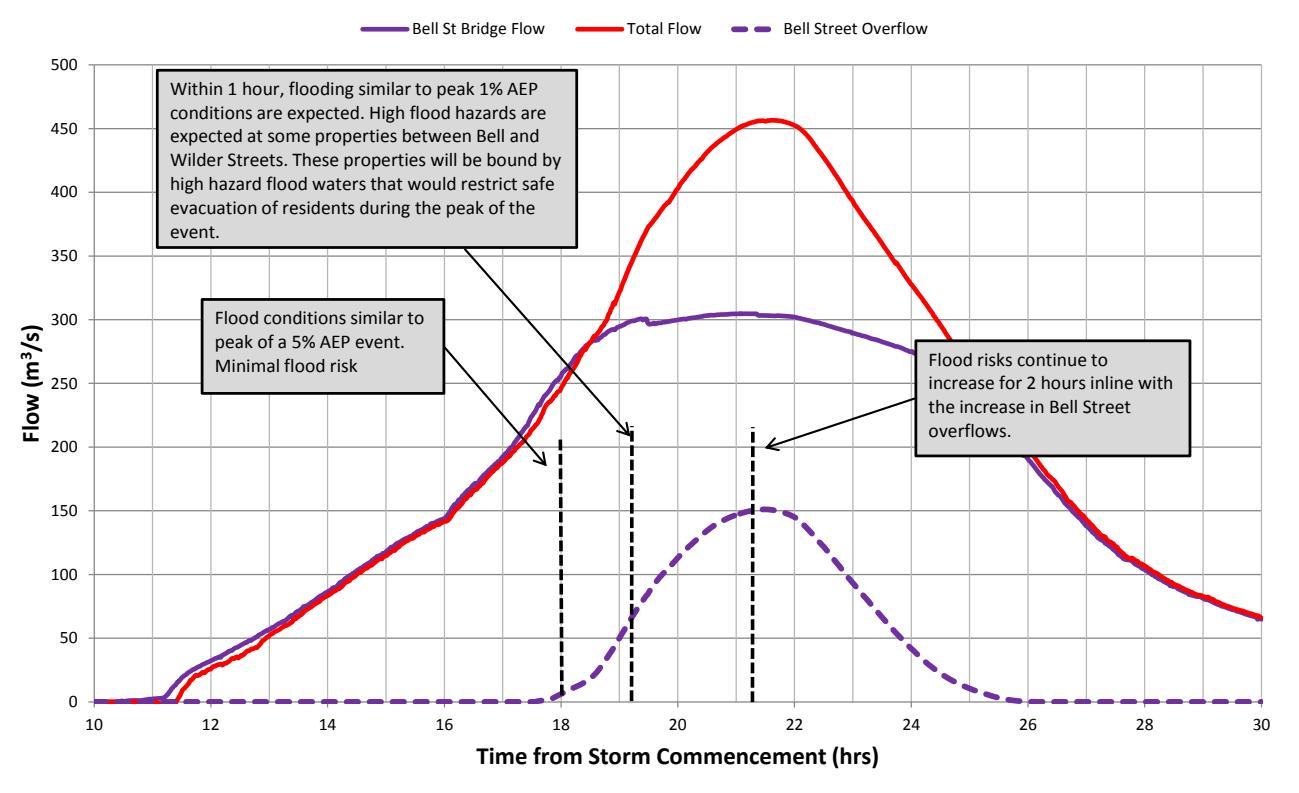
Plate 5-2 – Flood distribution at Bell Street for the 0.2% AEP event.

Plate 5-2 shows the flow distribution at Bell Street for the 0.2% AEP event. The chart compares flows through the Bell Street Bridge and Bell Street overflows to the total flow hydrograph. The model results indicate that 18 hours following the commencement of a 0.2% AEP event, flood conditions will be similar to peak 5% AEP conditions, with all flow passing under the Bell Street Bridge. Once overflows over Bell Street commence, peak 1% AEP conditions occur within 1 hour, and progressively increase for a further 2 hours before beginning to recede. This analysis indicates that without a flood warning system, emergency response services would have potentially less than an hour to safely evacuate residents located between Bell and Wilder Streets.
