15 March 2023

Attention: Suzanne Laucht, Associate Scientist - Planning and Assessment SMEC 74 Hunter Street Newcastle, NSW 2300

Re: Muswellbrook Pumped Hydro Energy Storage – Lower Reservoir Aboriginal Heritage Management

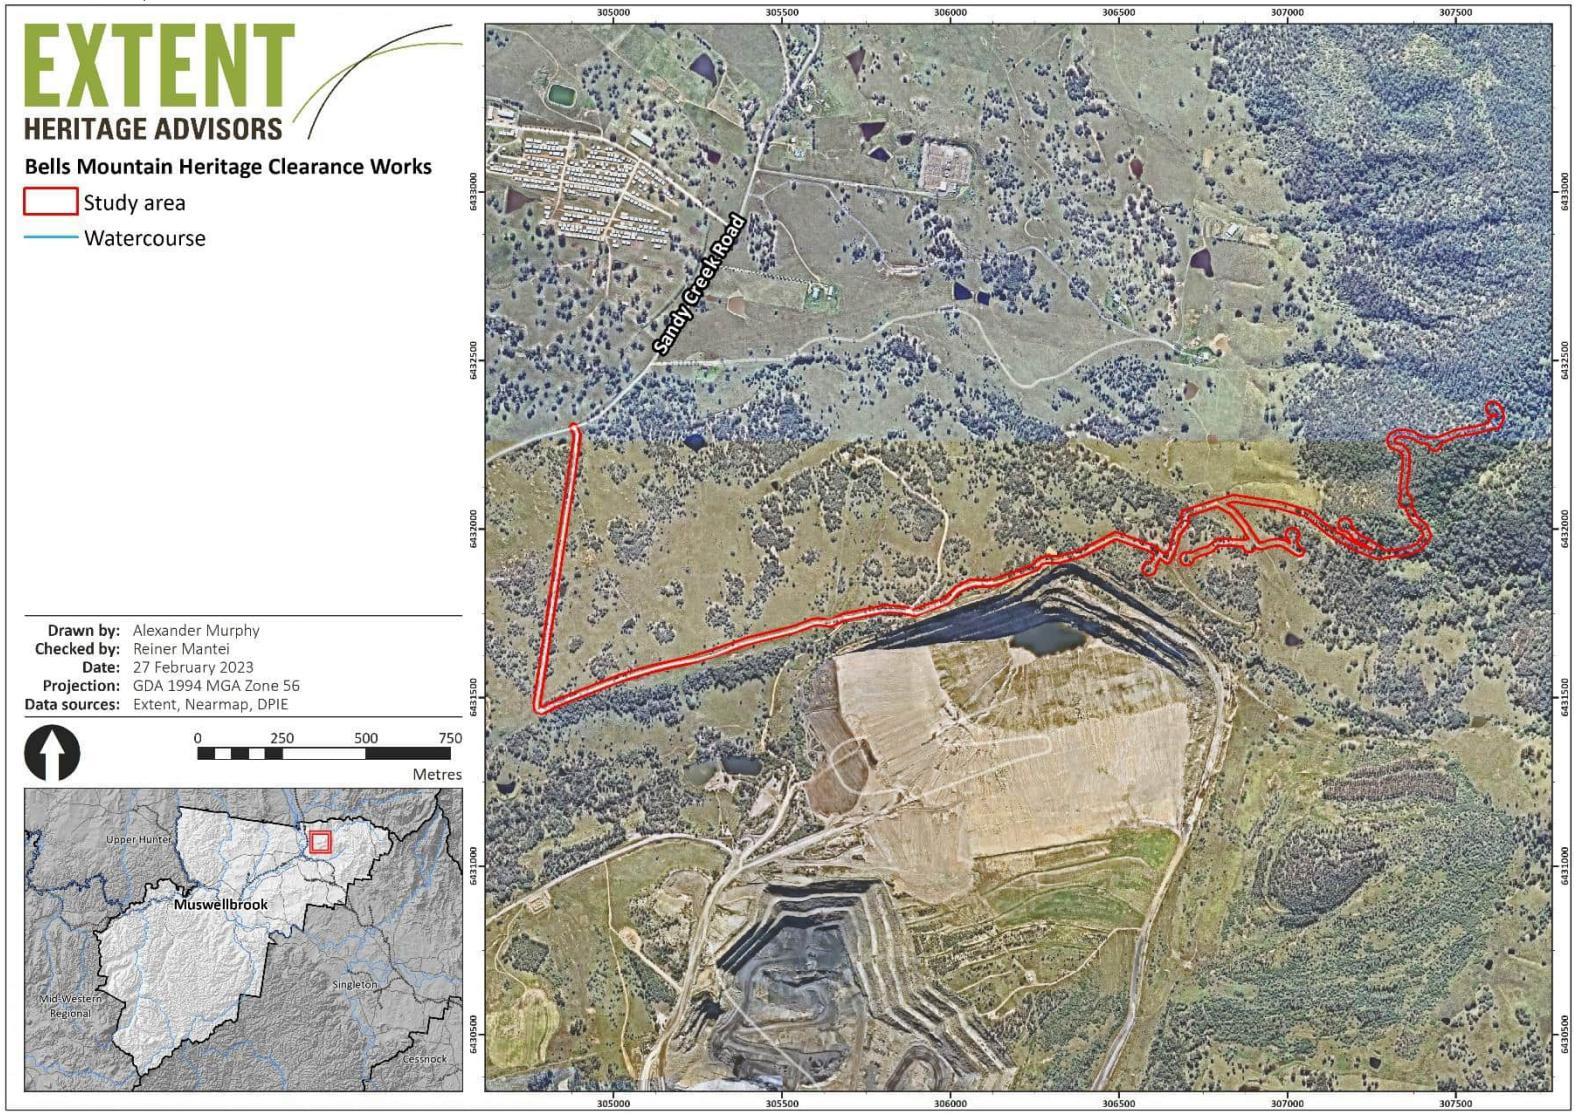
Figure 1. Overview map of Lower Reservoir study area.

The proposed boreholes and test pits would be drilled using a tracked drilling rig and rod carrier. This would cause localised ground disturbance in an area of some 15m x 15m at the drill site. The drilling rig and rod carrier would also be accompanied by various support vehicles including, but not limited to, MR sized rigid support trucks and water cart, LV 4wd vehicles, and the placement of water tanks. The work would also include less invasive activities in an area of some 15 x 15m around the boreholes (e.g., movement of heavy vehicles and pedestrian activity) and geophysical surveys (seismic refraction/reflection) which involves no ground disturbance or vegetation clearing. The program of borehole and test pit investigation would also involve the grading of tracks and management of tracks as illustrated in Figure 1.

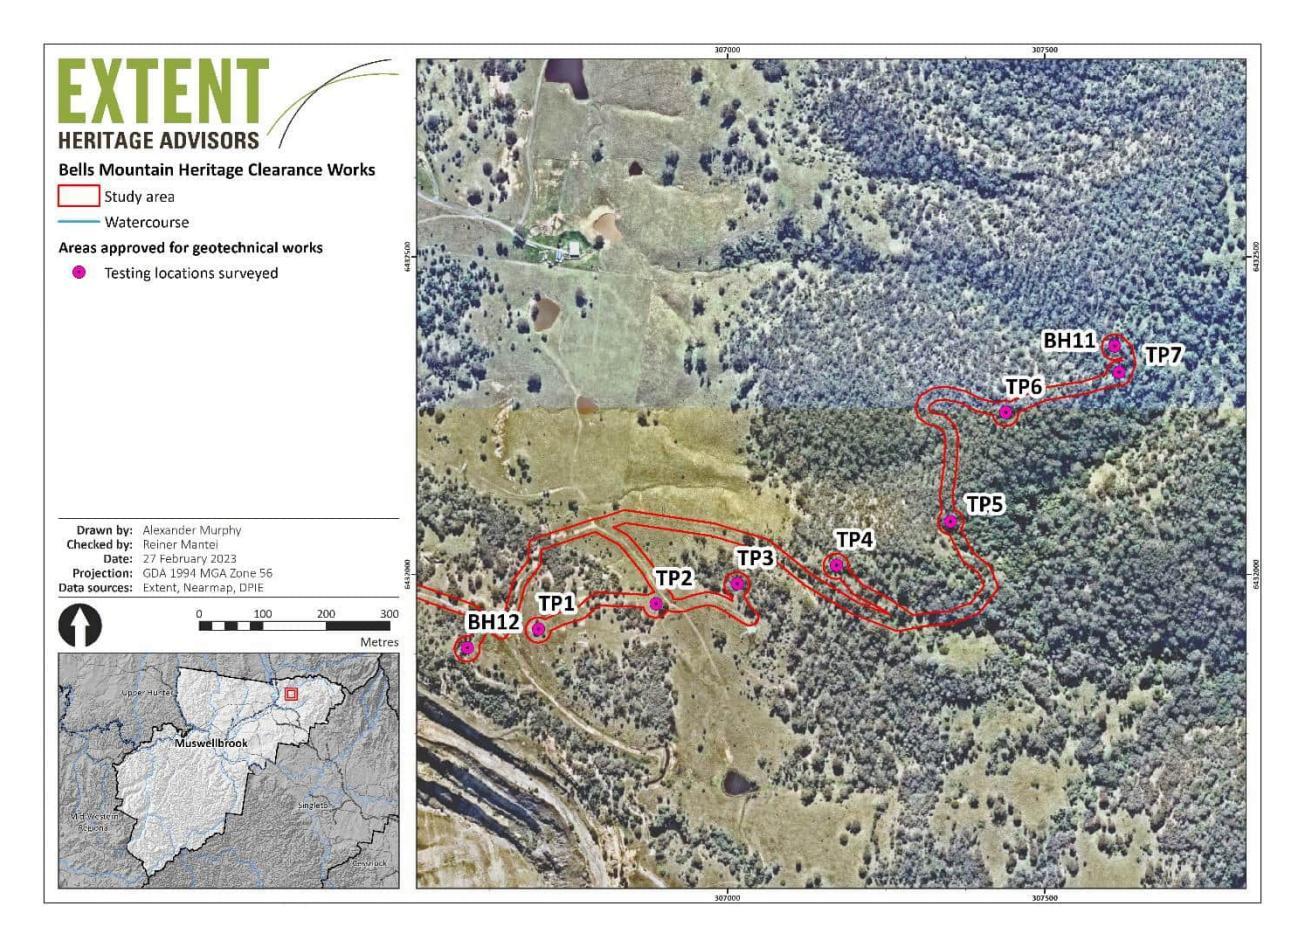
Figure 13. Location of the Boreholes and Test Pits (TP) in the study area; BH11, TP6, and TP7 were not surveyed, being inaccessible.

Conditions entirely prevented survey of TP7 and BH11 and made effective survey of TP5 and TP6 difficult.

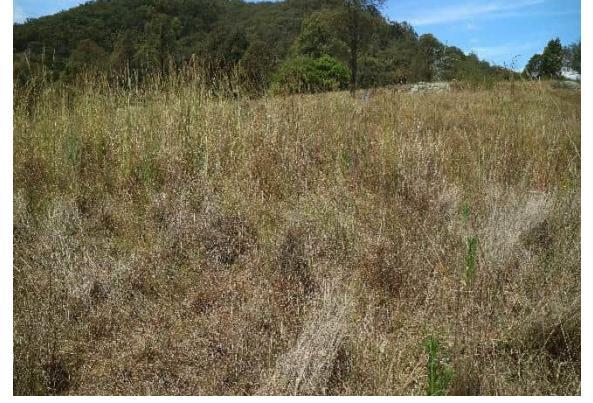
Figure 14. Track between TP1 and TP2 with low GSV.

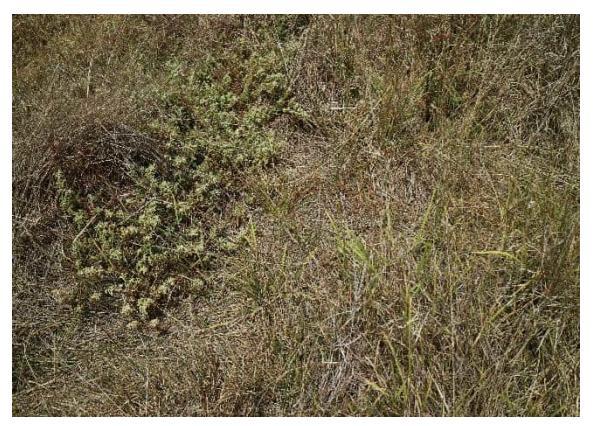
Figure 15. Dense vegetation around TP1 with low GŠV.

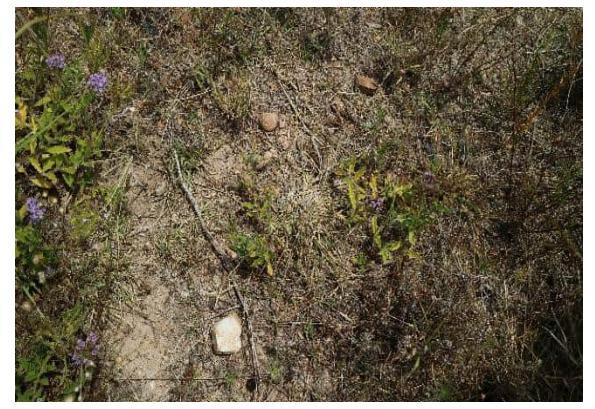
In the area of TP1 it is primarily a conglomerate and sandstone material of various cobble-sized rocks and hence, highly unsuitable as either a quarry for lithic artefacts or as a platform for grinding activities. Based on the shallow soil profiles at the location, and observed levels of disturbance, there is low potential for in situ subsurface Aboriginal archaeology to be impacted by the proposed works there. Similarly, there is low potential for surface Aboriginal archaeological material at BH12 and TP1 to be disturbed by the proposed works.

Figure 16. Area around TP1 and BH12 that has moderate GSV with various sized conglomerate and sandstone cobbles.

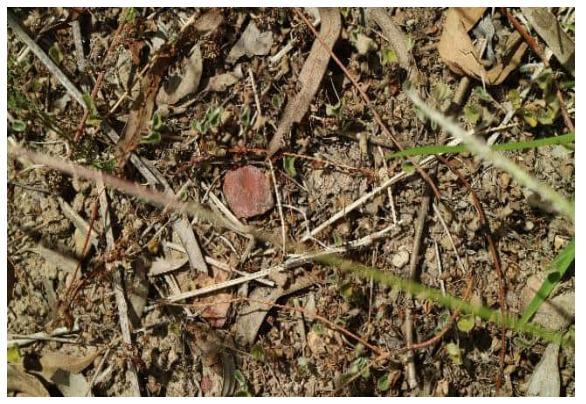
Based on the shallow soil profiles at the site of TP2, and observed levels of disturbance, there is low potential for in situ subsurface Aboriginal archaeology to be disturbed by the proposed works there. Similarly, there is low potential for surface Aboriginal archaeological material at the TP2 locality to be disturbed by the proposed works.

Figure 17. Ground surface around TP2 with moderate GSV; a single piece of red silcrete was identified in the area (not an artefact but indicating that suitable materials for their manufacture are in the study area).

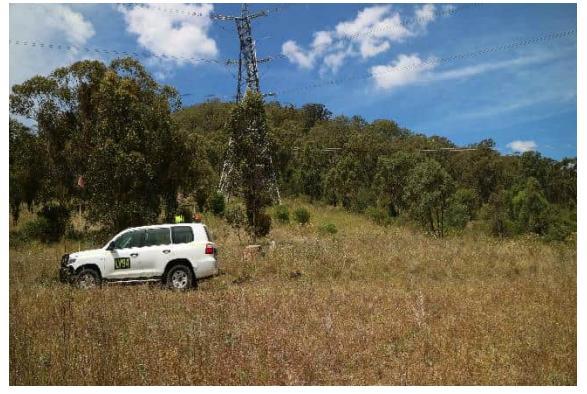
Figure 18. Area around TP2 located in previously disturbed area with transmission power lines, and vehicle tracks nearby.

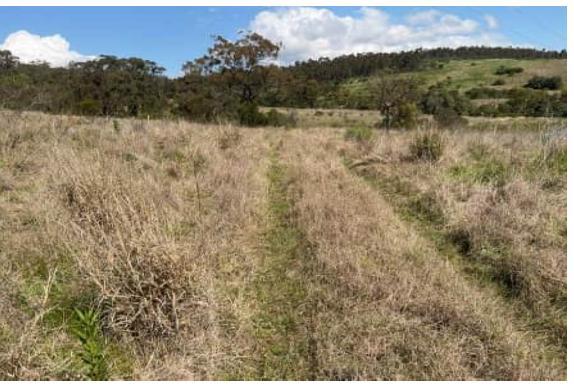
Figure 19. Vehicle track near TP2; either side of the track is overgrown and has poor GSV.

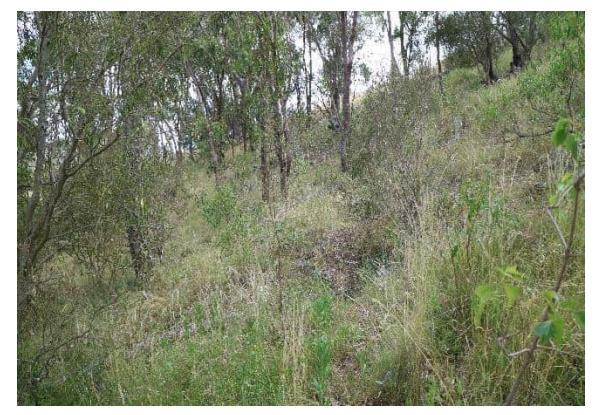
Figure 21. General location of TP3 set into hilly landscape; GSV in the area is poor.

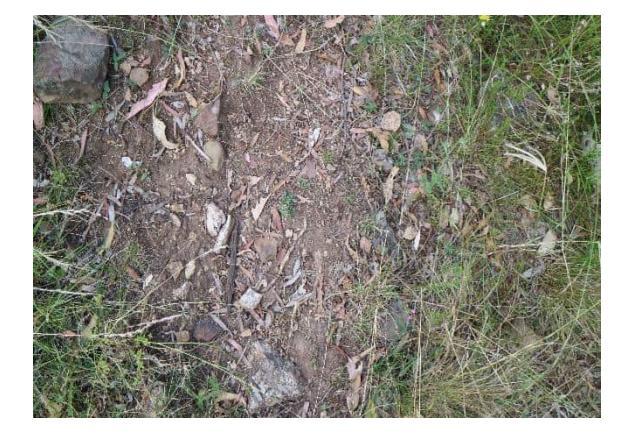
Figure 22. Patch of ground surface at TP3 with moderate GSV; the area contained natural conglomerate rock and no identified artefacts.

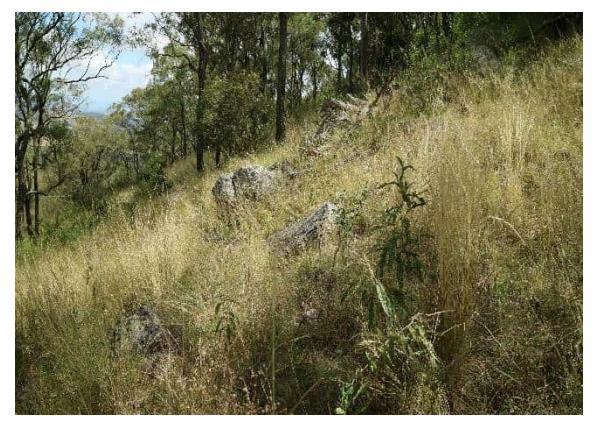
TP4 is situated in a highly disturbed, hilly, grassland environment on the lower slopes of Bells Mountain, where the original vegetation has been cleared. Immature Ironbark trees were found in some locations. The locality is adjacent to remnant/regrowth woodland forest that extends from the mountain to its northeast. The area around TP4 had poor GSV. Patches of conglomerate outcropping along shallow ledges were surveyed for any signs of Aboriginal objects and other signs of activity (such as art, charcoal, or visible smoke staining). However, no Aboriginal objects or evidence of Aboriginal activities were found on the outcrop.

Figure 23. The general location of TP4, with poor GSV. Note conglomerate outcropping.

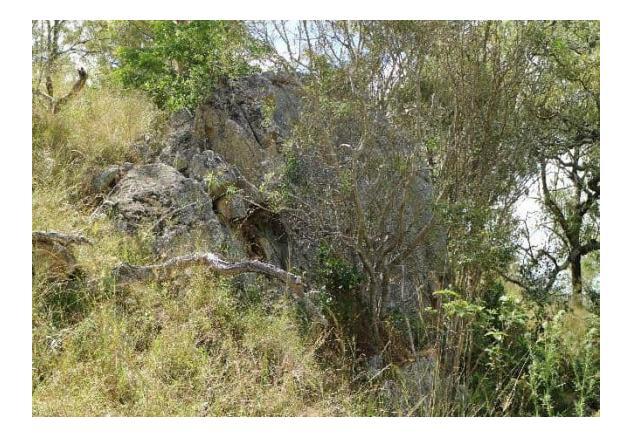
Figure 24. Conglomerate outcrop in vicinity of TP4. Outcrop was investigated.

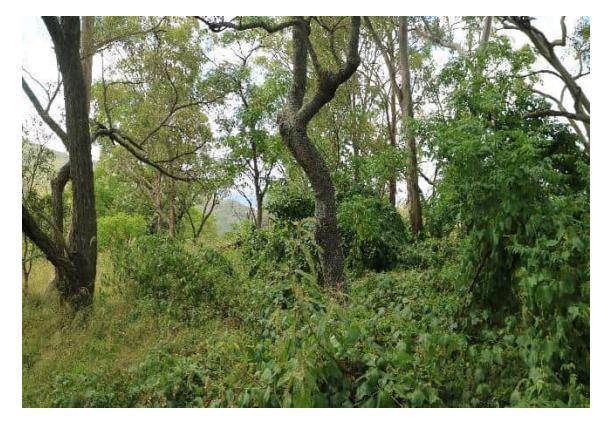
Figure 25. The general location of TP5, that was inaccessible due to fallen tree covered in wild passionfruit.

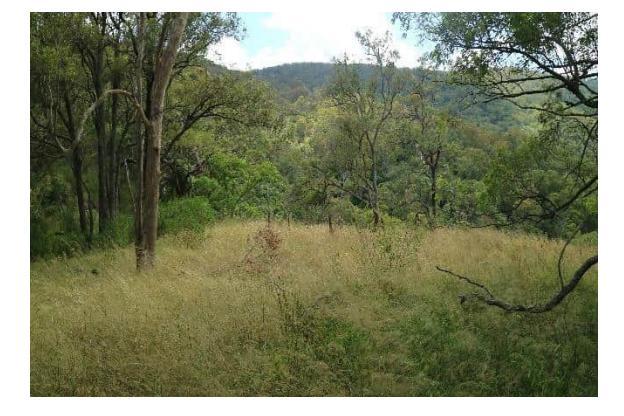
Figure 26. Area around TP5 is completely overgrown with no GSV.

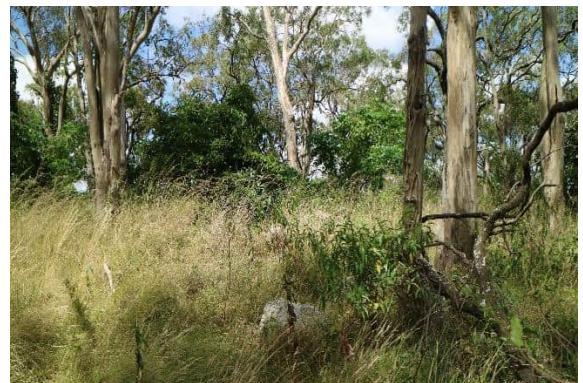
Figure 27. Track between TP5 and TP6 the area is overgrown with dense vegetation and no GSV.

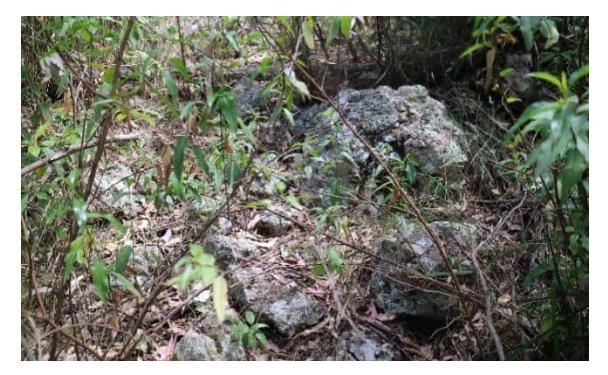
Figure 28. Conglomerate rock exposures on track between TP5 and TP6; no artefacts identified.

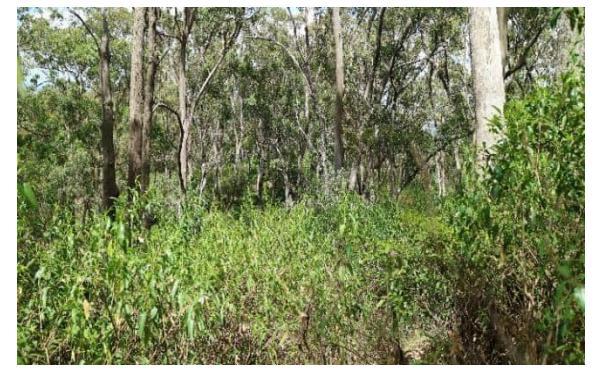
Figure 29. Dense vegetation around TP6, with stands of hot sticky bush surrounding the area, making it completely inaccessible.

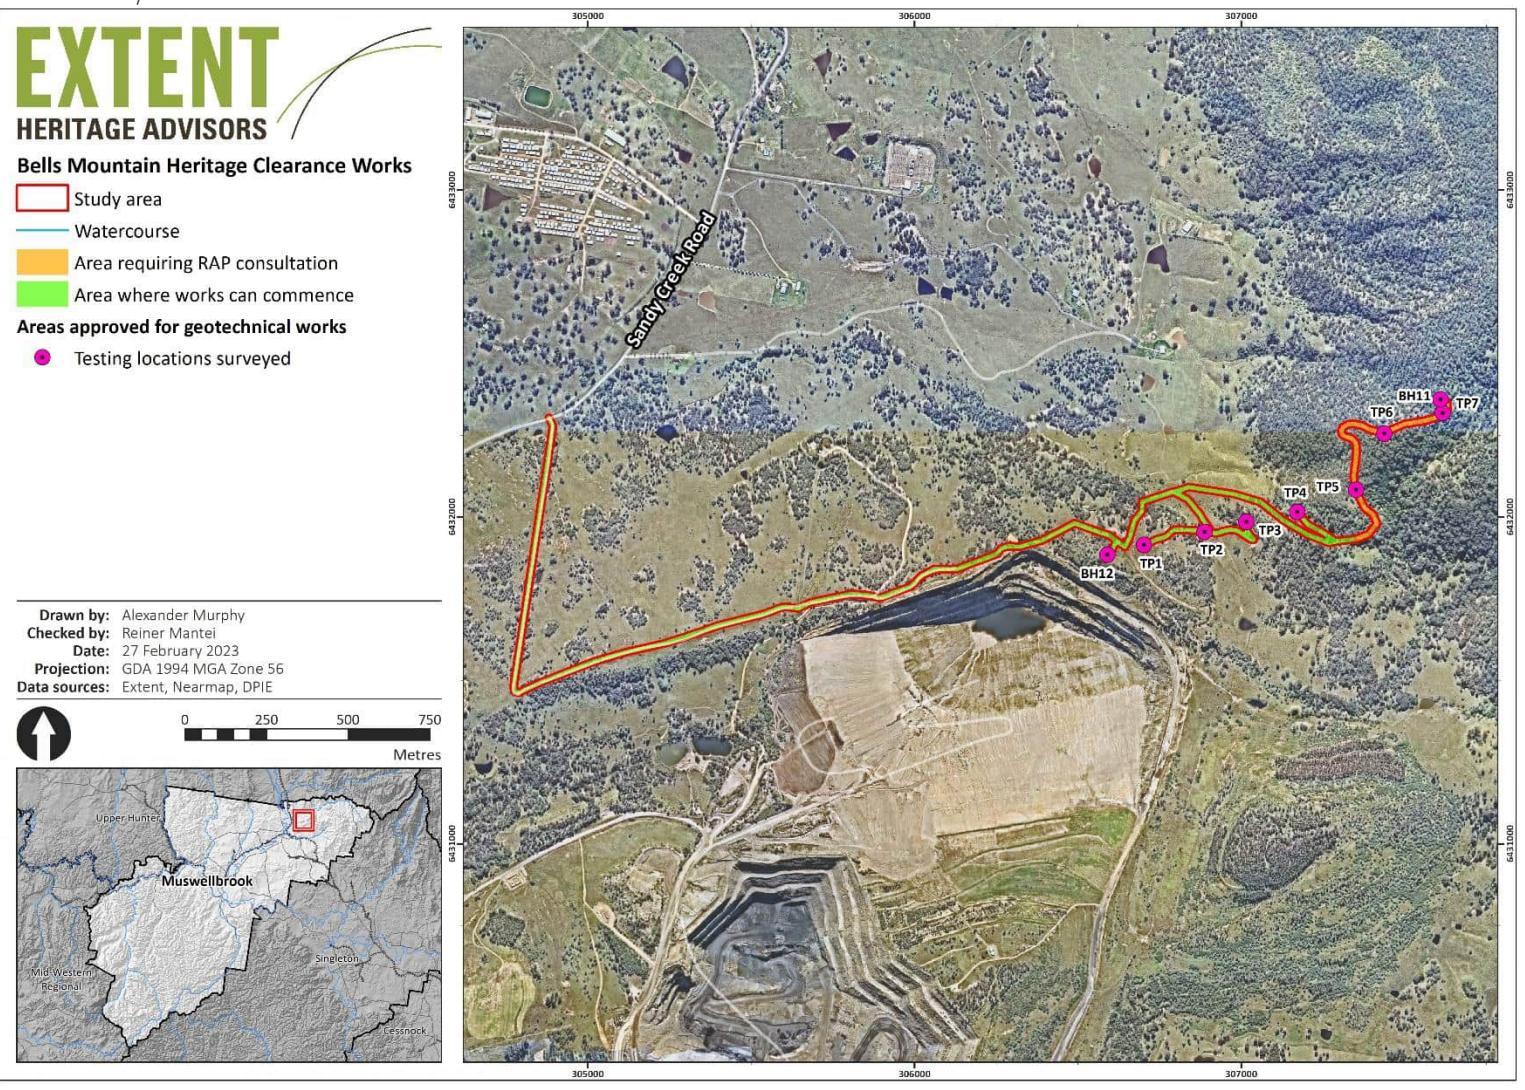
Figure 30. Map illustrating where it would be appropriate for the proposed works to proceed immediately and those areas where additional steps are recommended (the RAP consultation process).

Figure 30, below, illustrates those parts of the study area that could be most effectively surveyed (and where it is appropriate for the works to proceed) and those parts where survey was hampered by poor conditions (and where a cautious approach requires additional heritage management requirements).

To the east of the more effectively surveyed part of the study area, a different approach is recommended (see Figure 30, below). This area (which includes TP5, TP6, TP7 and BH11) is assessed as having an elevated potential for Aboriginal objects. These areas have historically undergone minimal ground disturbance with much of the area never being cleared. It is due to this factor that there is a higher potential for Aboriginal cultural heritage to still exist *in situ*. It is recommended that before works commence in this area a local Registered Aboriginal Party (RAP) be consulted (i.e., Local Aboringinal Land Council), or the statutorily defined processes of RAP engagement be commenced as per the NPW Act.

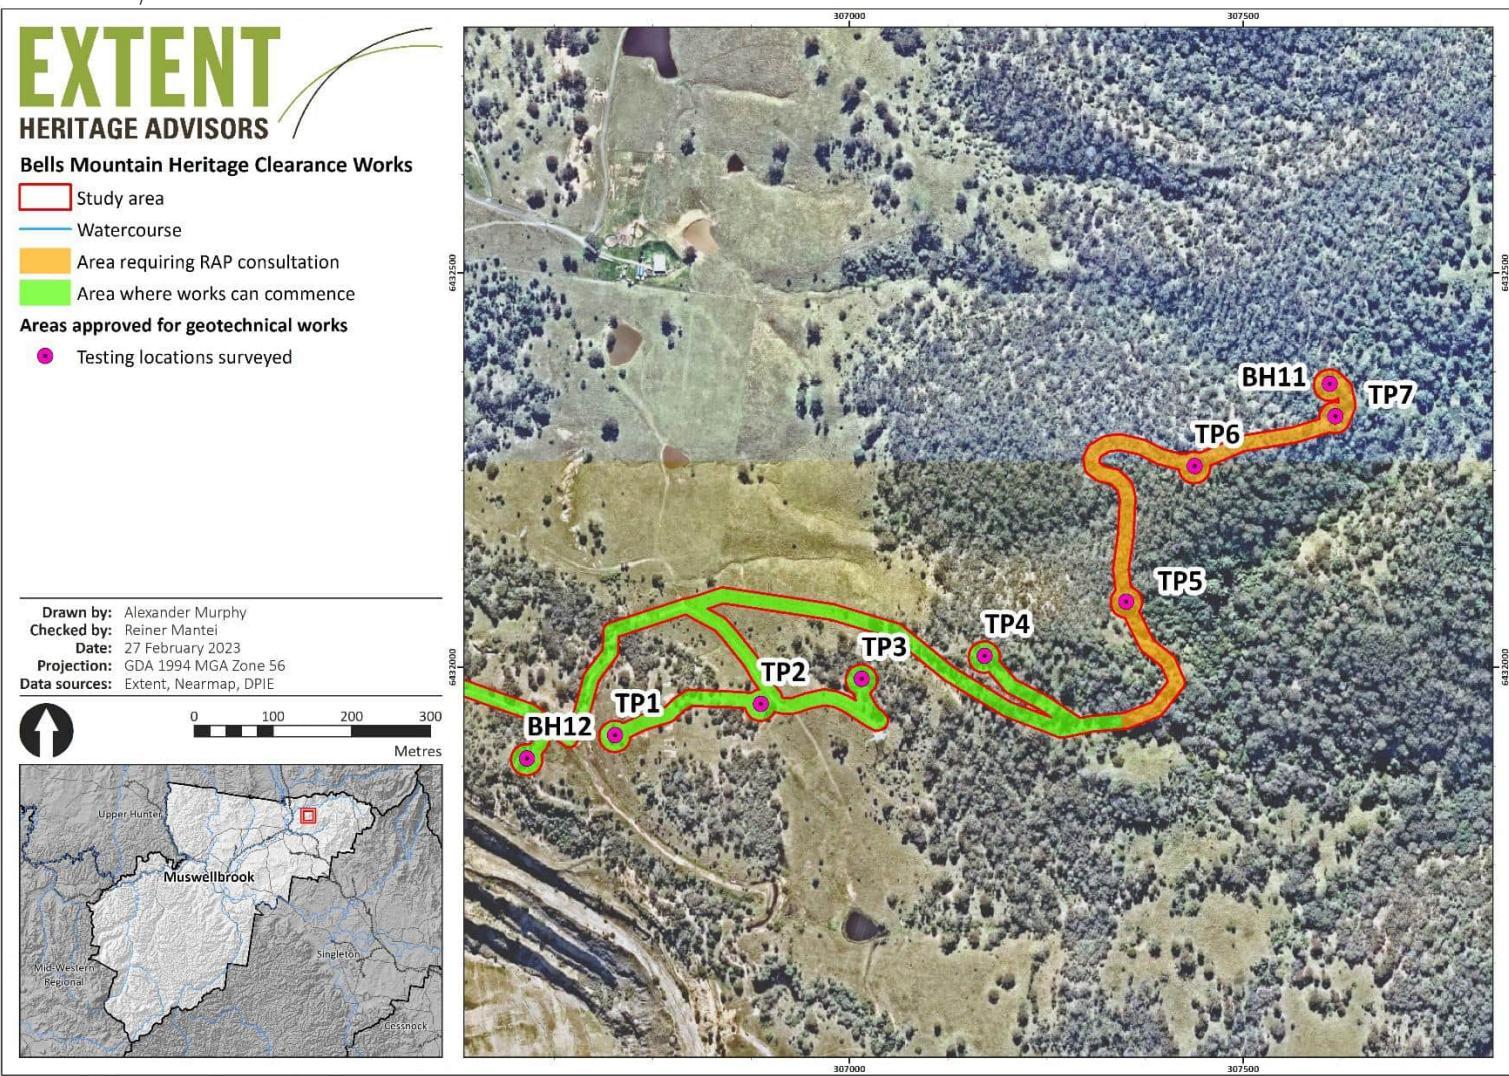
Figure 31 Map illustrating where it would be appropriate for the proposed works to proceed immediately and those areas where additional steps are recommended (the RAP consultation process).
