MUSWELLBROOK HERITAGE STUDY Inventory 1996

'HENNOR' - MUSWELLBROOK

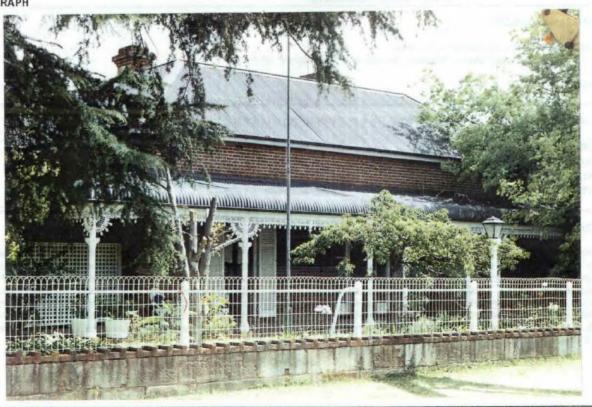
PHOTOGRAPH

Mus into and	plaster walls and ceilings. The house is	SPECIFICATIONS d Victorian Filigree	MATERIALS:	Exterior Eiron roof, o	Brick with galvanised corrugated east iron verandah posts and frieze.
Mus into and PHY a	plaster walls and ceilings. The house is SICAL CHARACTERISTICS / DESIGN ARCH. STYLE Victorian Georgian and	SPECIFICATIONS d Victorian Filigree	MATERIALS:	Exterior Eiron roof, o	Brick with galvanised corrugated east iron verandah posts and frieze.
Mus into and PHY a	SICAL CHARACTERISTICS / DESIGN ARCH. STYLE Victorian Georgian and	SPECIFICATIONS d Victorian Filigree PEARANCE Surrounded by a ling. New brick garage.	MATERIALS:	Exterior E iron roof, o Interior O pieces and	Brick with galvanised corrugated east iron verandah posts and frieze.
Musinto and PHY a	SICAL CHARACTERISTICS / DESIGN ARCH. STYLE Victorian Georgian and OTHER DETAILS OF PHYSICAL APP MODIFICATIONS New perimeter fend CURRENT CONDITIONS VINTAGE	SPECIFICATIONS d Victorian Filigree PEARANCE Surrounded by a ling. New brick garage.	MATERIALS: mature gardens.	Exterior E iron roof, o Interior O pieces and	Brick with galvanised corrugated ast iron verandah posts and frieze. Bedar joinery, marble chimney In plaster walls and ceilings.

Musinto and PHY a b c	OTHER DETAILS OF PHYSICAL APP MODIFICATIONS New perimeter fend CURRENT CONDITIONS INTAC DRMATION SOURCES TTEN National Trust Classification is	SPECIFICATIONS d Victorian Filigree PEARANCE Surrounded by a sing. New brick garage. CT RED - UNSYMPATHETIC FIONAL COMMENTS:	MATERIALS: mature gardens. □ REPAIRS REQU ✓ ALTERED - SY	Exterior E iron roof, o Interior O pieces and	Brick with galvanised corrugated ast iron verandah posts and frieze. Bedar joinery, marble chimney In plaster walls and ceilings.
Musinto and PHY a b c d INFC	OTHER DETAILS OF PHYSICAL APP MODIFICATIONS New perimeter fend CURRENT CONDITIONS INTAC DRMATION SOURCES TTEN National Trust Classification is Hunter Valley News - "Henno"	SPECIFICATIONS d Victorian Filigree PEARANCE Surrounded by a sing. New brick garage. CT RED - UNSYMPATHETIC FIONAL COMMENTS:	MATERIALS: mature gardens. □ REPAIRS REQU ✓ ALTERED - SY	Exterior E iron roof, o Interior O pieces and	Brick with galvanised corrugated ast iron verandah posts and frieze. Bedar joinery, marble chimney In plaster walls and ceilings.
