## Catchment Management Plan for Muscle Creek and Possum Gully

Client: Muswellbrook Shire Council

Reference: PA3263-RHD-MB-XX-RP-C-0001

Date: 2 July 2024

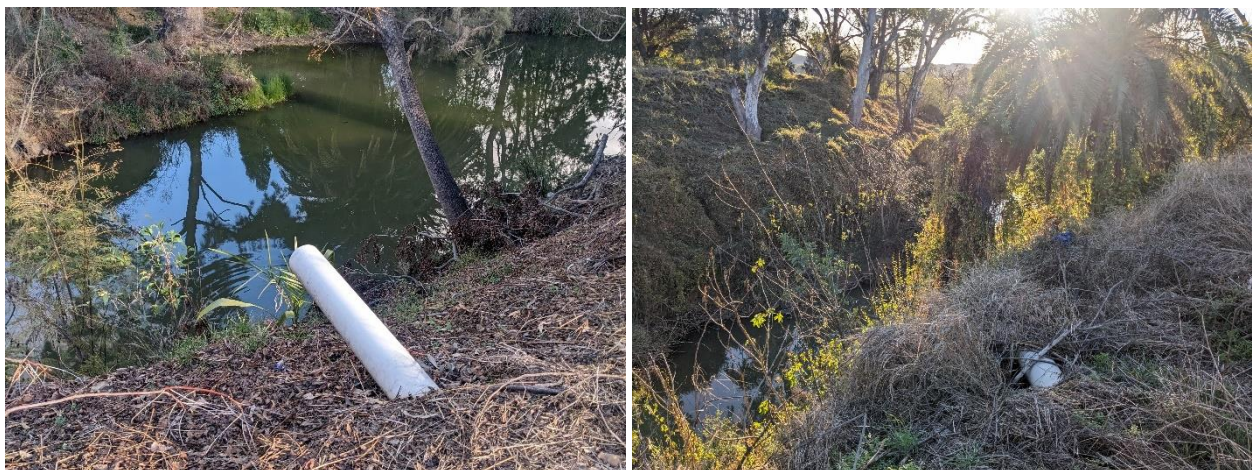
The study catchment includes a constricted stormwater network that consists of underground stormwater pipes, pits, gross pollutant traps (GPTs), substantial culverts at road crossings, stormwater detention basins and open channels. Stormwater detention basins within the catchment reduce stormwater quantity and pollutants to Muscle Creek. The stormwater network is shown in **Figure 7-15**. Many stormwater outlets to Muscle Creek discharge at levels above the low flow channel and most do not have adequate (or in some cases any) scour protection, therefore causing bank scour as shown in **Figure 2-5**.

Figure 2-5: Stormwater outlets that do not have adequate scour protection, therefore causing bank scour. Examples given are located in reach 3 (left) and reach 4 (right).

- Detailed analysis for scour protection at outlet structures (**Figure 2-5**) based on the [Department of Planning and Environment guidelines for outlet structures on waterfront land](#).

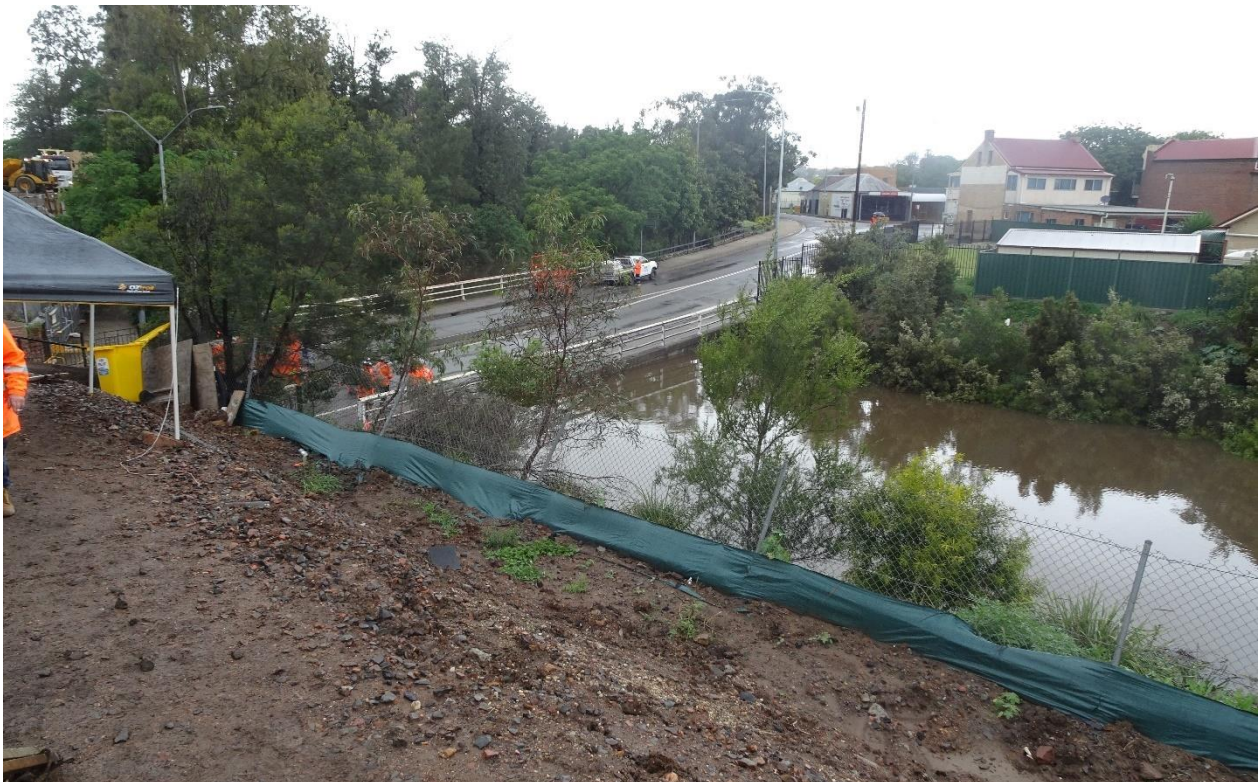
**Figure 2-6** shows the raised water levels that occurred at Muscle Creek in November 2021 where Bridge Street and Muscle Creek cross.

*Figure 2-6: Bridge Street Muscle Creek Flooding in November 2021 (ARTC, 2021)*

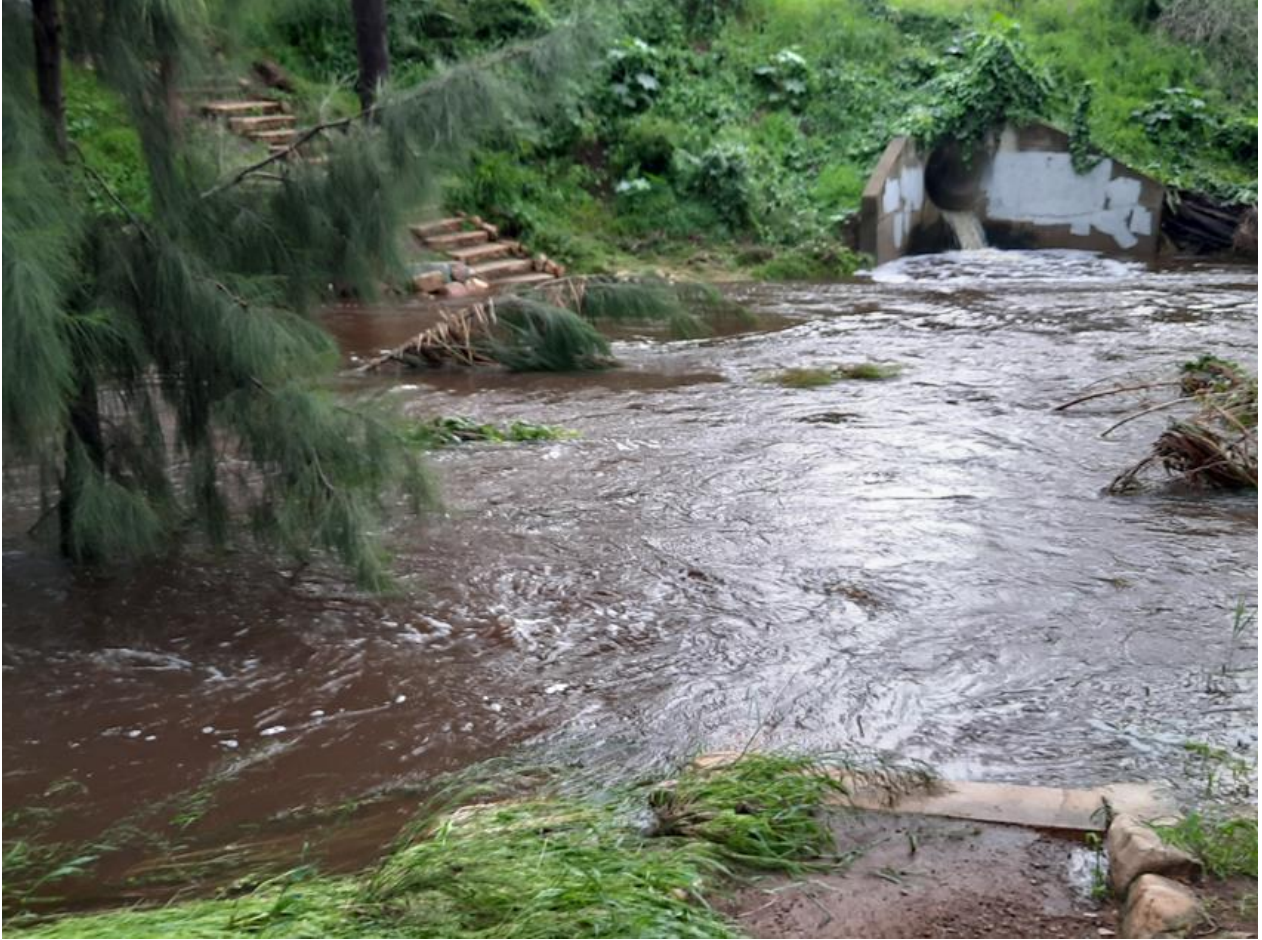
Figure 2-7: Muscle Creek after rain – 14th February 2022 (Council Staff Record)

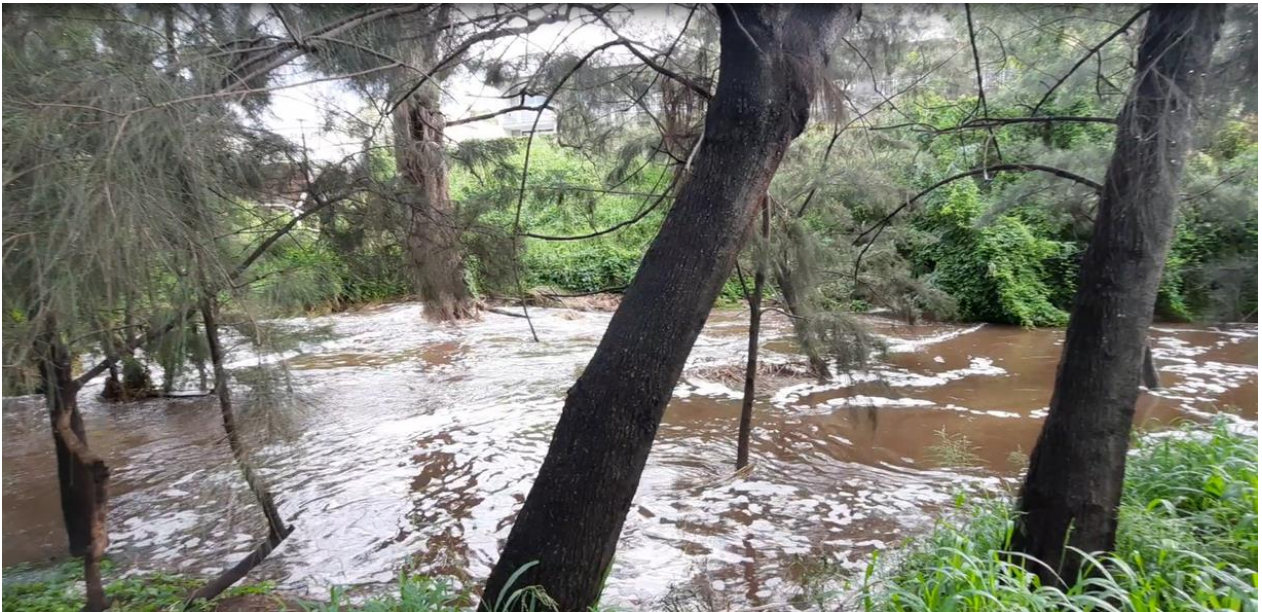
Figure 2-8: Muscle Creek after rain – 14th February 2022 (Council Staff Record)

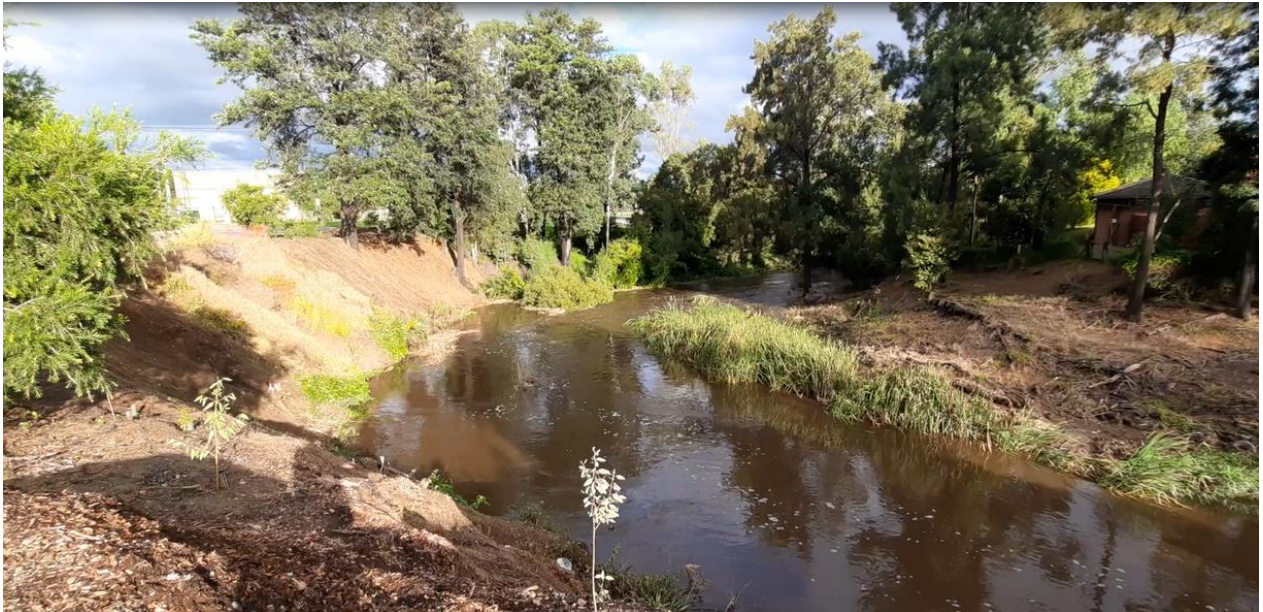
*Figure 2-10: Muscle Creek after rain – 14th February 2022 (Council Staff Record)*

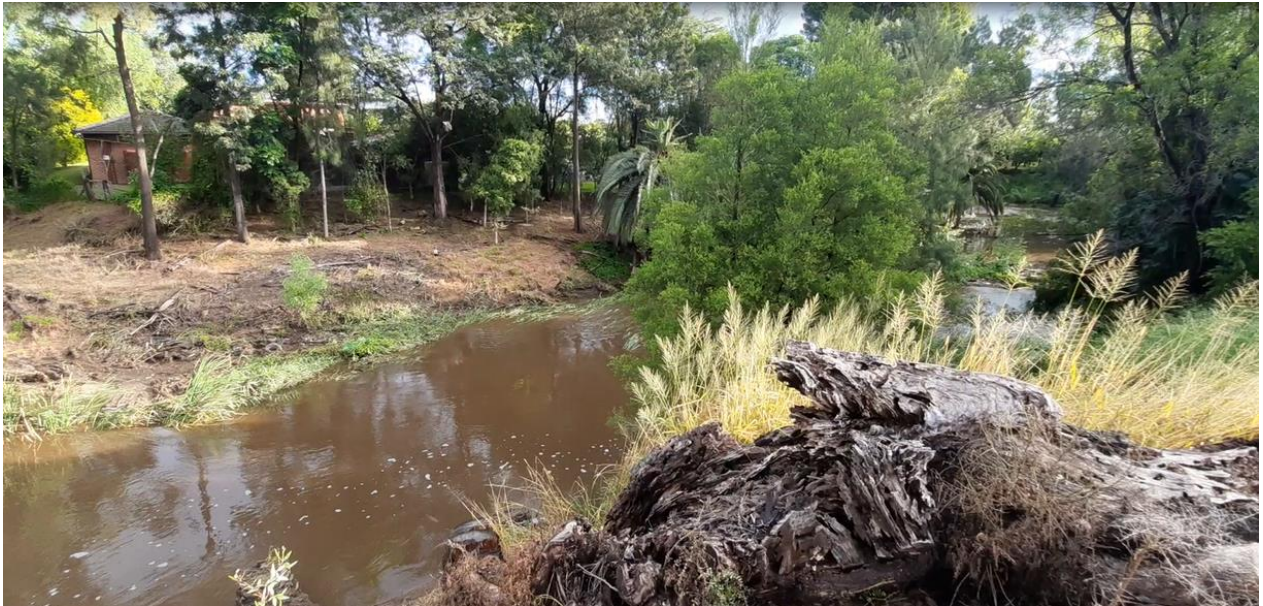
Figure 2-11: Muscle Creek after rain – 14th February 2022 (Council Staff Record)

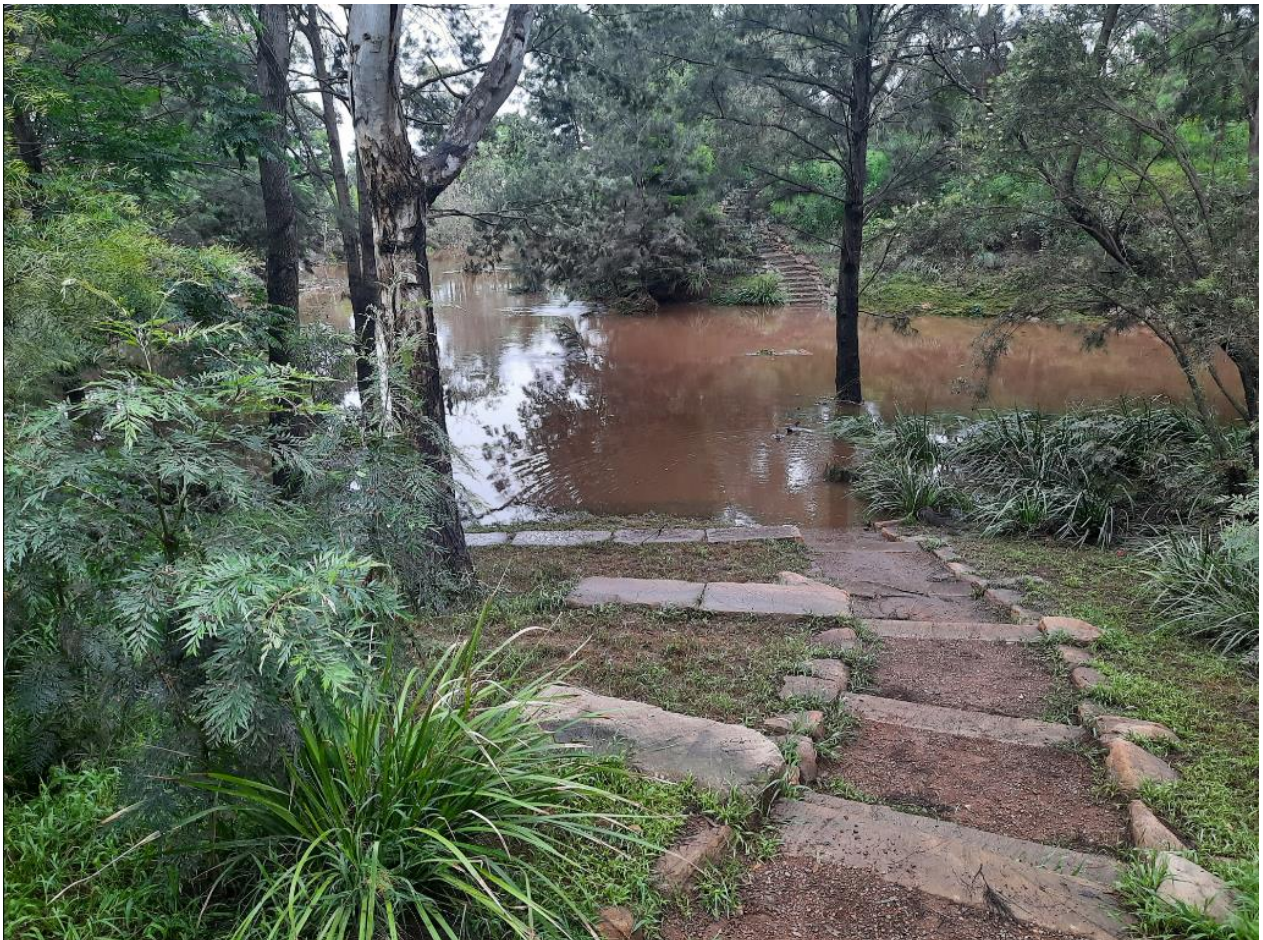
Figure 2-12: Muscle Creek after rain – 11th November 2022 (Council Staff Record)

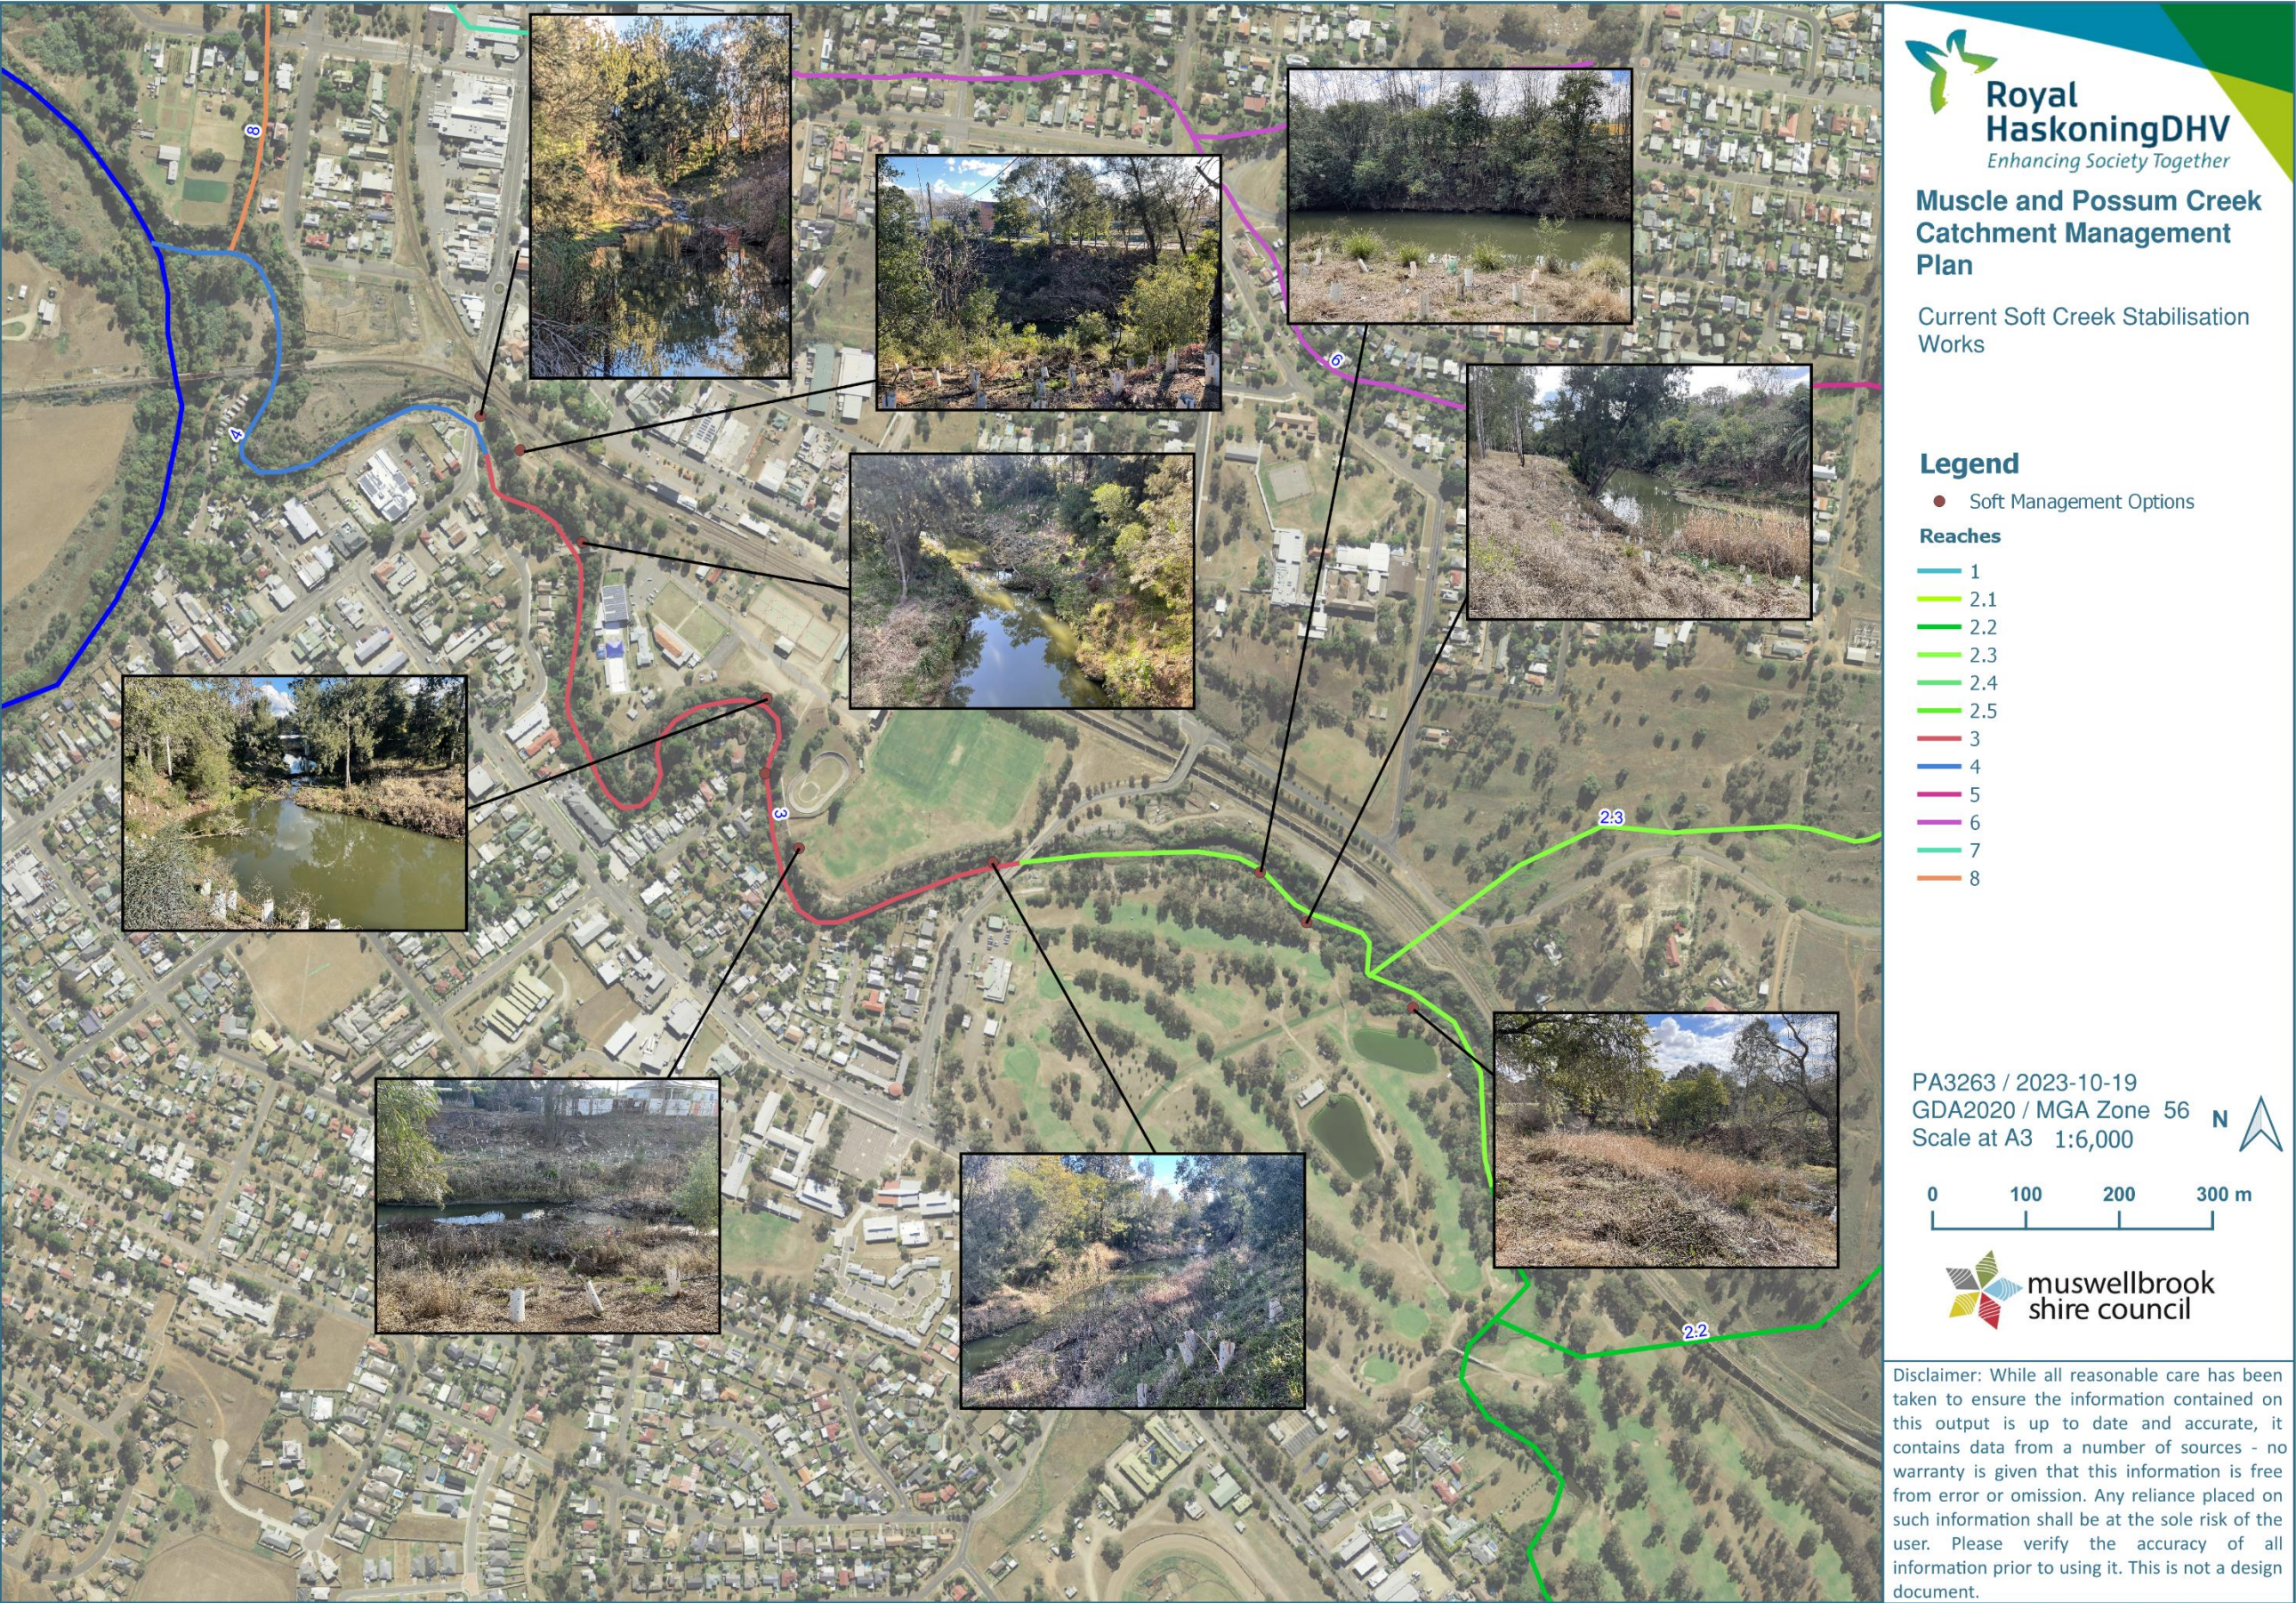
Figure 7-13: Current bank stabilisation works (soft)

Locations of low risk bank instability and higher-risk bank instability are shown in **Figure 7-12** of **Appendix A1** and **Figure 7-35** of **Appendix A6** respectively. Locations where works have previously been undertaken to arrest instability, observed during fieldwork, have been noted in **Figure 7-13** and **Figure 7-14**.
